# DAYTIME BAT SURVEY & BAT EMERGENCE SURVEYS

## GOW HOLE FARM, FURNESS VALE, HIGH PEAK

APRIL - JUNE 2021

**RACHEL  
HACKING  
ECOLOGY**

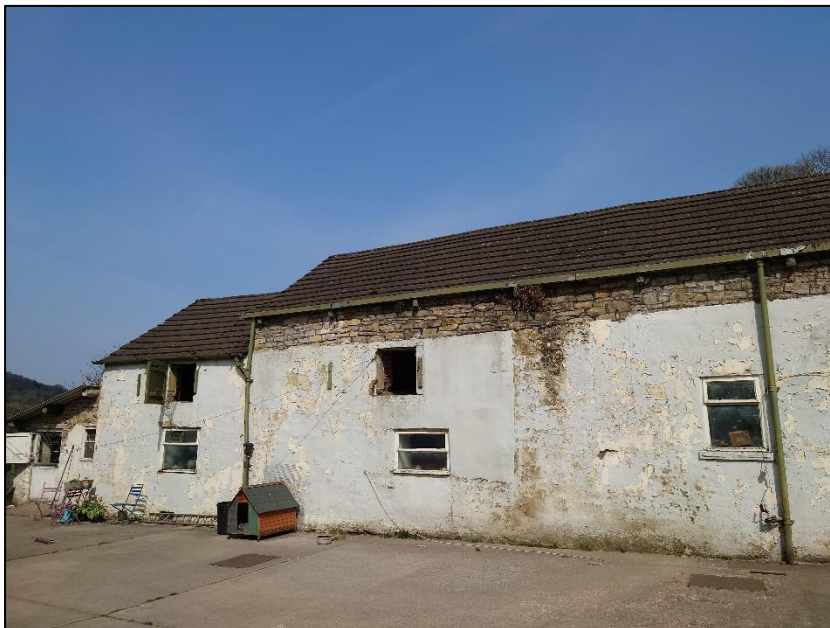
- 3.2 The external stone walls are in reasonable condition and are partially rendered (see Photograph 1). The external render offers no suitable cracks for bats to exploit. The rear elevation and gable wall offer some gaps between stones (see Photograph 2). A small lean-to is attached to the gable end, and this has a sheet-metal roof.

*Photograph 1 showing the exterior of Barn 1*

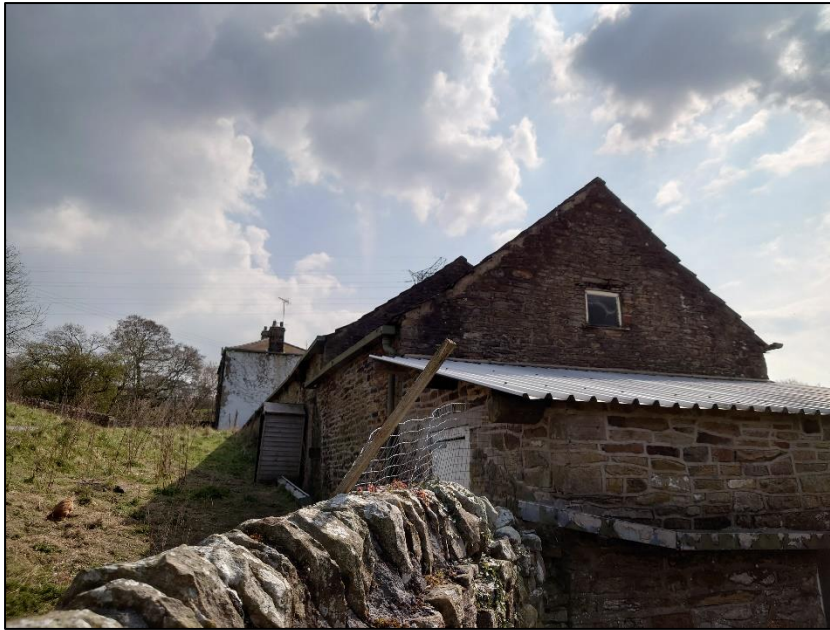
*Photograph 2 showing the gable end of the building*

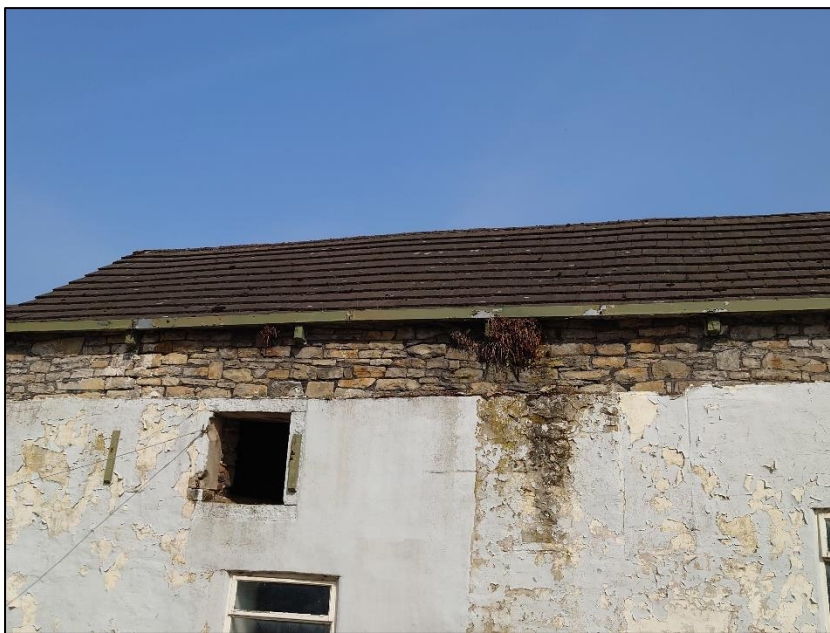
- 3.3 The roof is pitched with clay tiles. The roof tiles are in position and flush to one another (see Photograph 3). The ridge tiles are in situ and mortared. The roof edges are mortared. The barn does not have soffits or bargeboards, and the roof joists penetrate the upper brick courses.

*Photograph 3 showing the roof of the building*

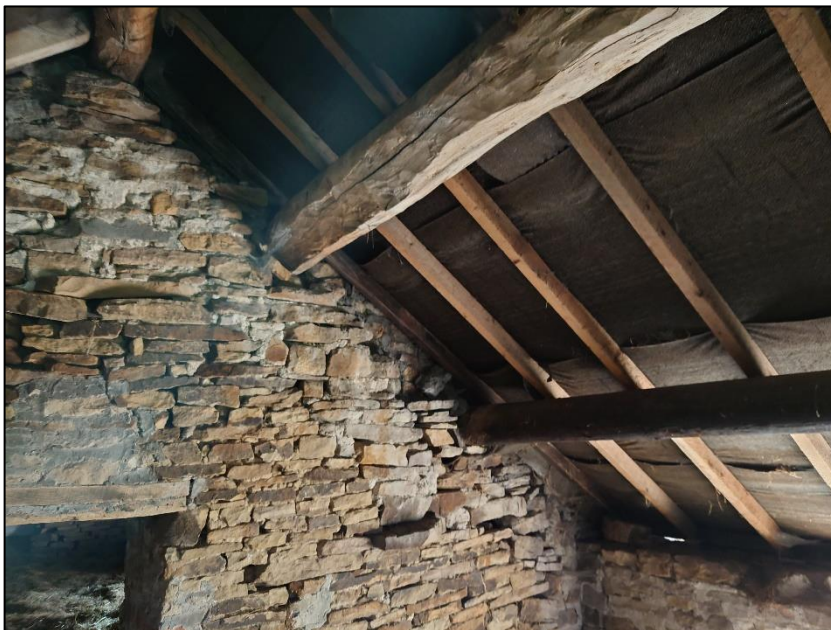
- 3.5 Internally, the upper floor of Barn 1 is accessible and is open to the roof, with no separate roof void present (see Photographs 4 and 5). The roof joists are complete, with no major cracks or gaps. The roof is lined with felt, and there are no major tears in the lining. The internal stone walls are not mortared, with gaps present between the stones. Several of the gaps were searched with an endoscopic camera, with no signs of bat roosting present. Daylight is present at the roof edges.

*Photograph 4 showing the upper floor and internal stonework of Barn 1*

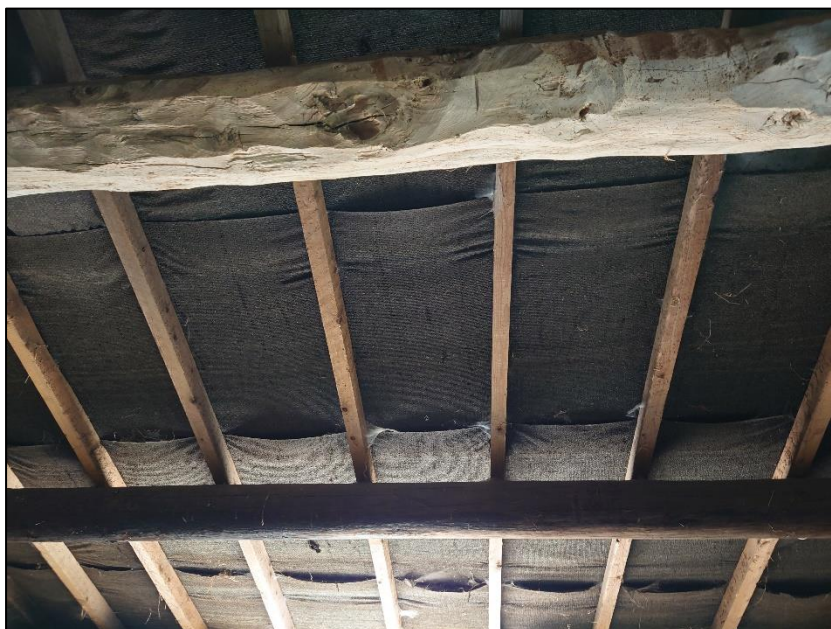
*Photograph 5 showing the roof structure of Barn 1*

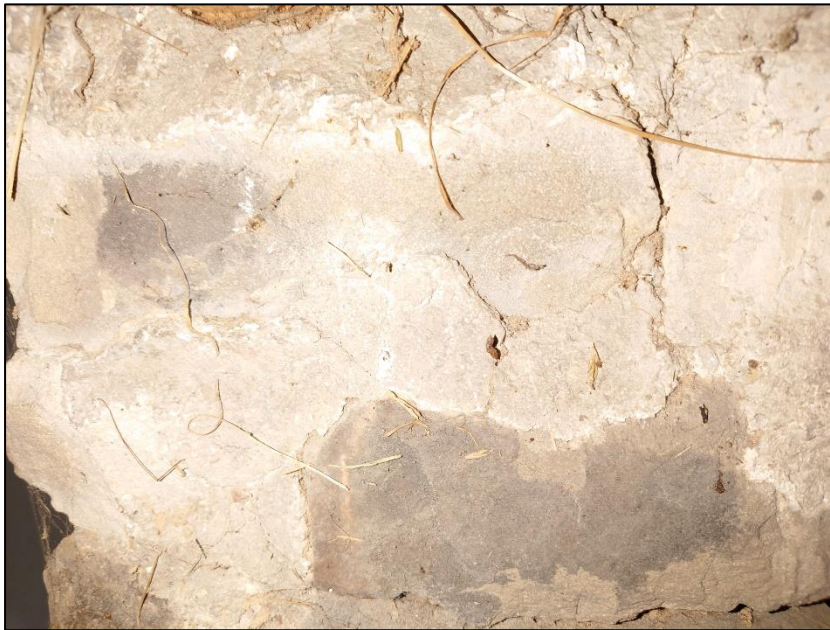
- 3.6 Small numbers of scattered bat droppings (<10) were found within Barn 1, including a couple attached to one of the internal walls (see Photograph 6). No major concentrations of bat droppings are present.

*Photograph 6 showing one of the bat droppings on the wall of the barn*

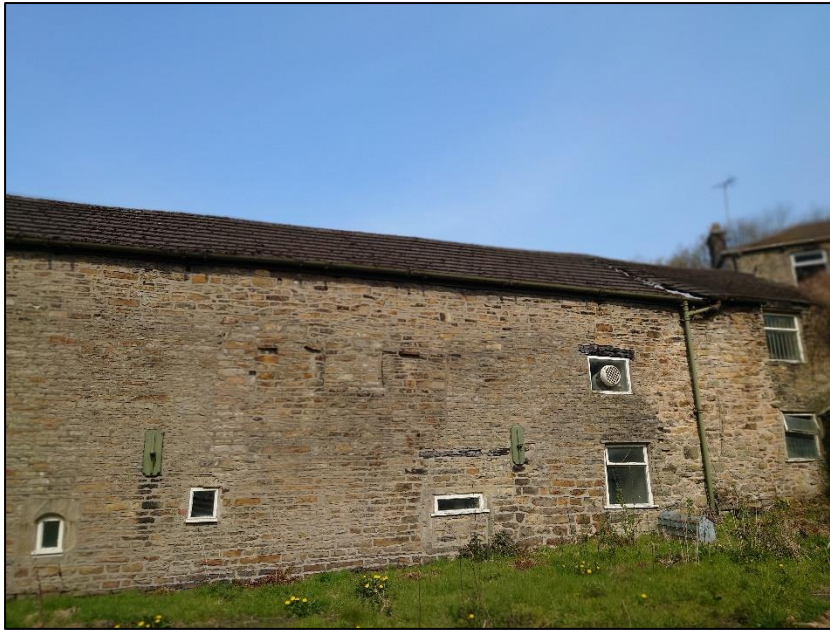
- 3.7 Barn 2 is a large two-storey barn constructed from stone (see Photograph 7). The external stonework is complete and mortared. The front elevation is rendered, with no major cracks in the render (see Photograph 8). The window frames are flush to the surrounding masonry.

*Photograph 7 showing the interior of the property*

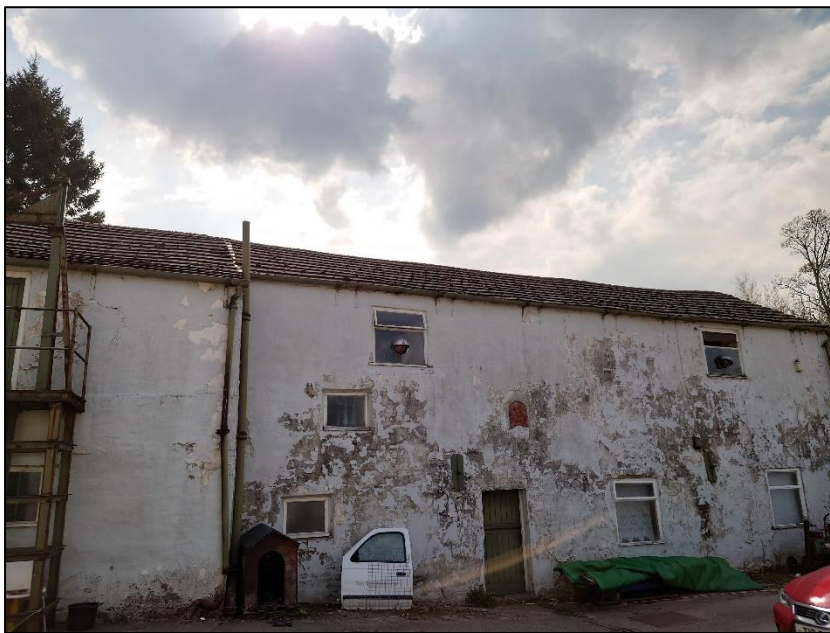
*Photograph 8 showing the exterior of the barn*

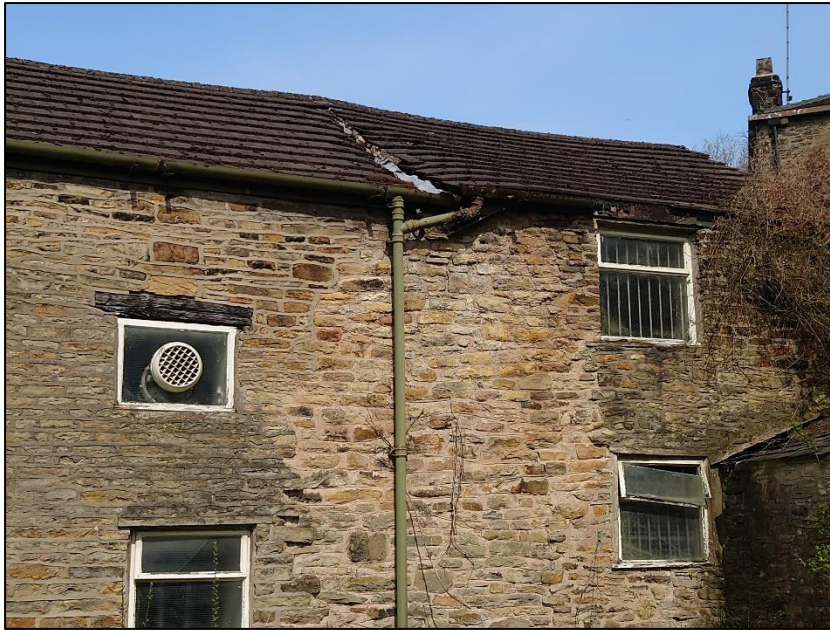
- 3.8 The roof is pitched and tiled with clay tiles (see Photograph 9). The roof tiles are in-situ, and the ridge tiles are present and mortared. The roof is partially lifted on the rear elevation, exposing some of the tiles (see Photograph 9).

*Photograph 9 showing the roof of the barn*

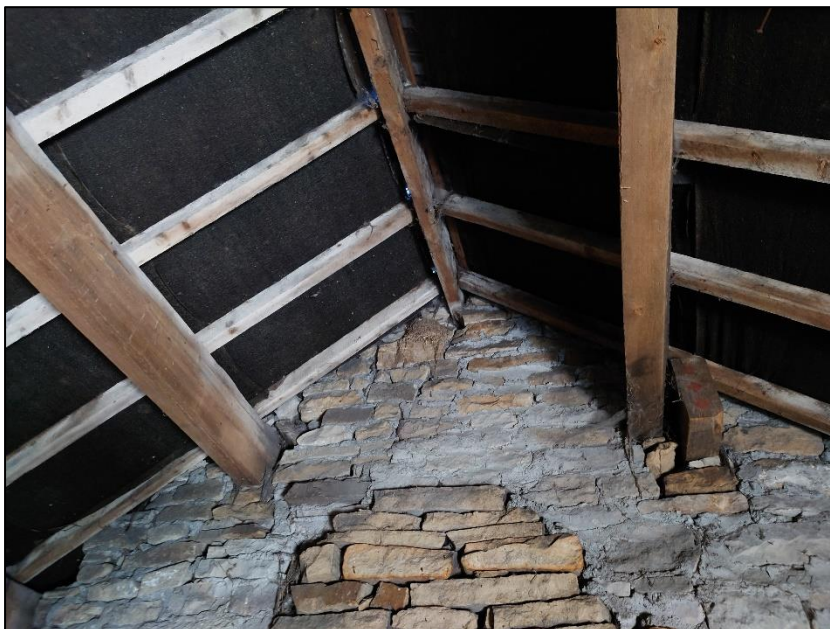
- 3.9 Internally the barn is used for storage. A large roof void is present, covering the expanse of the roof space. The roof joists are complete and without cracks or gaps for bats to exploit (see Photographs 10 and 11). The roof is lined with felt, with no major tears in the lining. The internal stone walls are partially mortared.

*Photograph 10 showing the interior of Barn 2*

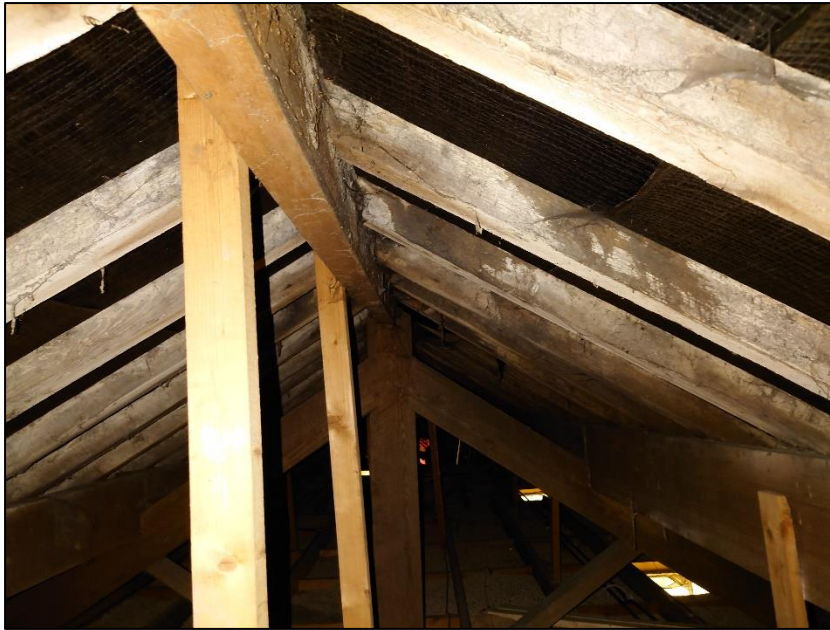
*Photograph 11 showing the roof void of Barn 2*

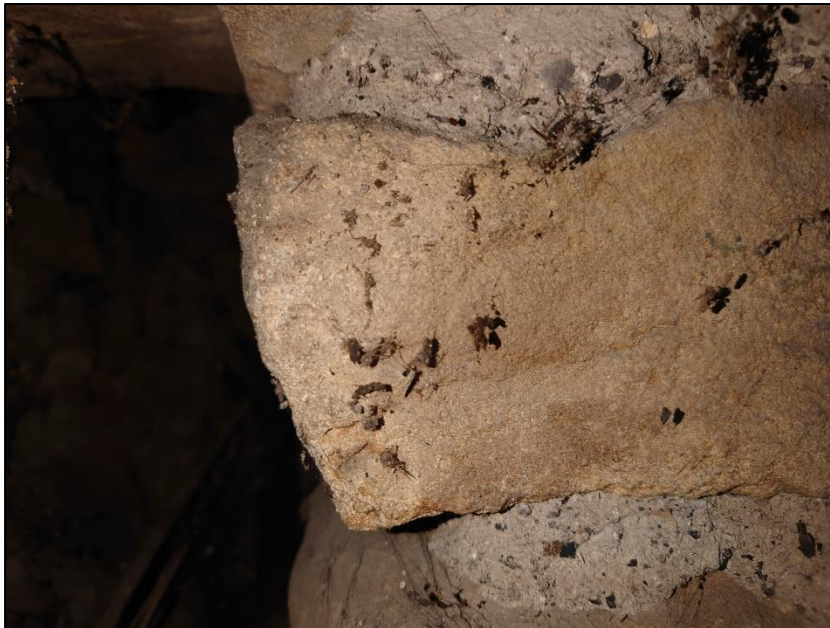
- 3.10 A small number of bat droppings are present in the roof void (<15), with several collected on the gable wall (see Photograph 12). Insect feeding remains are also present in the roof void.

*Photograph 12 showing the bat droppings on the wall of Barn 2*

- 5.4 It is recommended that two Greenwoods Eco Habitat single cavity bat boxes be installed on each barn, following completion of the development, to enhance bat roosting habitat on the site.
