# DAYTIME BAT SURVEY

## LAND ADJACENT TO 1 MELLOR ROAD, NEW MILLS, DERBYSHIRE

OCTOBER 2021

**RACHEL  
HACKING  
ECOLOGY**

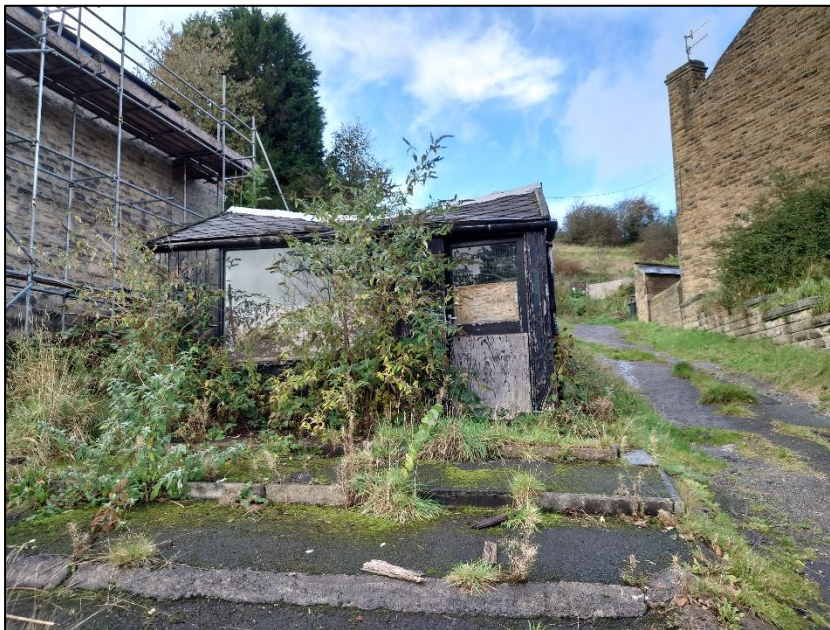
- 3.2 The shed exterior is clad with timber panels. The timber panels are complete, though showing signs of disrepair. The window and door frames are in position (see Photographs 1 and 2). All gaps were searched with an endoscope and no evidence of bat usage was found.

*Photograph 1 showing the exterior of the shed on the site*

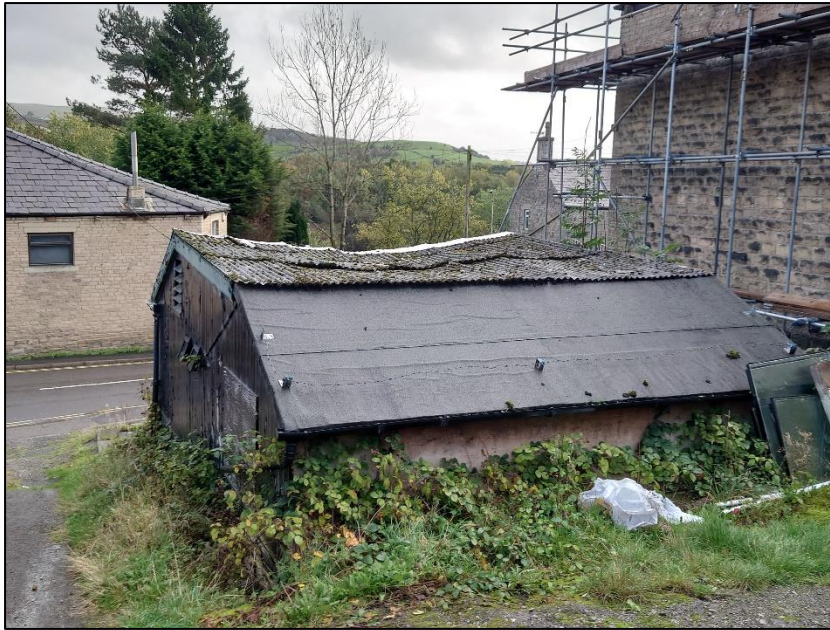
*Photograph 2 showing the rear and side of the shed*

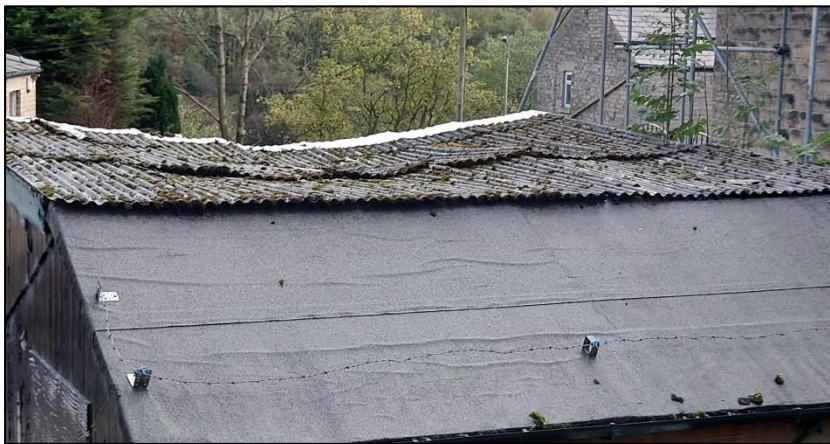
- 3.3 The roof of the shed is constructed from a variety of materials. The roof at the front of the property has sunk. The sheet-metal in the centre of the shed is not flush to one another and is raised in places. The rear of the roof is lined and appears to be in relatively good condition (see Photograph 3).

*Photograph 3 showing roof at the centre and the rear of the shed*

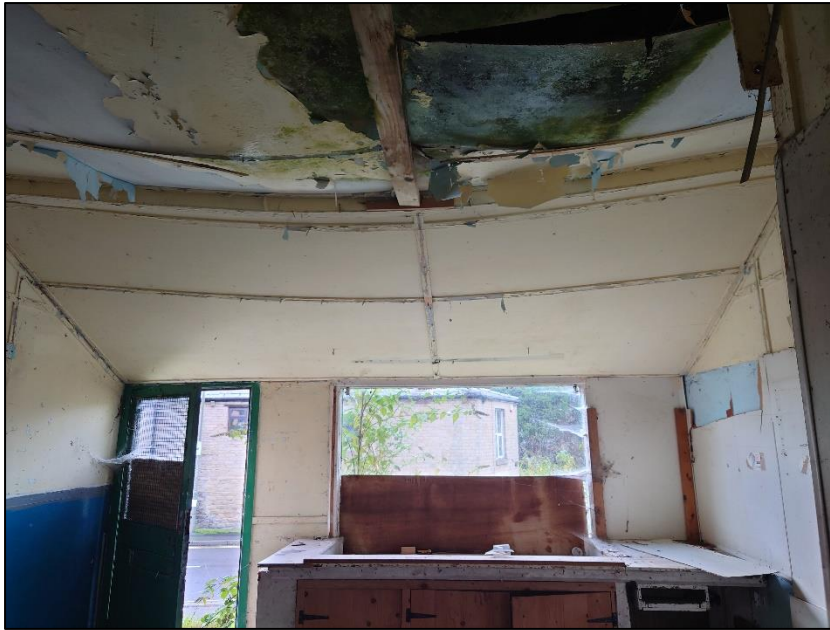
- 3.4 Internally, the shed does not support a roof void (see Photograph 4). The building does not contain any insulation. The roof joists are in poor condition and are rotting in places (see Photograph 5). They are damp and offer no suitable bat roosting cavities. The ceiling is collapsing in places (see Photograph 6). The roof and walls are not sealed, making the interior cold, draughty and well-lit (see Photograph 7). No evidence of bat activity was found inside the shed and no suitable bat roosting cavities were found. No evidence of nesting birds was found.

*Photograph 4 showing the interior of the shed*

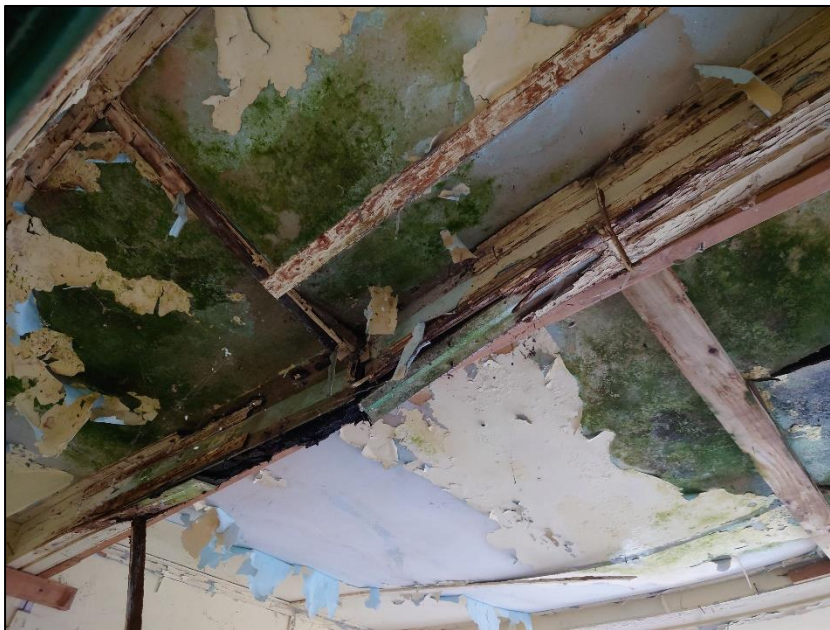
*Photograph 5 showing the damaged roof joists*

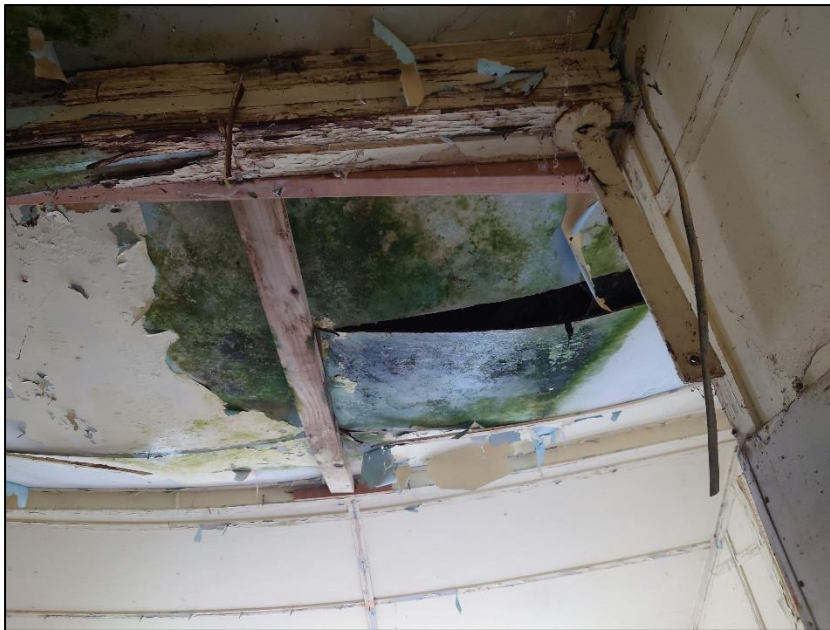
*Photograph 6 showing the ceiling*

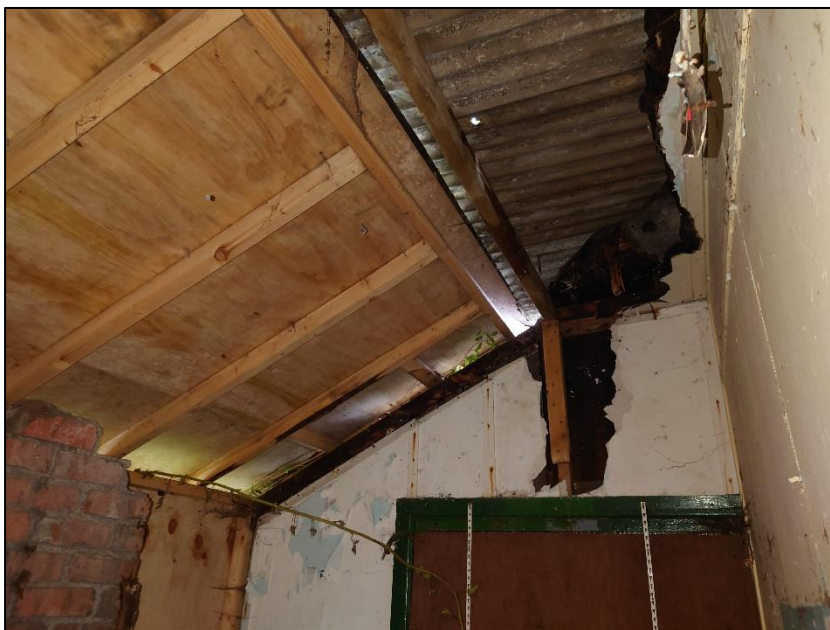
*Photograph 7 showing the state of the walls*

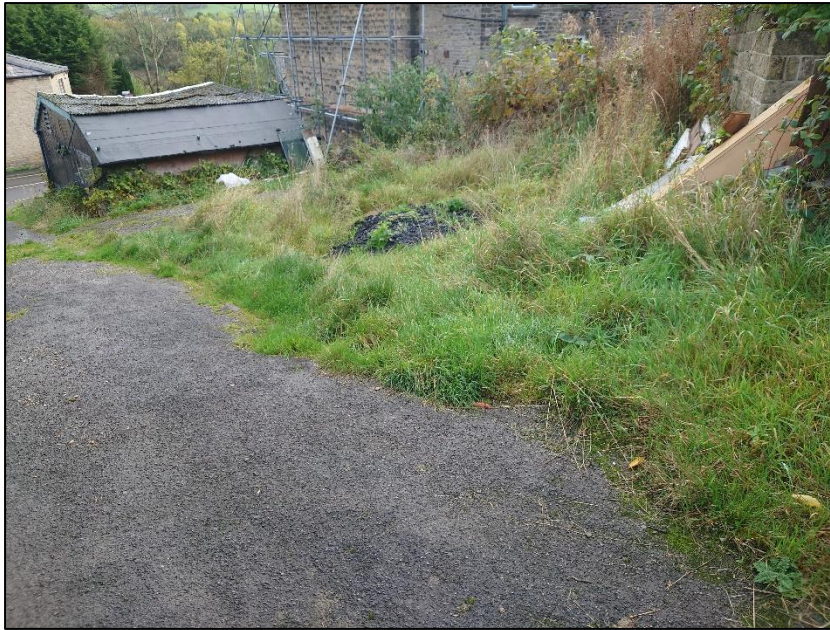
- 3.5 The land on the site comprises of overgrown amenity grassland, scattered scrub, and hardstanding (see Photograph 8). No evidence of other protected species, such as Badger, could be found on the site. No mature trees exist on site.

*Photograph 8 showing the grassland and hardstanding on site*
