# DAYTIME BAT SURVEY

## HIGHWOOD BARN, NEW MILLS, HIGH PEAK

MAY 2022

**RACHEL  
HACKING  
ECOLOGY**

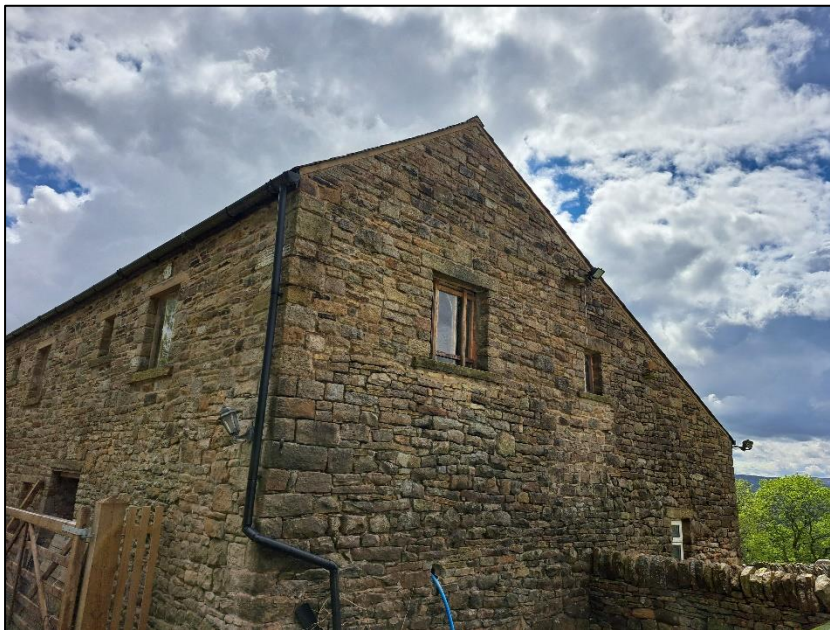
- 3.2 The external stonework is in good condition (see Photographs 1 and 2). Most of the stones are mortared and sit flush to one another. Some small gaps occur between stones on the rear elevation, but these do not provide an onward cavity. The stone window lintels are complete. The window frames sit flush to the surrounding masonry.

*Photograph 1 showing the exterior of the barn*

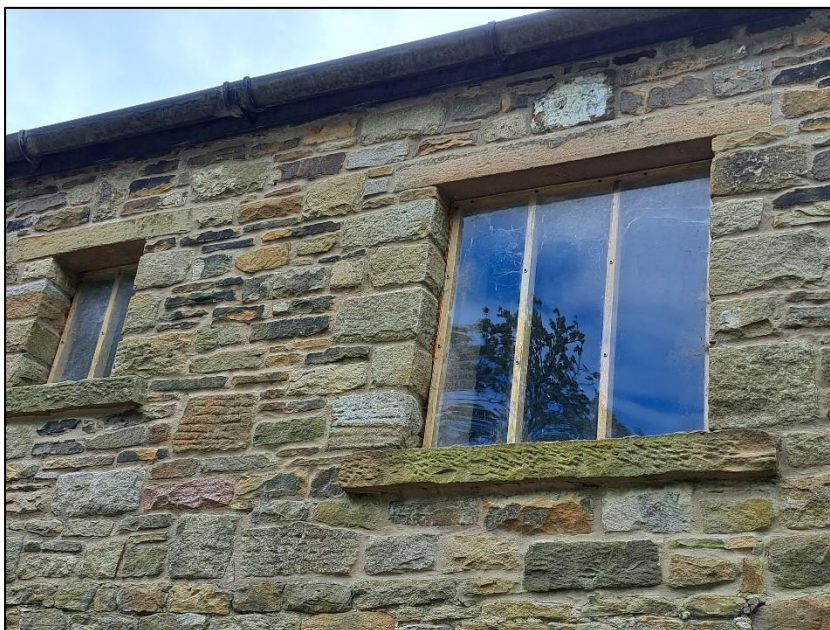
*Photograph 2 showing the stone lintels*

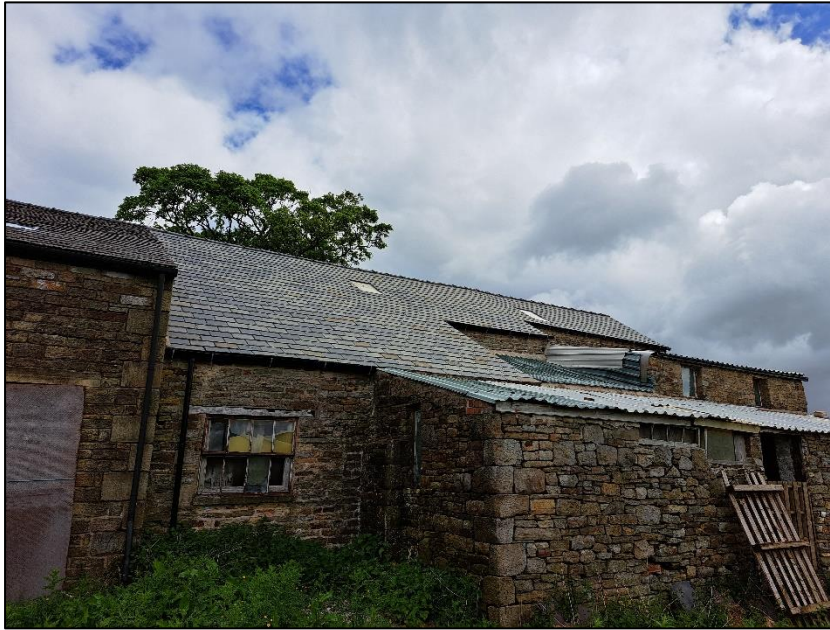
- 3.3 The roof is pitched with slate roof tiles (see Photograph 3). The roof tiles are complete and sit flush to one another. The ridge tiles are complete and mortared. The single-storey extension to the rear has a sheet-metal roof, which is intact.

*Photograph 3 showing pitched roof*

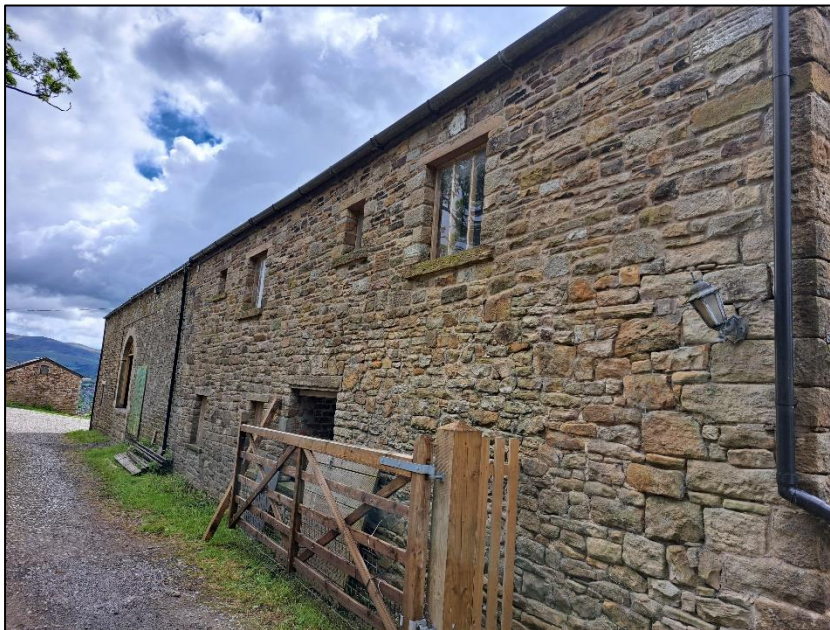
- 3.4 The property does not have soffits, and the roof edges are mortared and sealed (see Photograph 4).

*Photograph 4 showing the barn exterior*

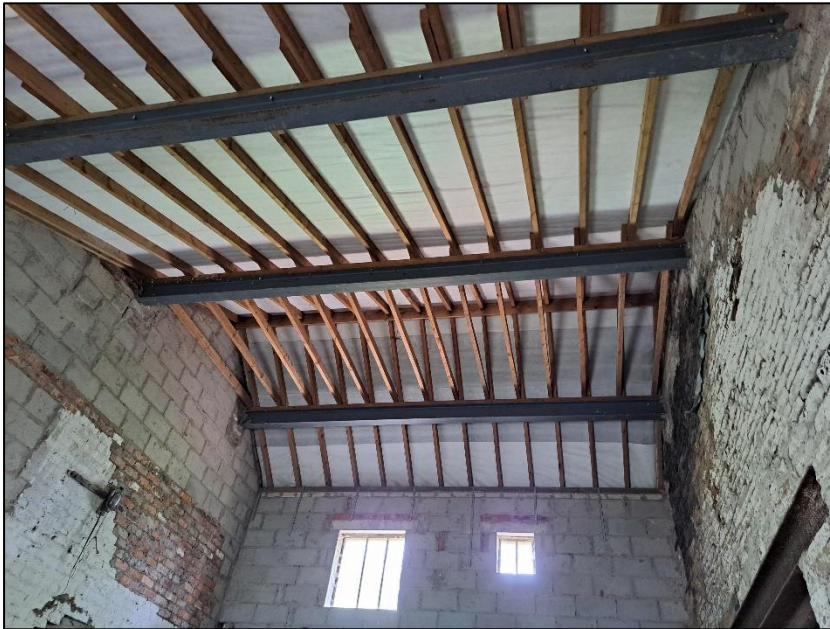
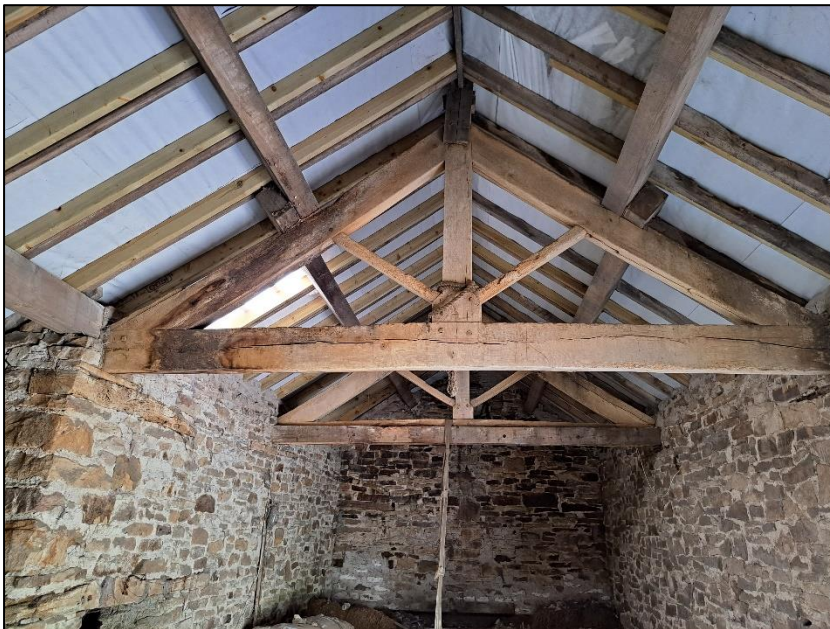
- 3.5 The interior is open to the roof, with no separate roof voids (see Photographs 5 and 6). The roof is new, and the roof joists are complete and intact, offering no cracks for bats to exploit. The roof is lined with Breathable Roofing Membrane, which has no tears or rips. The interior is well-lit. The internal brick and breezeblock walls are complete and mortared.

*Photograph 5 showing the barn interior*

*Photograph 6 showing the barn interior*

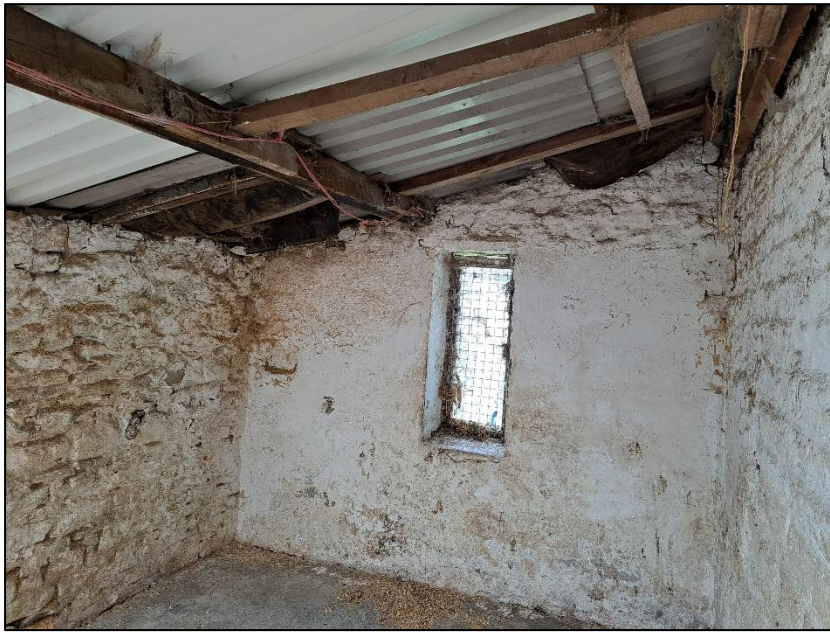
- 3.6 No evidence of bat activity, such as bat droppings, could be found inside the main section of the barn. The interior of the single-storey section also has no roof void (see Photograph 7). The roof joists in this section are complete, and the internal walls are cemented. No evidence of bat activity was found in this section.

*Photograph 7 showing the interior of the single-storey section*
