# DAYTIME BAT SURVEY & NESTING BIRD SURVEY

## HORWICH LODGE, WHALEY BRIDGE, HIGH PEAK

SEPTEMBER 2022

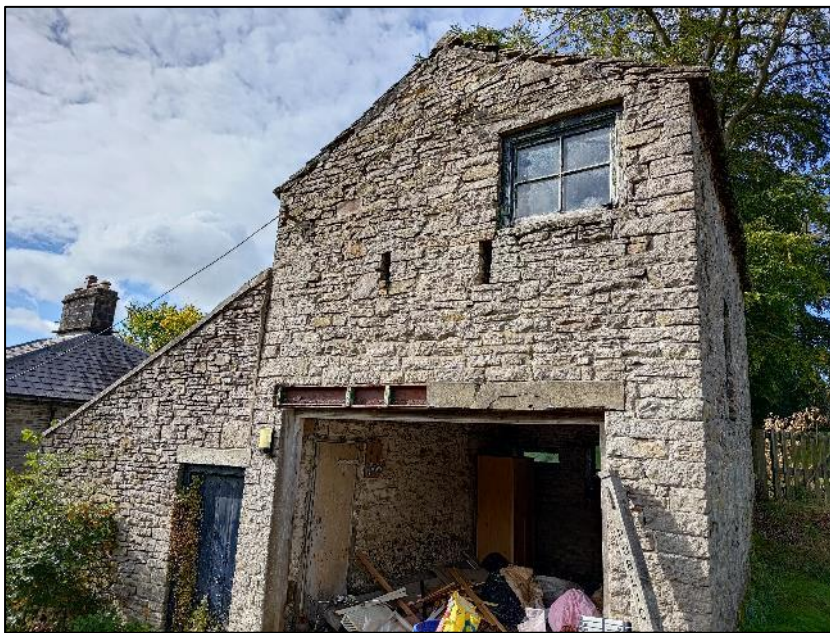
- 3.2 The external stone walls are complete and mortared (see Photographs 1 and 2). The walls are mortared, with ventilation holes present on each elevation. The window frames are rotting but retain a good seal with the surrounding masonry. The front elevation is open.

*Photograph 1 showing the front elevation of the dwelling*

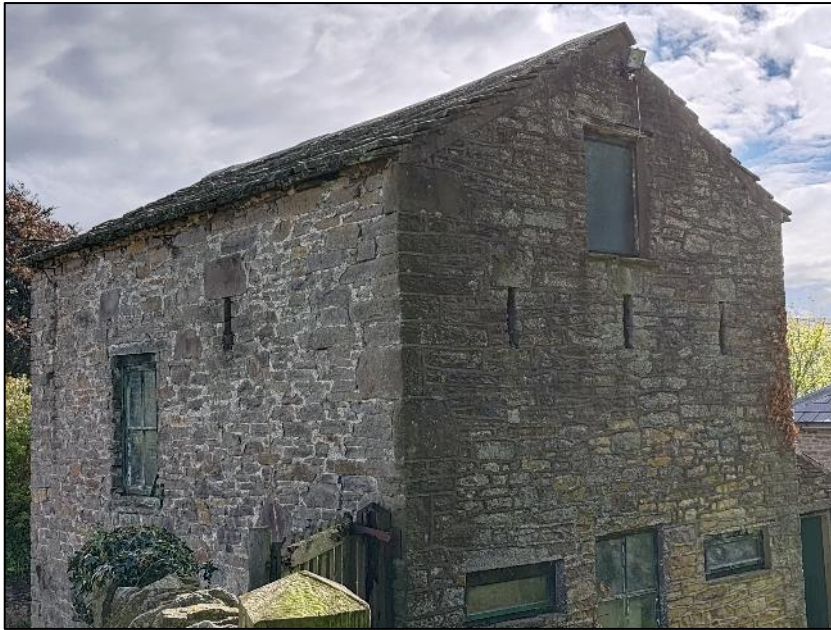
*Photograph 2 showing the exterior of the building from the rear*

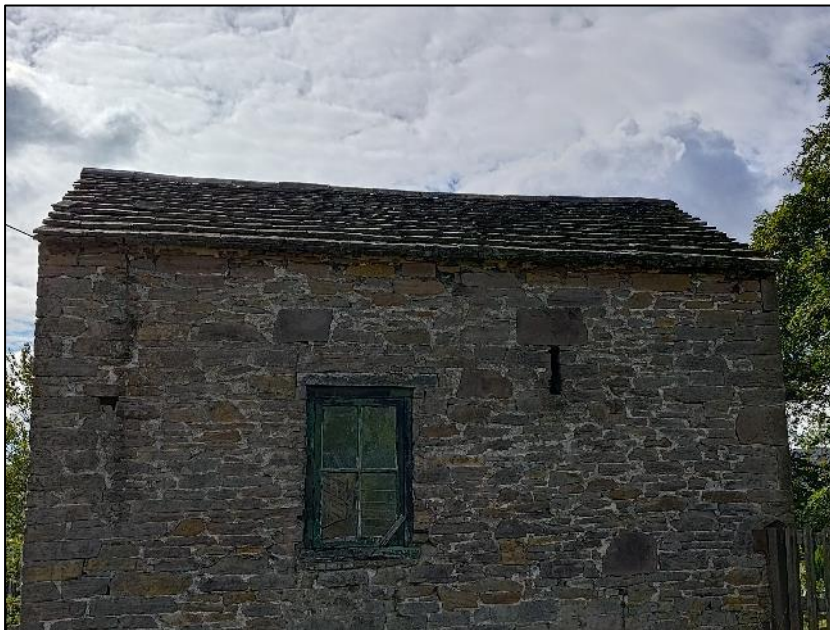
- 3.3 The roof of the property is tiled with cement roof tiles. The roof tiles are in situ, with only minor gaps between tiles. The ridge tiling is complete (see Photograph 3). A single-storey lean-to is present on the side elevation, and this is firmly sealed to the main building. The lean-to has an elevation with corrugated metal, which is complete, and sealed to the main section of the building. The roofing on the lean-to has slate tiling, which is complete and intact.

*Photograph 3 showing the roof of the property*

- 4.3 It should be noted that bat absence is very difficult to prove definitively due to their mobility and size, and single or small numbers of bats are able to roost in extremely small spaces, such as in gaps between panels. The development work should be undertaken with care, for example with roof tiles lifted rather than dragged.

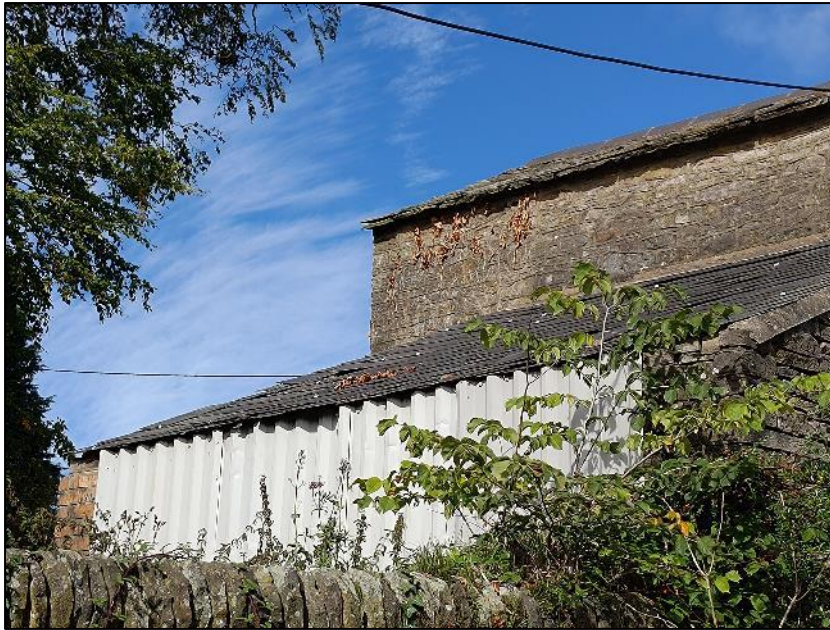
*Photograph 4 showing the lean-to*

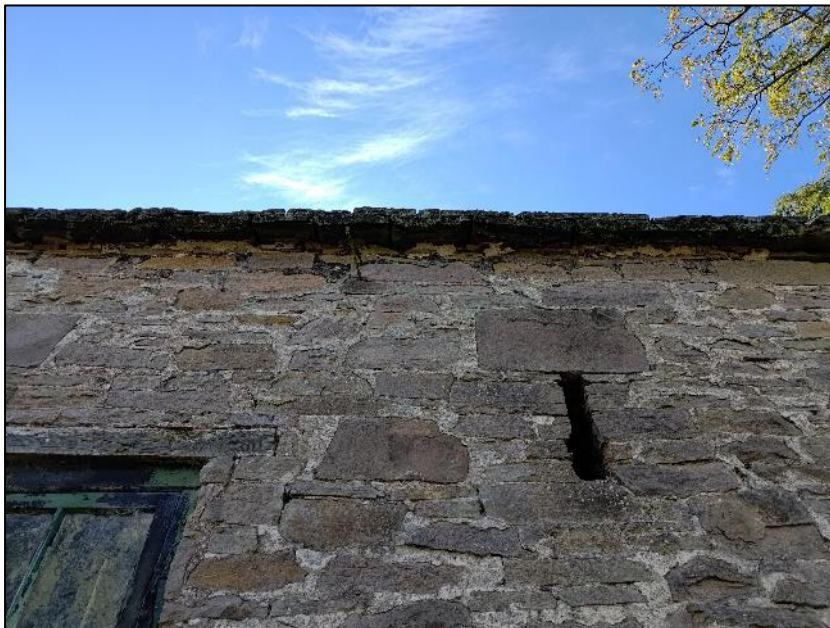
- 3.4 No soffits or bargeboards are present where the roof meets the stone walls (see Photograph 5). The upper stone courses are complete.

*Photograph 5 showing the upper stone courses*

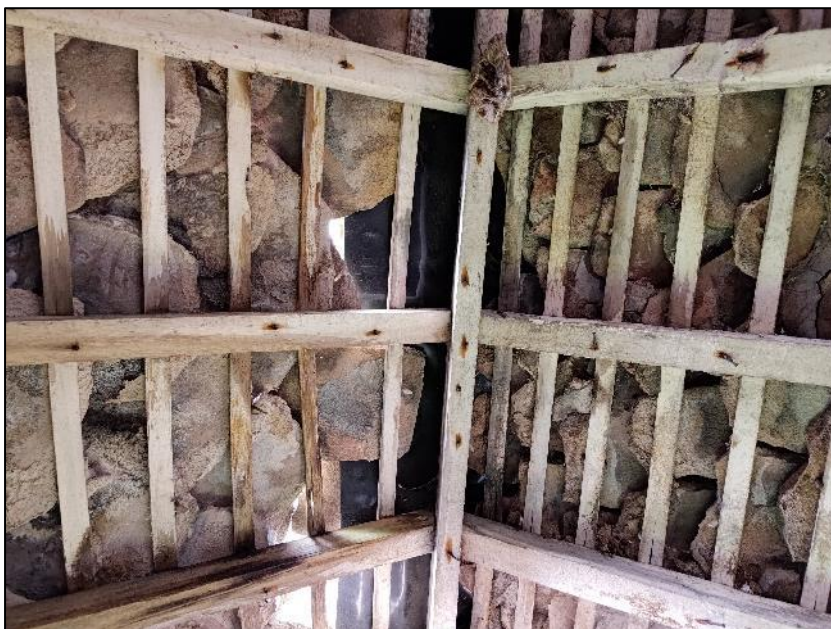
- 3.5 The upper floor is accessible, and is a well-lit space due to the windows and ventilation holes. The roof is not mortared behind the tiles. The wooden roof joists are complete and without gaps or cracks (see Photograph 6). Several holes are present in the roof. The window and ventilation hole lintels were inspected, and where possible searched with an endoscopic camera. No evidence of bat activity was found in the upper floor or in any of the lintel cavities. The upper floor offers poor thermal properties. Many of the

roof tiles, walls and roof beams have dense cobwebbing present, suggesting no recent bat access.

- 3.6 Several disused bird nests are present on the upper floor of the barn.

*Photograph 6 showing the roof structure of the upper floor*

- 4.5 Evidence of historic bird nesting was found inside the property, with several nests and present on the wooden beams. If works is to commence during the nesting bird season (generally March-August) then a nesting bird survey should be undertaken by a suitably qualified ecologist.

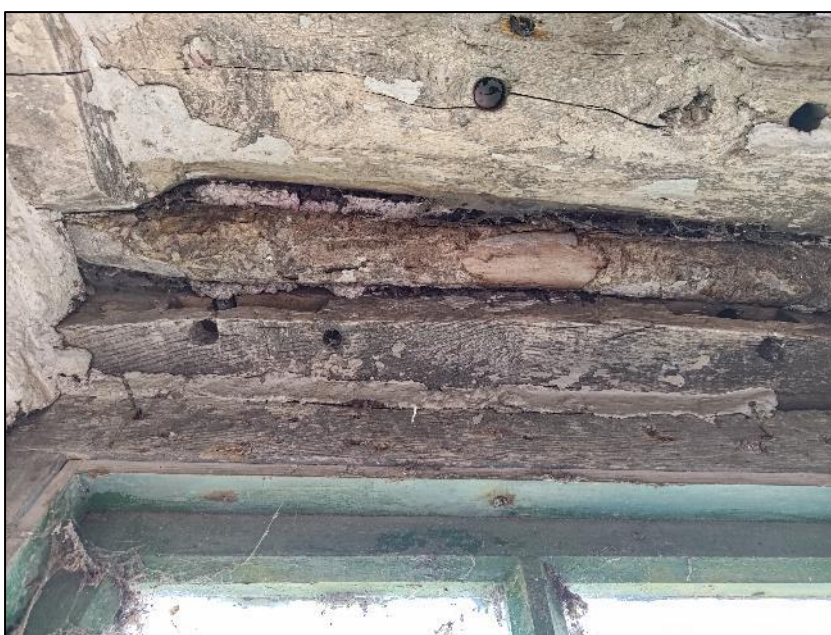
*Photograph 7 showing the window lintel*

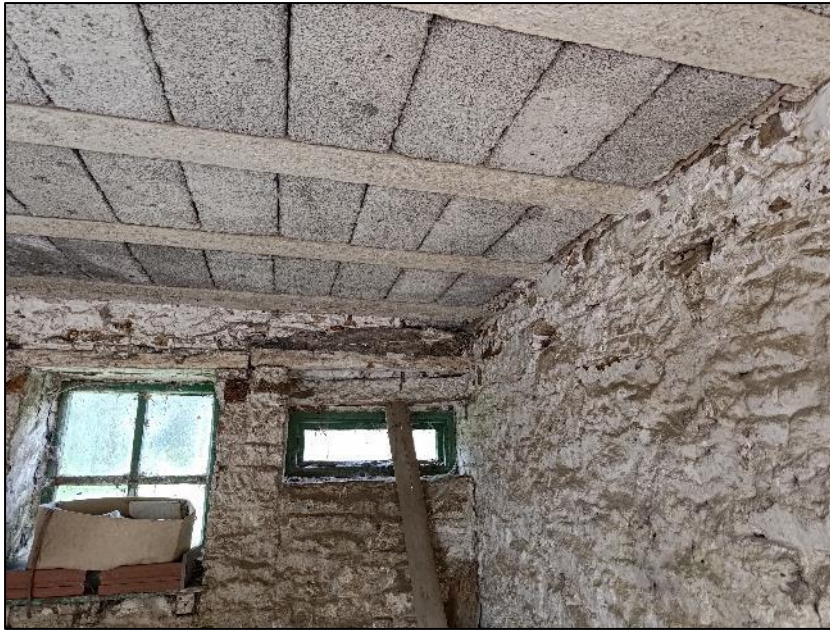
- 3.7 The ground floor is well-lit internally, and the internal stone walls are cemented and painted. The concrete flooring above is complete, with no significant crevices between the concrete slabs (see Photograph 8). The lintel above the open front door was searched, with no onward cavity and no evidence of bat activity found.

*Photograph 8 showing the ground floor*
