## **New Mills, Church Lane**

### **Review of the existing Artificial Turf area at New Mills FC**

To provide a report on the safety or otherwise of the current Astro turf tennis court being used for 5 aside football (and other potential uses).

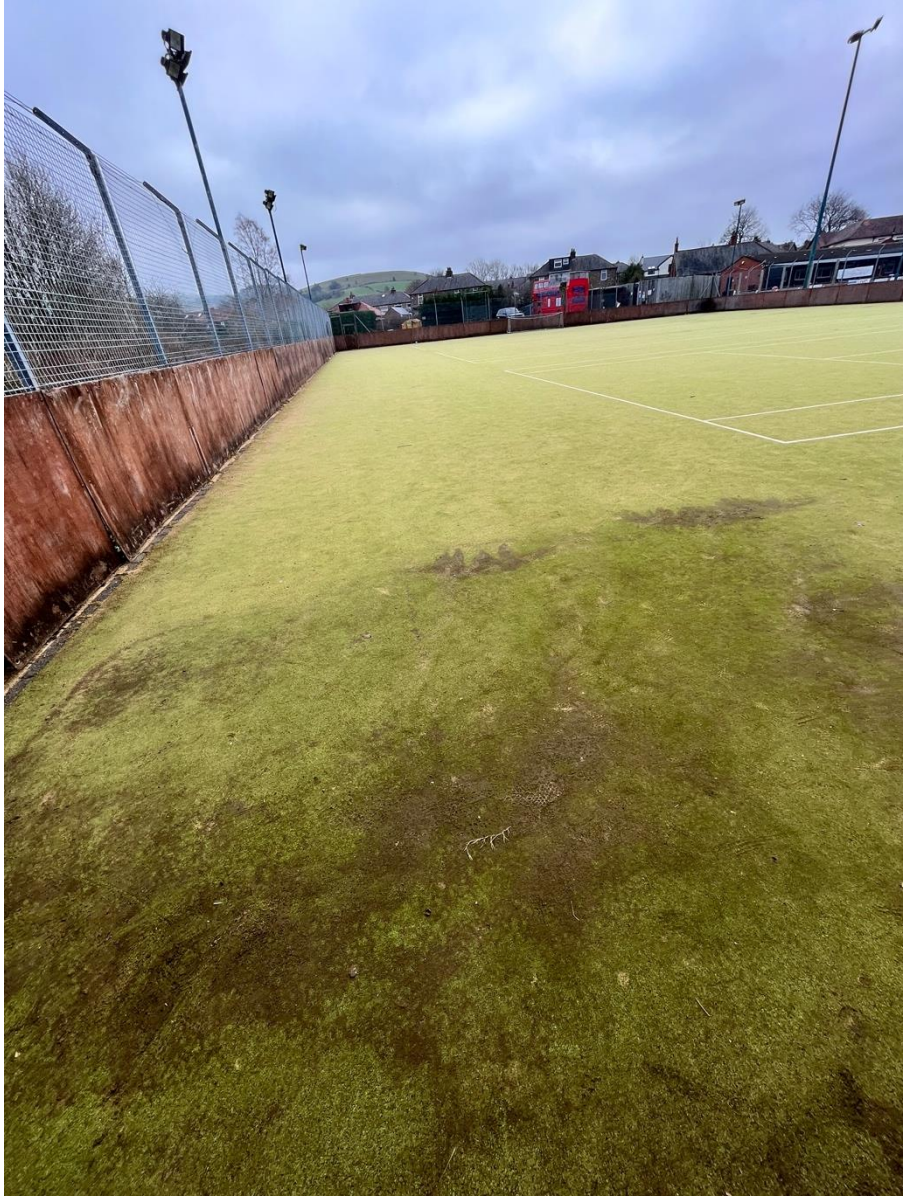
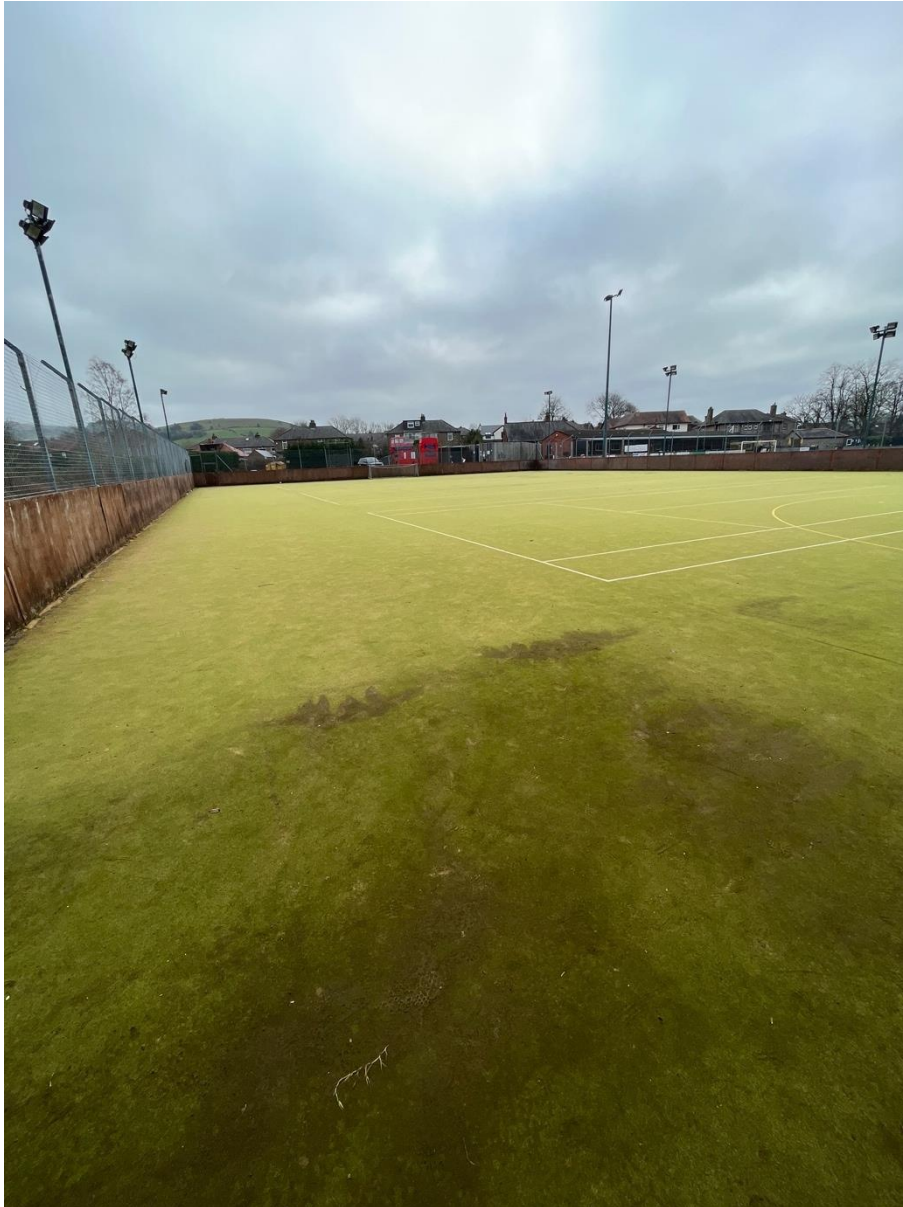
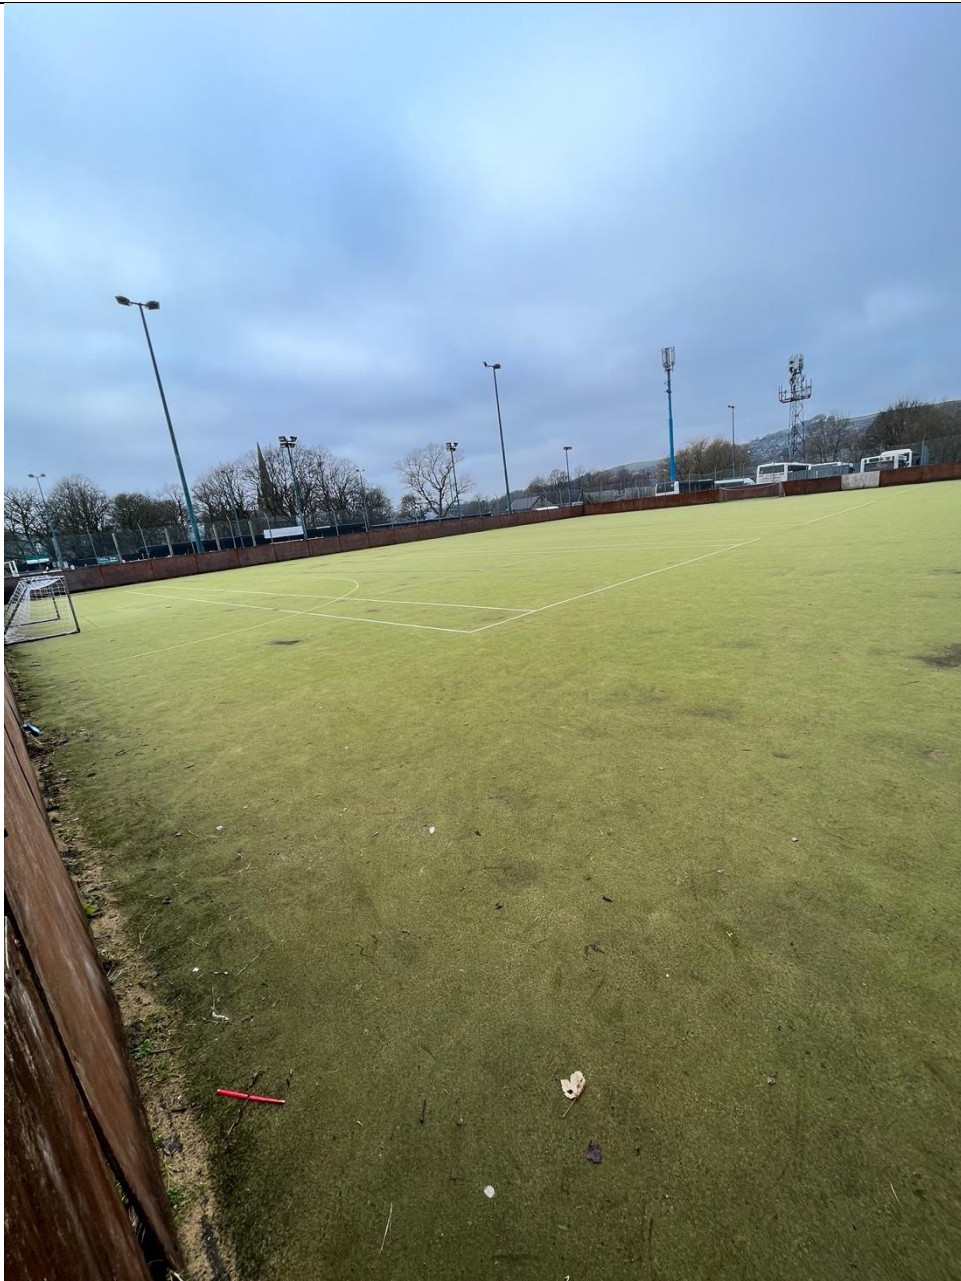
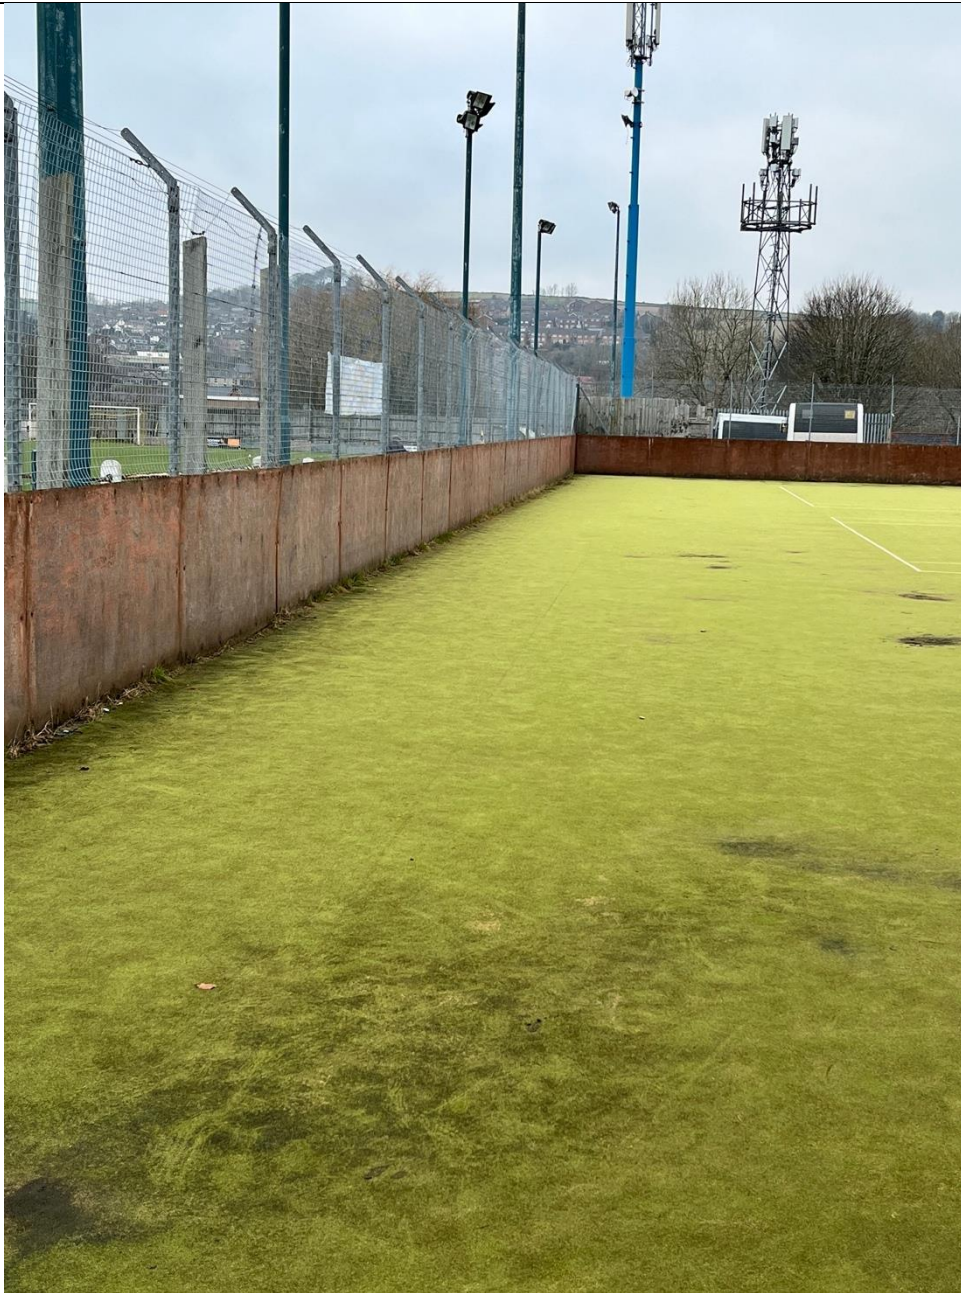
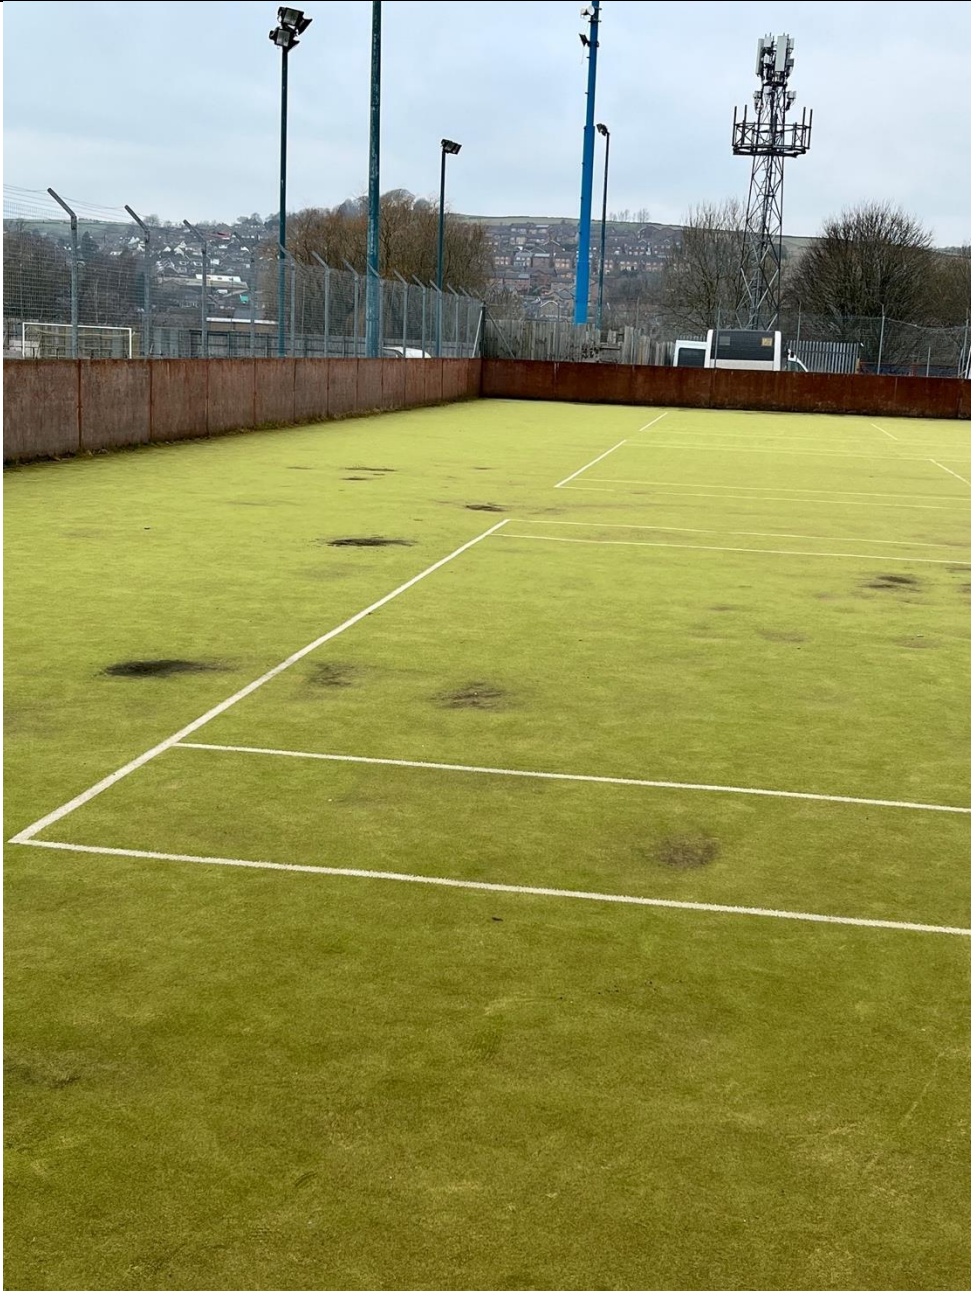
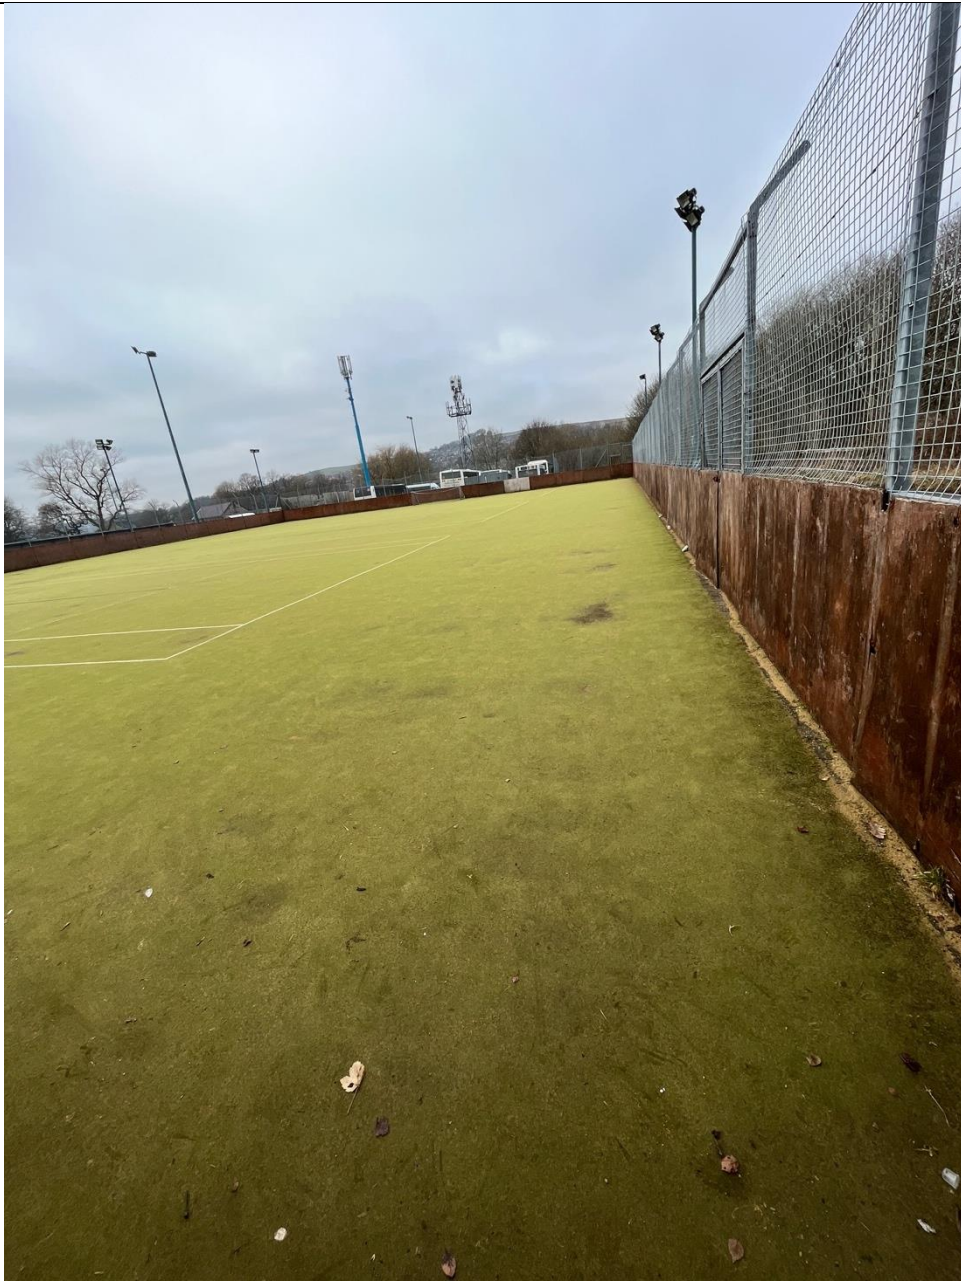
## Photographs

I attach images taken from the perimeter of the Artificial surface.

When it was initially laid as a tennis court it would have been laid on a sand base surface to provide a 'hard' surface conducive for tennis. There is evidence that a 'rubber/tyre crumb' may have been used. This is the likely cause for the black patches noted in the images.

The 'Re-Bound fence is timber and badly deteriorated. Impact against this would cause splinter/cut injury

Due to the density of the surface, the breakdown of the surface, the possibility the breakdown allows tyre crumb to 'lie' on the surface, the area is not suitable for use as a football pitch or a hockey pitch.

The timber Re-Bound fence is a significant hazard in its present state.
