# **BAT SURVEYS OF LAND OFF HOLLINCROSS LANE, GLOSSOP, DERBYSHIRE**

**2019**

**RACHEL HACKING ECOLOGY**

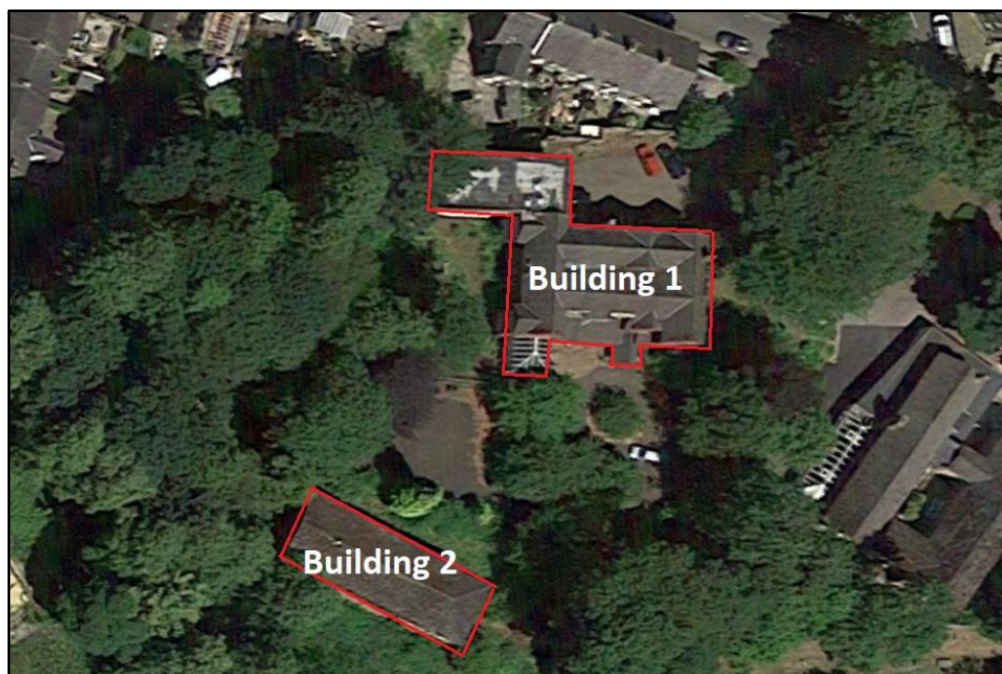
Figure 1 showing the location of the buildings on site

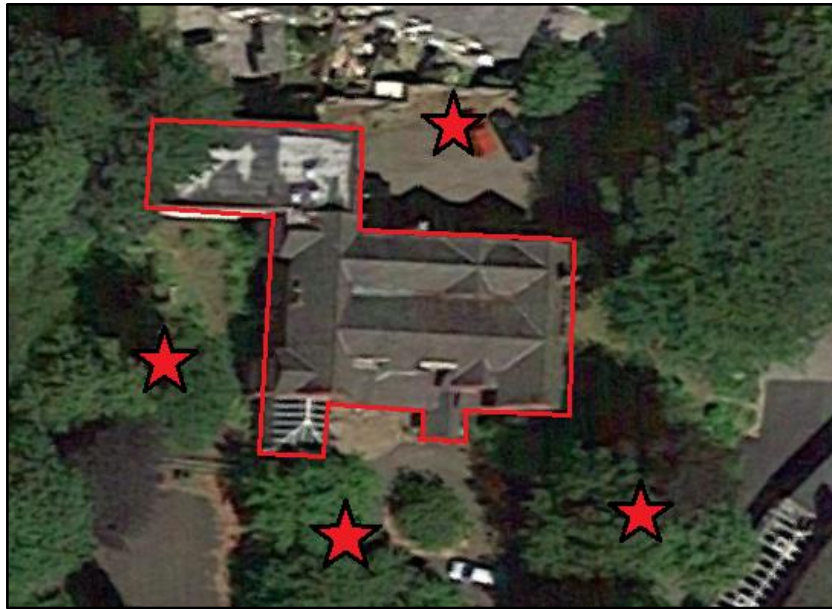
- 3.1 Figure 2 shows the approximate locations of the surveyors at building one during the surveys.

**Figure 2 showing the locations of surveyors (red stars)**

- 3.2 No bats were observed emerging from Building 1 during the dusk emergence surveys. Therefore, following two emergence surveys, and the fact that no evidence of bat activity was found during the daytime internal and external survey in May 2019, it was considered that the survey effort was adequate and a further survey would be unnecessary.
- 3.3 Low levels of bat activity were recorded within the vicinity of Building 1 during the surveys, with Common Pipistrelle *Pipistrellus pipistrellus* and Brown Long-eared *Plecotus auritus* bats recorded foraging around the building during the survey.
- 3.4 Table 1 details the bat activity observed at building one during the 4<sup>th</sup> July dusk emergence survey.

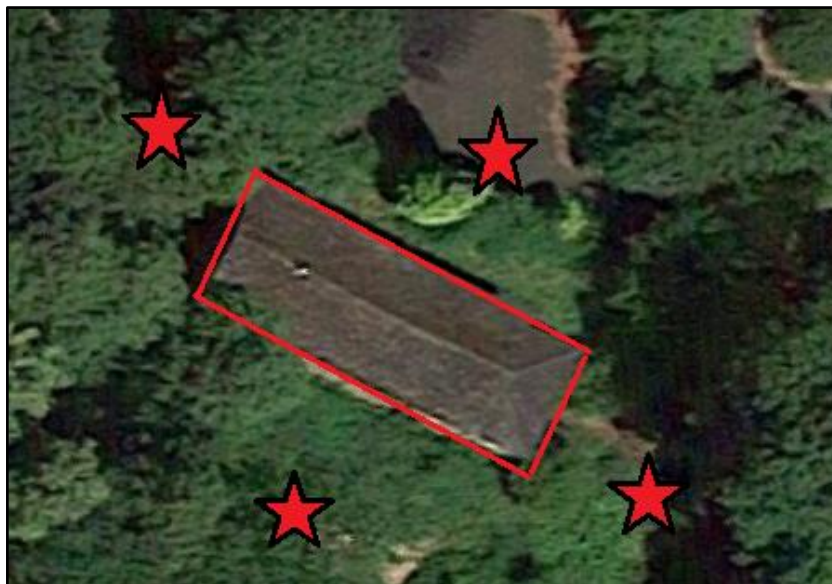
- 3.8 Figure 3 shows the approximate locations of the surveyors during the surveys at Building 2.

**Figure 3 showing the locations of surveyors (red stars)**

- 3.9 No bats were observed emerging from Building 2 during the dusk emergence surveys. This building was assessed as having low bat roost suitability in May 2019, therefore further survey effort was unnecessary.

- 3.10 Low levels of bat activity were recorded around building two during the survey, with Common Pipistrelle and *Myotis* sp. recorded foraging nearby during the survey.
- 3.11 Table 5 details the bat activity observed on the site during the 26<sup>th</sup> June dusk emergence survey.

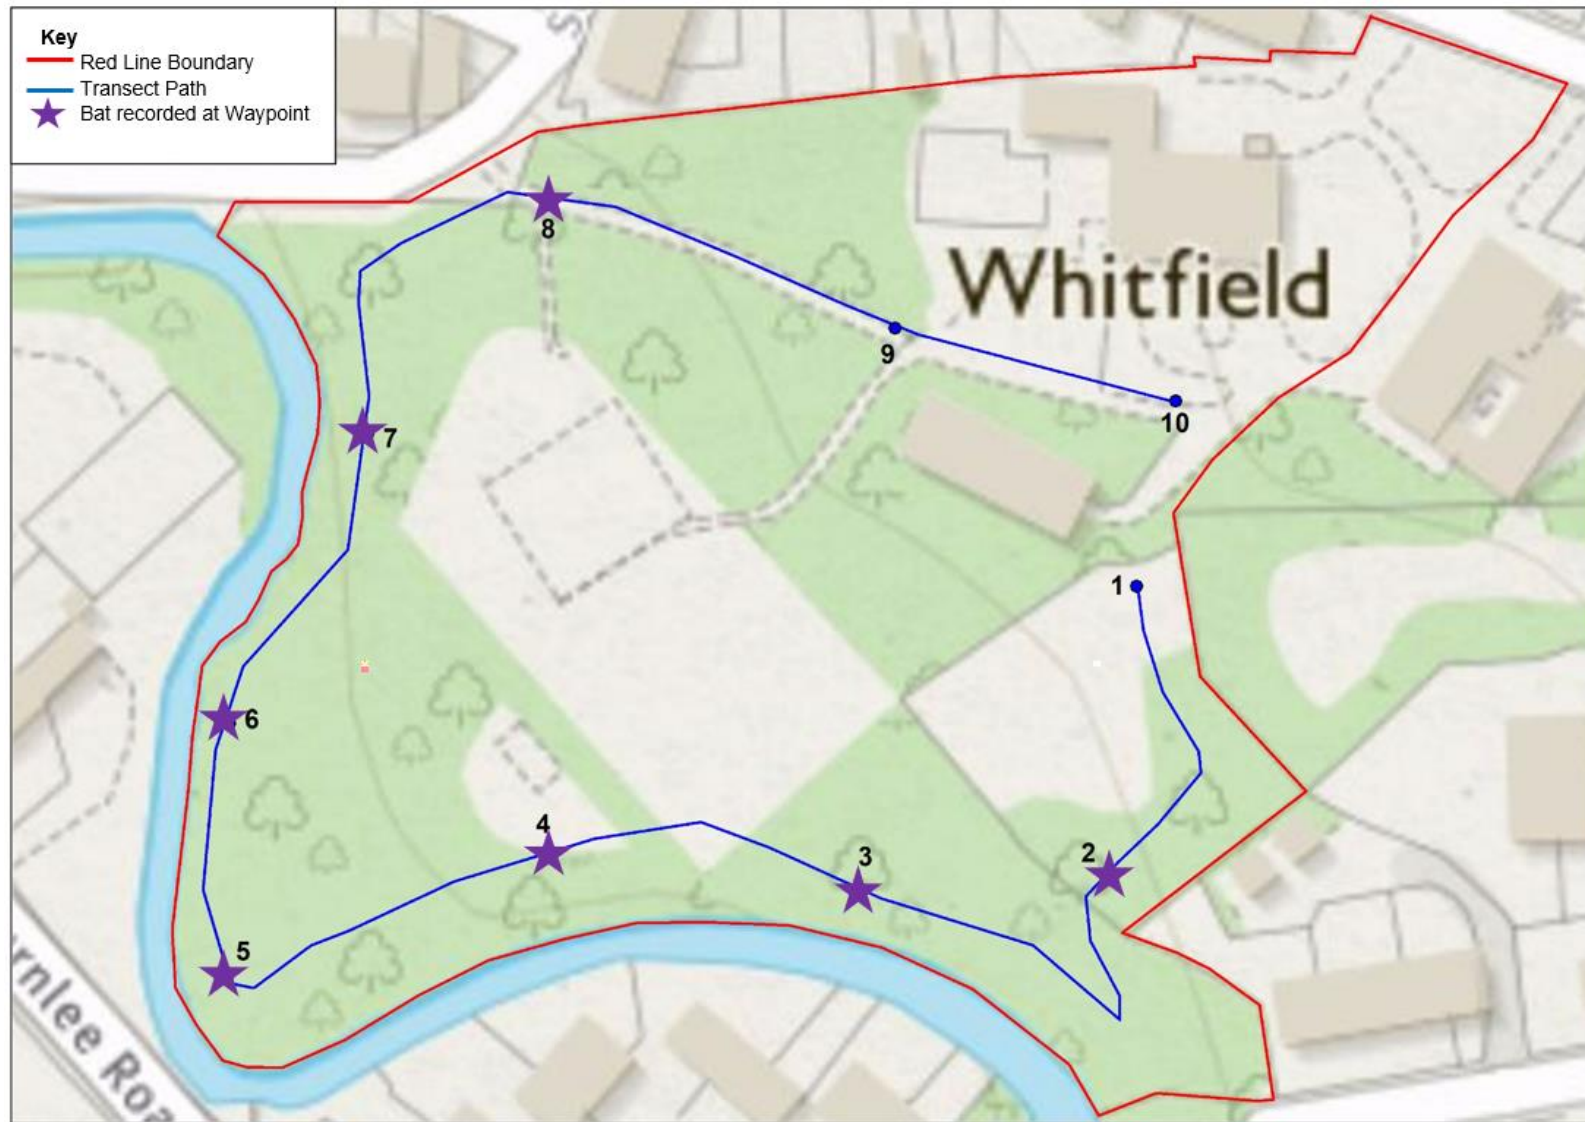
## BAT TRANSECT MAP

- 3.15 Two bat transect surveys were undertaken across the wider site, concentrating on suitable bat foraging and commuting habitat. The Bat Transect Map can be found at the back of the report.
- 3.16 The bat transect surveys were carried out on the site to ascertain important bat commuting and foraging spaces on the proposed development site. The surveys aim to determine where the key parts of the site are in terms of importance to bats, and to inform construction and post-construction mitigation plans, including the provision of a sensitive lighting scheme.
- 3.17 The transects followed a circular route across the site. The transects had multiple 'waypoints', at which the surveyors paused and recorded bat

passes. These waypoints are marked on the Bat Transect Map and the same waypoints were used on each transect.

3.18 Low levels of bat activity were recorded during the transect survey. Small numbers of bat passes were recorded and these were all Common Pipistrelle bat *Pipistrellus pipistrellus*.

- 4.6 Two bat transect surveys of the site were conducted to assess the general levels of bat activity across the site and to determine if any habitat on site is of particular importance for bat foraging. Low levels of bat activity were recorded during the surveys, predominantly by the river and woodland edges. No further transects were considered necessary. There will be minimal loss of bat foraging habitat from the development. It is recommended that a sensitive lighting scheme is implemented as a part of the development and during construction to protect these habitats.
