# Devonshire Dome – Buxton SK17 6RY– Listed Building Consent – Heritage Statement

## Heritage Statement

Statement in support of a listed building consent application in relation to Devonshire Dome, Buxton SK17 6RY.

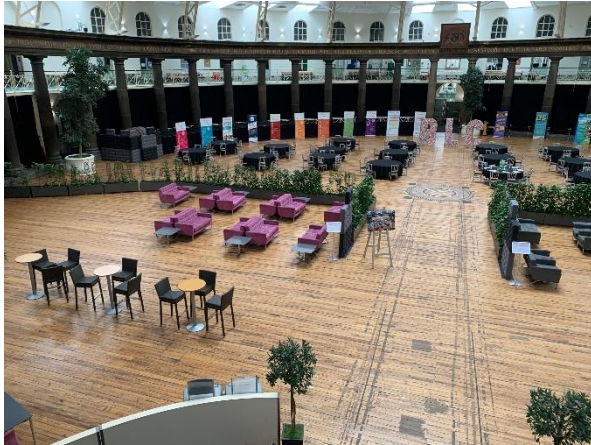
1

1. Overview of the Dome floor.
2. Chosen method – Sample area sanded
3. Chosen Method – First coat of tone diluter
4. Chosen method - Layer of lacquer removed to reveal timber floor
5. Central piece to be repaired.
6. Chosen method - Second coat of tone diluter
7. Chosen method - Second coat added and almost dried to reveal final finish.
8. Rejected method - High abrasion to be repaired due to being quite damaging towards the timber.
