| Project Title :- 7 Unit Housing Scheme - Existing Outbuildings | | |
| Drawing Title :- Existing Plans & Elevations | | |
| Drwg No :- 09/23/90 | 16 of 19 | Date :- Oct '23 |
| Site Address :- Bankwood Mill, Charlesworth, Glossop, SK13 5ES. | | |

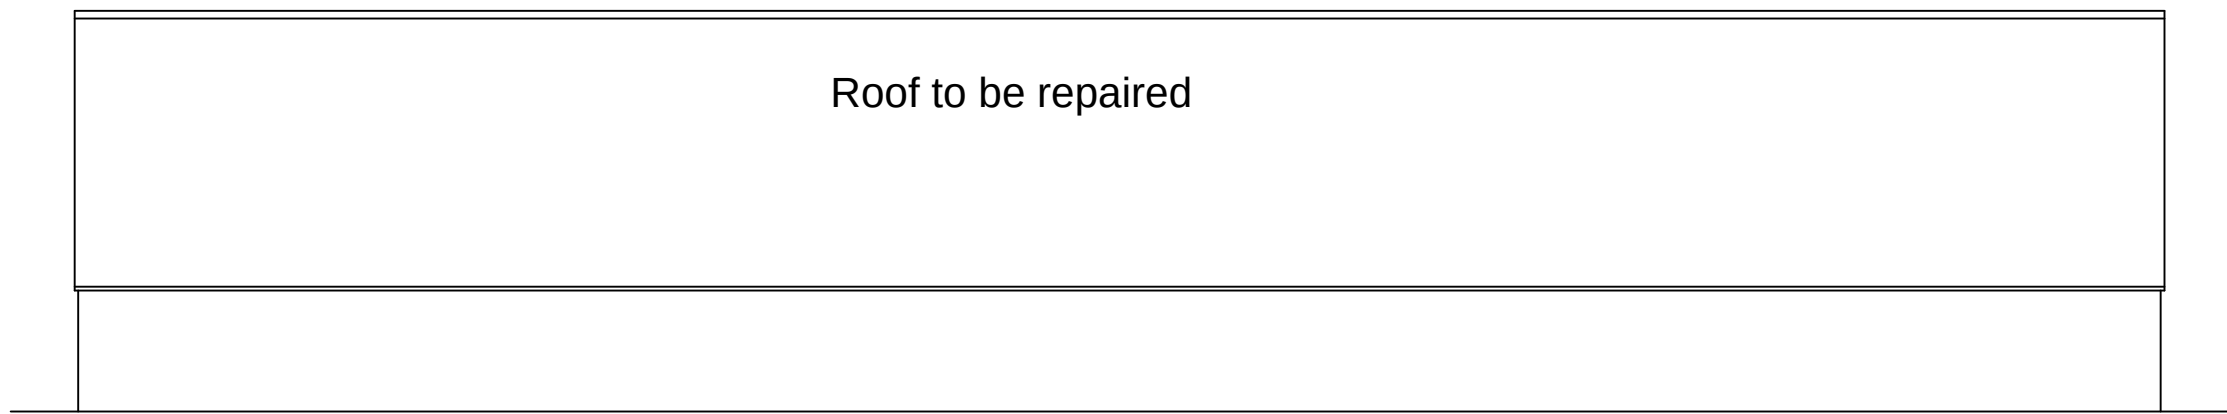
Existing Side Elevation

Rotten timbers to be replaced and staining to all external elevations

- 1) replace rotten timbers and staining the outside timbers
- 2) introduce a damp proof course
- 3) install full height sliding entrance door
- 4) repair roof
