## Phase I Preliminary Risk Assessment

Dinting Road,  
Glossop

Client: Halton Housing & OSUK Ltd Open Solutions (OSUK) Ltd  
Our ref: 30241LG – R01  
Date: April 2019

Report Reference: 30241LG – R01    Issue: Rev. 0    Date: April 2019

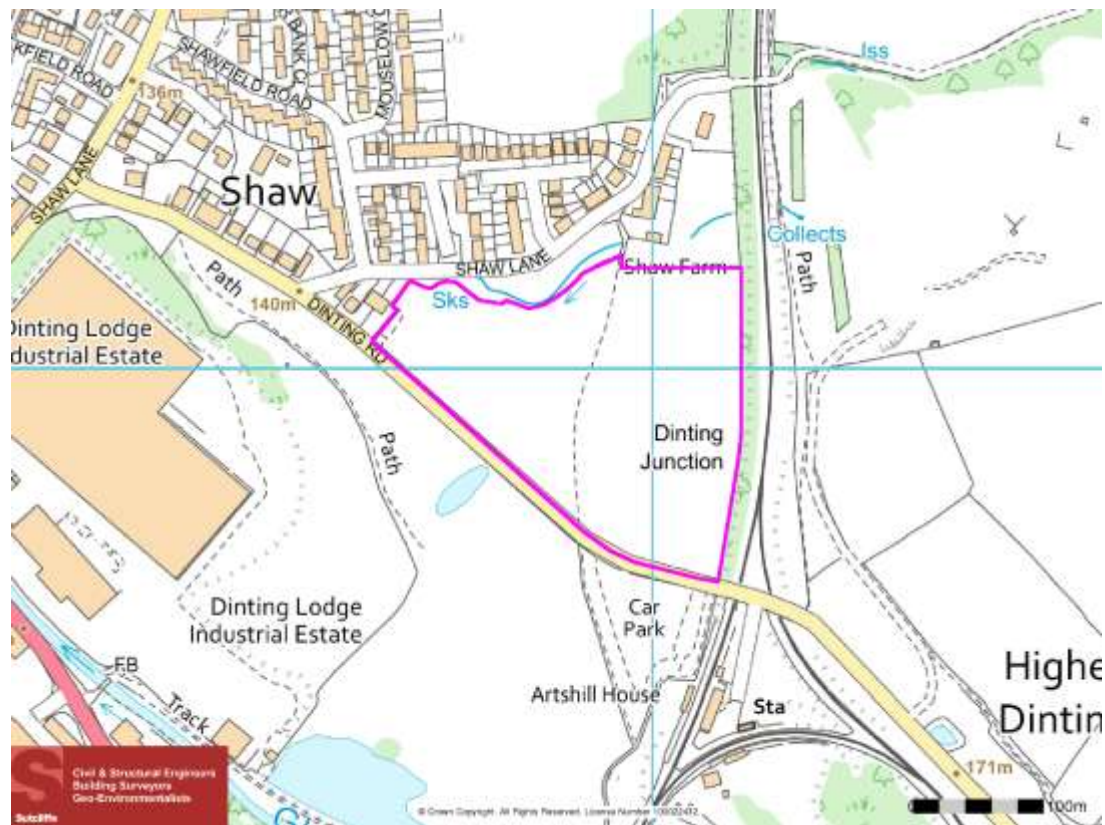
Figure 2: General Site Layout of the Site

The site is triangular in shape, and can be accessed via Dinting Road to the south of the site. The site comprises 100% vegetation cover, with a number of trees across the site and a public footpath striking north to south through the centre of the site. The site slopes from east to west and also from north to south, with a raised section along the eastern boundary and a dip located to the north of the site. A small wire fence borders the site at the south and vegetation to the north. The site is currently undeveloped. A photographic log of the site is presented as *Appendix B*.
