| Grove Hotel, Buxton | | | |
| Proposed Canopy Works & Works to Existing Flat Roof | | | |
| P800 | | | |

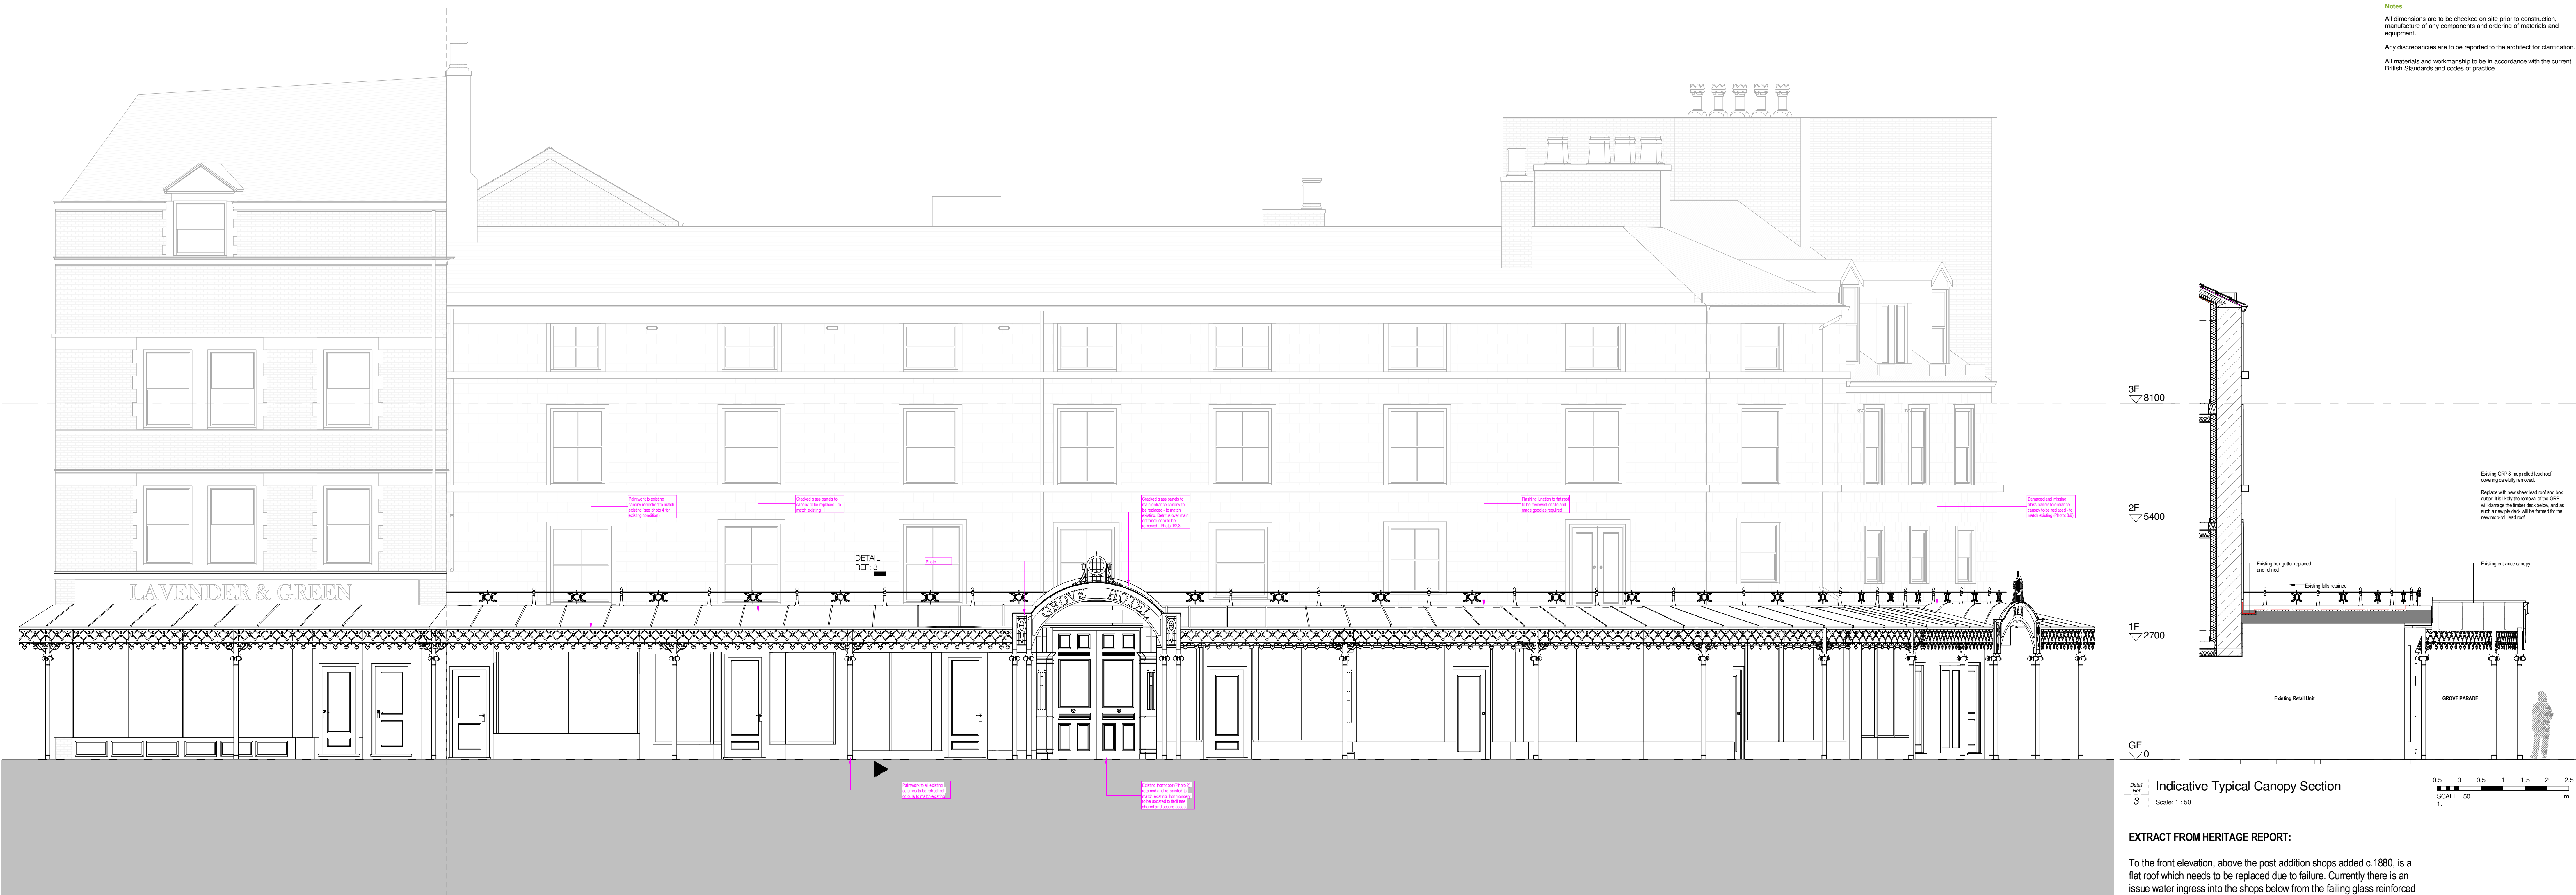
Proposed Elevation - Grove Parade Entrance Canopy  
Scale: 1 : 50

**EXTRACT FROM HERITAGE REPORT:**  
The existing canopy, which dates to c.1920 replaced a previous, post addition canopy which was added to the building c.1880 in conjunction with the shop frontages.  
The structure of the canopy appears to be constructed from cast iron and the glazing is Georgian wire glass. Whilst this type of glass has historic context dating to 1892, when the material was patented by Frank Shuman, the in situ glazing appears to be comprise of modern replacement panes. Where these are in sound condition, they are to be retained, whilst broken or damaged panes will be replaced with matching wire glass. All works concerning glazing will be completed by an heritage-aware glazing firm that has completed similar works before.  
The cast iron structure will be cleaned to remove algae and plant growth as well as unblocking the rainwater goods. The structure will be painted black, matching the existing colour context.

**PROPOSED SCHEDULE OF WORKS**  
**REFURBISHMENT OF CANOPY:**  
Glass canopy to be cleaned and made good.  
Glass canopy and associated columns and decorative features re-painted to match existing.  
All debris to be removed from existing flat roof and glass canopy roof.  
Existing lead flashing to flat roof and glass canopy parapet to be retained and made good as required.  
Existing gutters and any associated downpipes to glass canopy to be cleaned/leaks to joints made good and repainted to match existing.  
Existing glass panels to canopy to be reviewed on site and all damaged panels to be replaced - with Georgian wired glass - to match existing (to the approval of the conservation officer).  
Existing rooflight to flat roof over main entrance lobby contains cracked panels - Rooflight to be replaced. Design to match existing lantern - Spec: Akaley Timber rooflight - refer to Akaley drawing for detail.

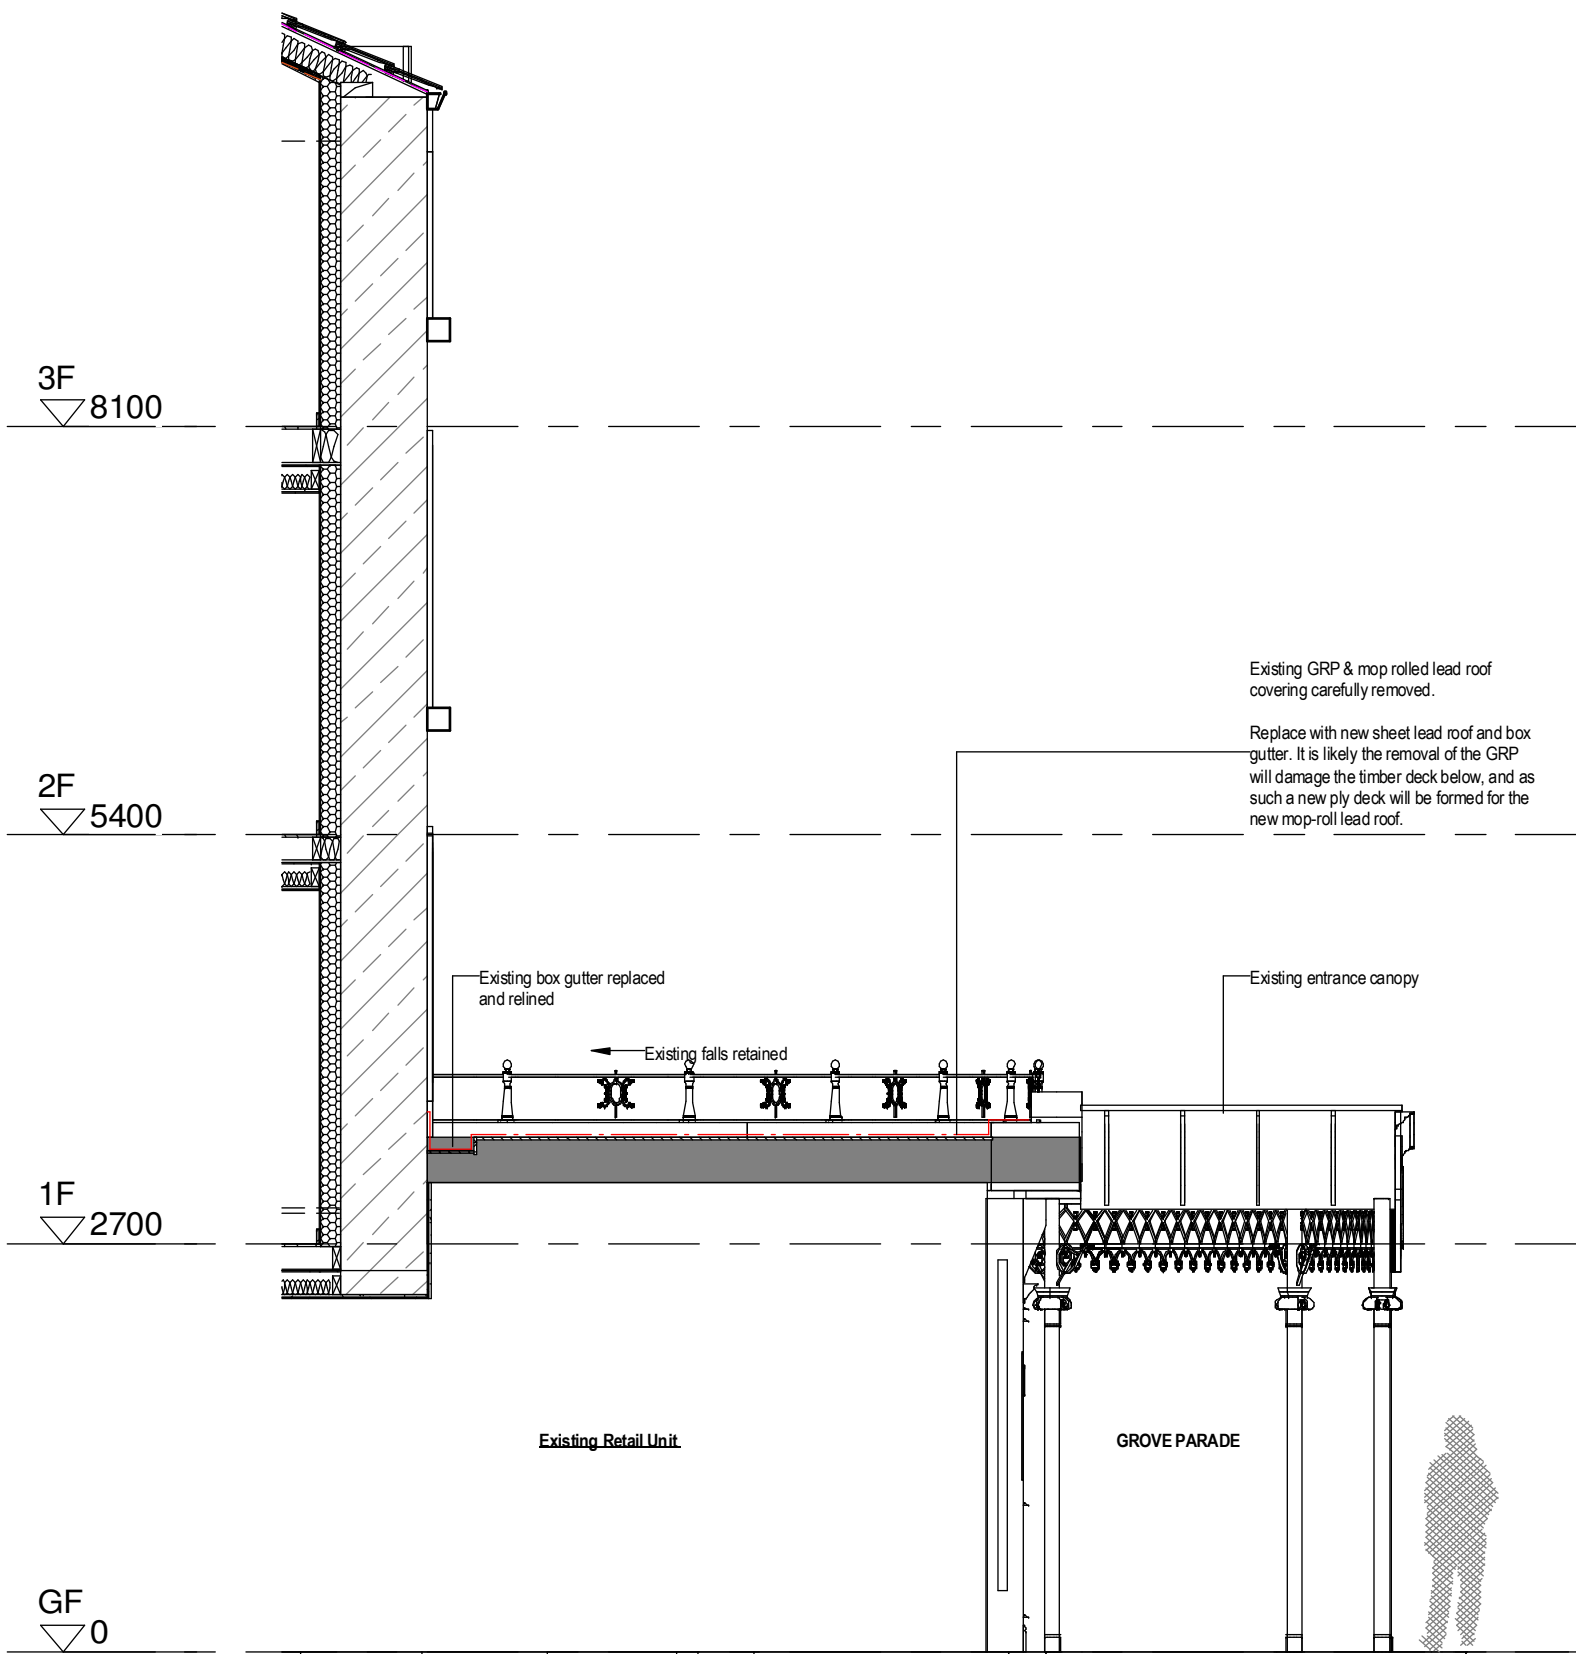
Indicative Typical Canopy Section  
Scale: 1 : 50

**REFURBISHMENT PROPOSAL:**  
On top of the GRP is a lead mop-roll roof which is showing signs of decay. It is proposed to remove the lead and GRP roof and replace this with a new sheet lead roof and box gutter. It is likely the removal of the GRP will damage the timber deck below, and as such a new ply deck will be formed for the new mop-roll lead roof.  
The lead will be code 5 and the work carried out in accordance with the Lead Sheet Association guidance for rolled lead sheet work.

**PROPOSED SCHEDULE OF WORKS**  
**REFURBISHMENT OF LEAD FLAT ROOF:**  
The proposed refurbishment works for the existing flat lead roof:  
Remove the existing lead and the fibreglass roof underneath.  
Inspect the decking and replace with water resistant plywood where necessary  
Re cover the roof with Code 5 lead panels with mop roll joints in accordance with the lead sheet associations (LSA) recommendations.  
Work to be carried out by accredited LSA contractors.

**EXTRACT FROM HERITAGE REPORT:**  
To the front elevation, above the post addition shops added c.1880, is a flat roof which needs to be replaced due to failure. Currently there is an issue water ingress into the shops below from the failing glass reinforced plastic (GRP) roof – primarily from the box gutter.

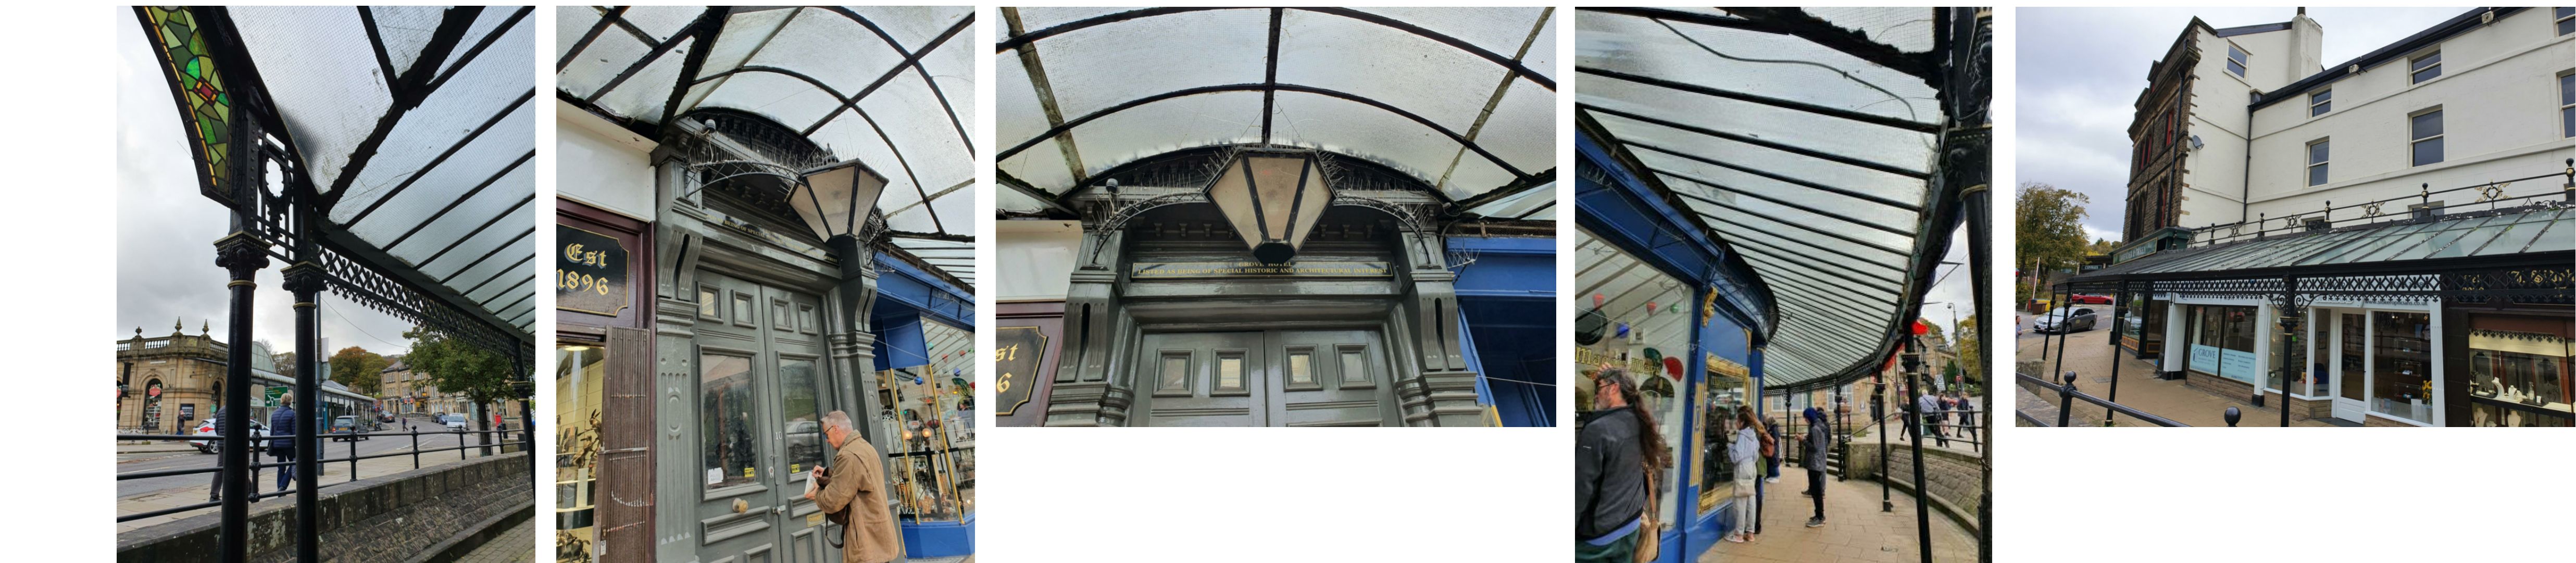
1. View: US of glass canopy over main entrance indicating broken panels to be replaced.  
2. View: US of glass canopy over main entrance indicating broken panels and debris over main entrance door.  
3. View: US of glass canopy over main entrance indicating broken panels and debris over main entrance door.  
4. View: US of glass canopy looking towards retail unit (Maggie Mays) indicating broken panels - to be replaced  
5. View: Top of glass canopy looking towards retail unit (Lavender Green) indicating existing condition of paintwork - paint work to be made good (colours to match existing)

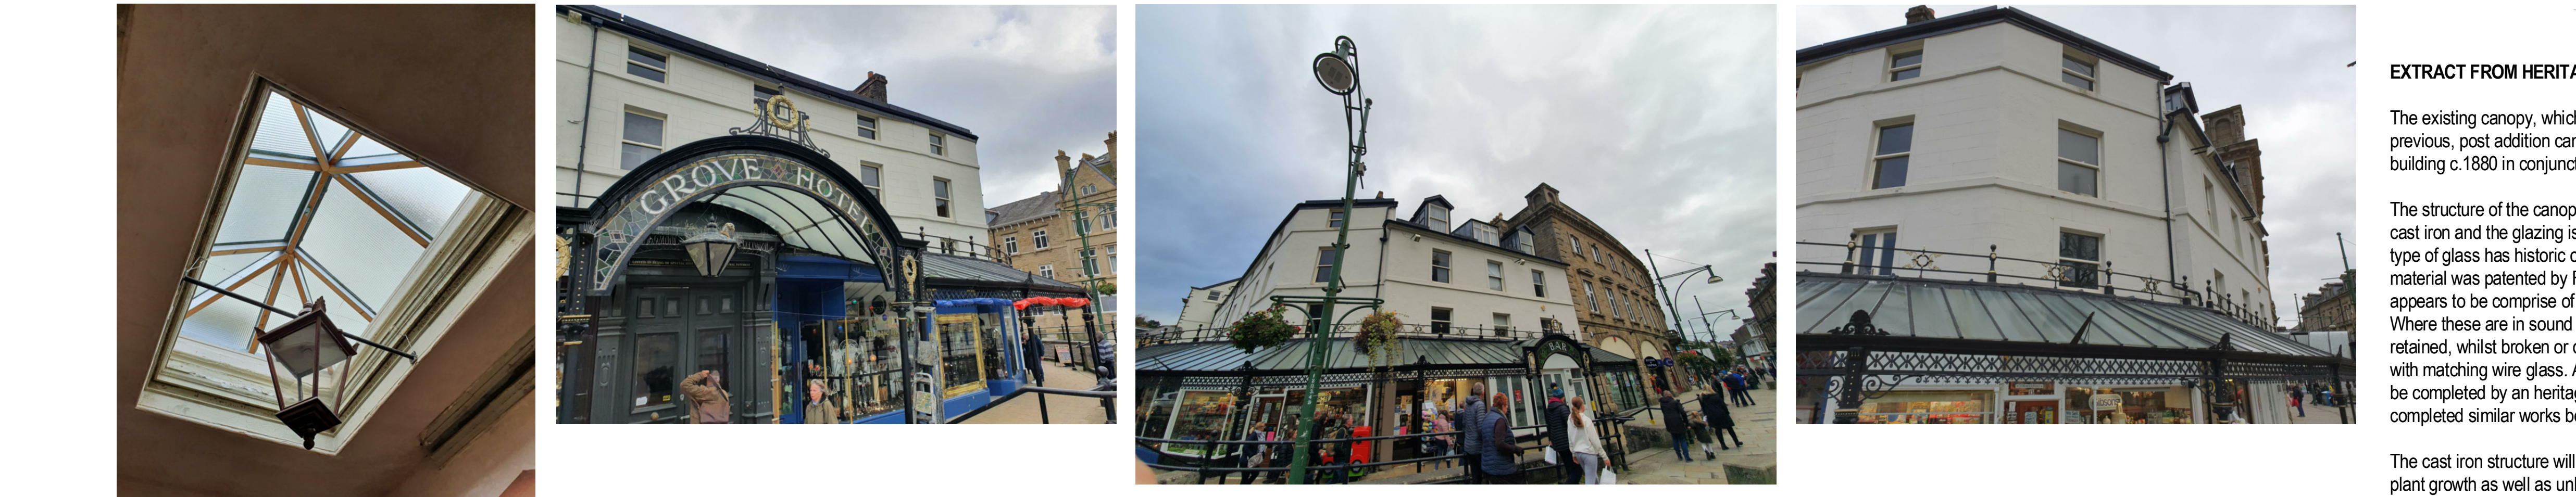
6. View: Internal US of roof lantern within main entrance lobby - to be replaced (design to match existing lantern)  
7. View: View: Stained glass signage over main entrance  
8. View: Stained glass signage "BAR" - missing and damaged panels to be replaced  
9. View: Top of glass canopy looking towards Spring Gardens - indicating existing condition of paintwork and damaged glass panels - paint work to be made good (colours to match existing)/glass panels to be replaced with Georgian wired glass (to match existing)

**NOTE: The stained glass nameplate features are to be repaired to match existing with lead came and coloured glass as required. All works concerning glazing will be completed by an heritage-aware glazing firm that has completed similar works before.**
