ELEVATION FACING THE CRESCENT (FRONT)

1.0 The Exterior of The Pump Room

2.0 Interior of The Pump Room

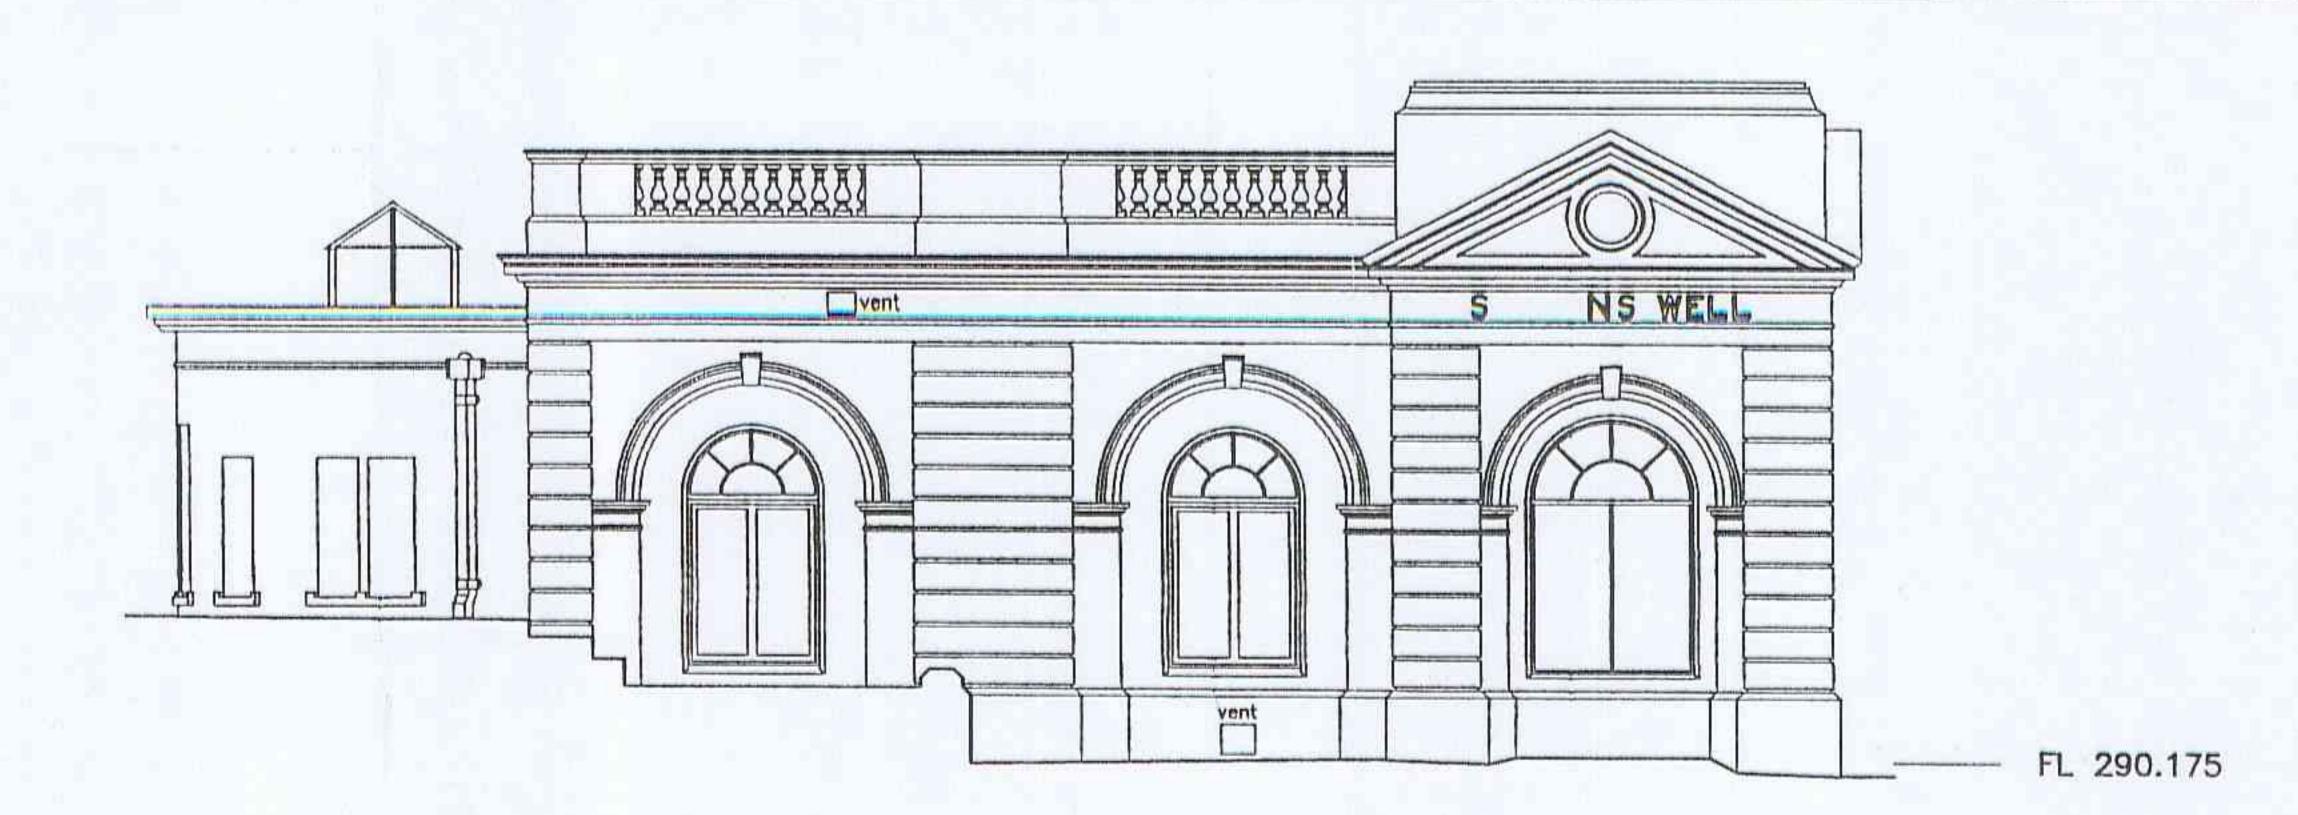
LHS ELEVATION

FL 288.965 ----

FL 290.175
