PROJECT TITLE  
**DEVONSHIRE DOME ROOF REPAIRS**

DRAWING TITLE  
**AREA 3 - DINING SPACE CUPOLA ELEVATION  
AND SECTION DETAIL AS PROPOSED**

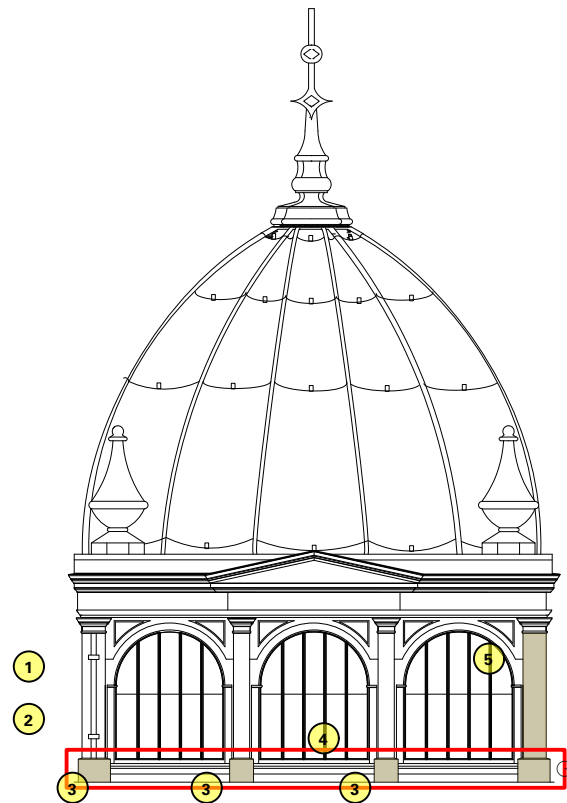
NORTH CUPOLA WESTERN FACE ELEVATION  
1:100

- 1 REDECORATE ALL EXISTING AND REPLACEMENT TIMBER
- 2 FILL ALL MINOR GAPS IN TIMBER AND SAND PRIOR TO DECORATION
- 3 REPLACE TIMBER PLINTH BOARD TO FRONT AND SIDES
- 4 FILL ALL MINOR GAPS IN TIMBER AND SAND PRIOR TO DECORATIONS
- 5 REPLACE TIMBER PLINTH BOARD TO FRONT AND SIDES AND PILASTER FRONT BOARD

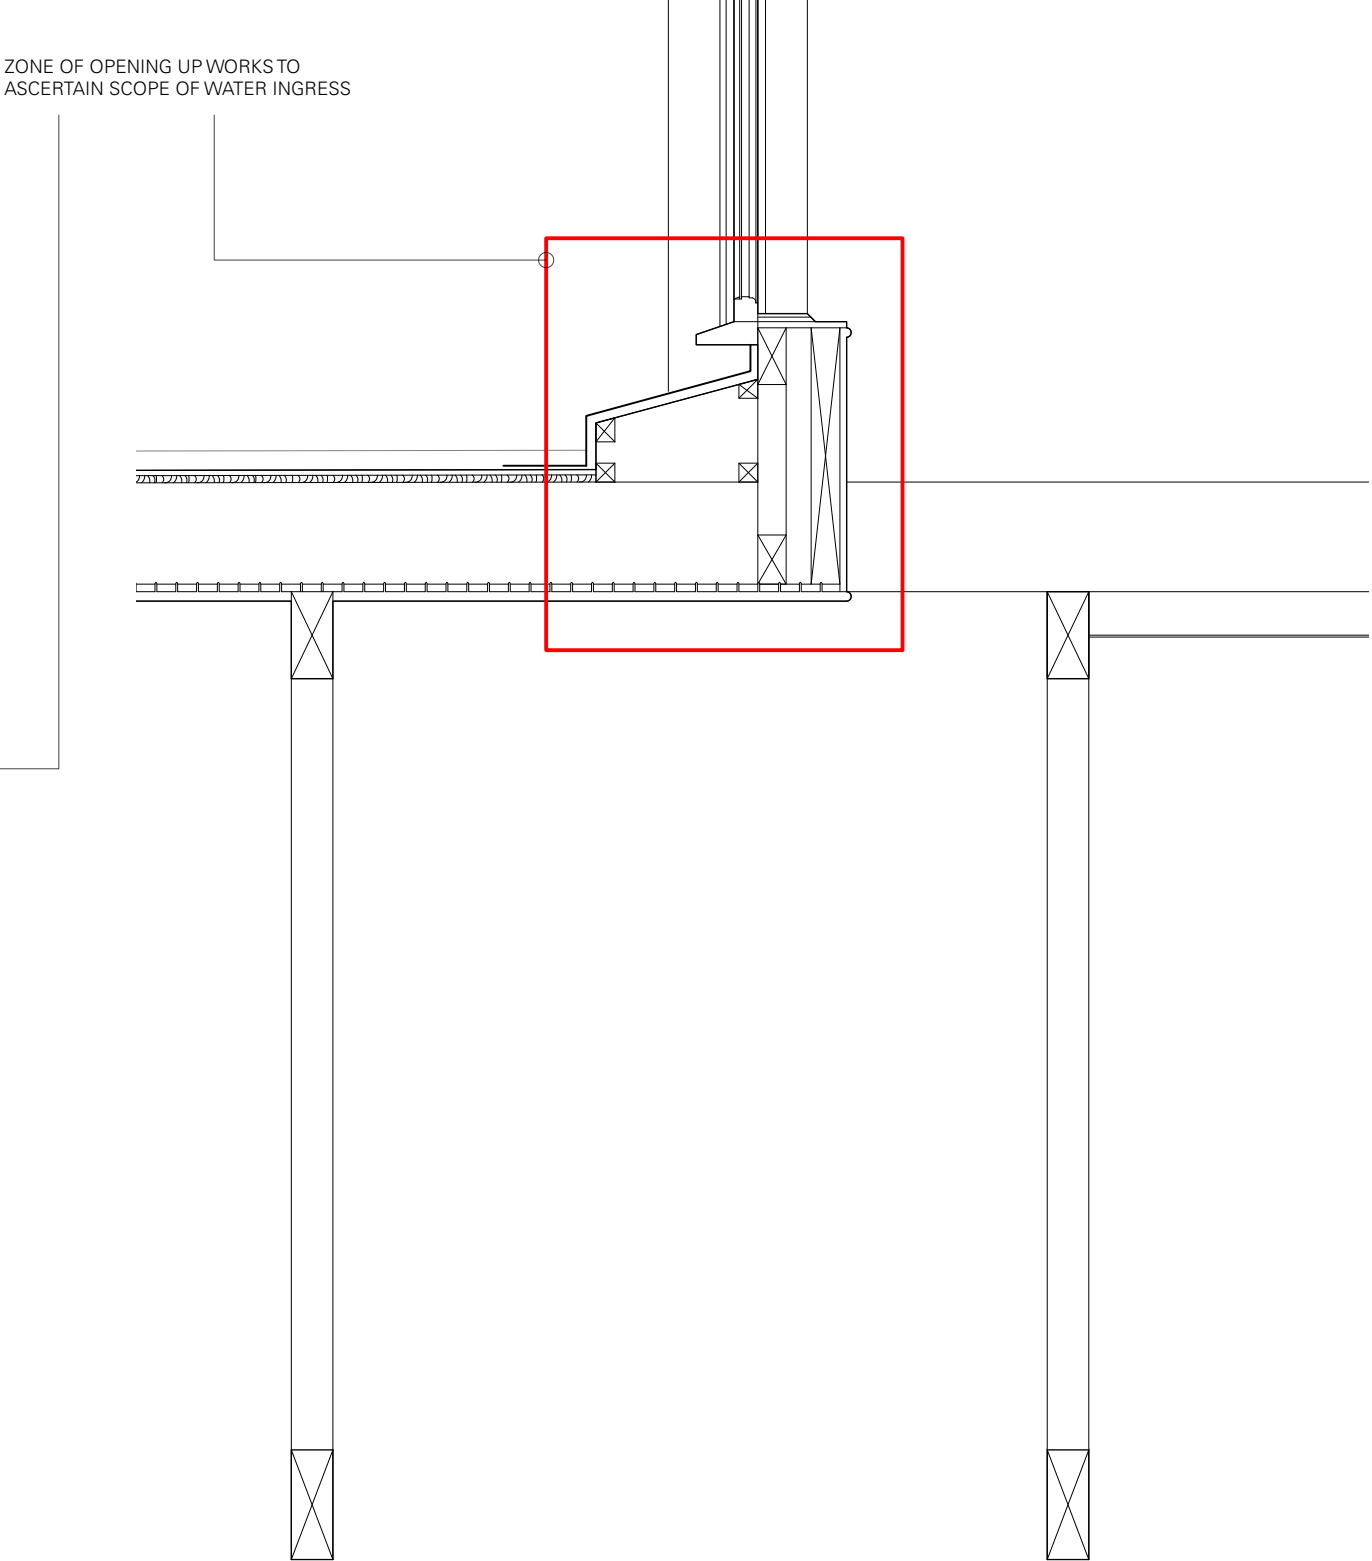
SECTION DETAIL  
1:20

ZONE OF OPENING UP WORKS TO  
ASCERTAIN SCOPE OF WATER INGRESS
