## Preliminary Roost Assessment

Adult Education Centre, Spring Bank, New Mills, High Peak, SK22 4AZ

Boss Prop Limited

“The conversion of two on-site existing buildings into apartments.”

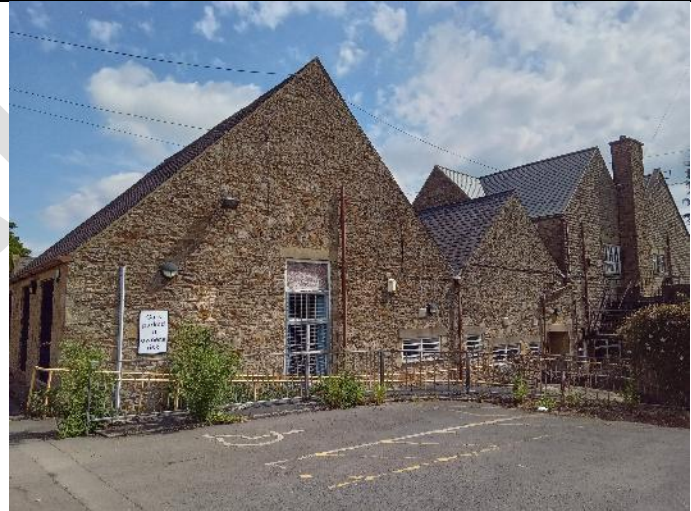
| <p>scattered trees extend beyond the site adding to vegetated linear features present in the wider landscape. Bats are well known to utilise linear features to aid navigation whilst travelling between foraging resources and roost sites.</p> <p><b><u>Roosting habitat:</u></b></p> <p>Buildings to be impacted by the proposed development are assessed for their suitability to support roosting bats below. There are a total of two buildings on-site: the main vacant education centre (B1), and one vacant outbuilding (B2). No evidence of roosting bats was identified along or within the on-site buildings.</p> | | | |
|---|---|---|---|
| <p><b>Summary</b></p> <p>B1 is a large double-storey vacant stone-built building with a pitched and gabled roof clad in slate roof tiles, with an area of flat roof clad in bitumen. The building will be converted into apartments as part of the proposed works, with loft spaces converted. The building is generally in excellent condition, however, there is gapping along the eaves of the north and west elevations which could support low numbers of bats for roosting along crevices/cavities along the wall tops. There is also slight gapping along the tiles of a section of the west elevation roof structure which could support low numbers of crevice-dwelling species. The building is unlikely to support a maternity or hibernation roost. Based on the features present, suitable for low numbers of void or crevice-dwelling species, the building has <b>low roost value</b>.</p> | | | |

| <p><i>Recommendations</i></p> | <p><b><u>Roosting habitat:</u></b></p> <p><b>B1: One bat emergence survey is required during the active bat season (optimal May to August, suboptimal September) to confirm presence or likely-absence of a bat roost in the building.</b> Infra-red cameras should be used as an aid. Seven surveyors are required to provide full coverage of the building. If the absence of a bat roost cannot be determined during the first visit, then further surveys will be required.</p> <p><b>If bat roosts are confirmed in the building additional surveys may be required to characterise the roost and to inform an EPSL application to Natural England.</b> Surveys should be a minimum of three weeks apart. The EPSL application requires that surveys have been undertaken within the most recent active bat season and planning permission must have been granted and all relevant wildlife-related conditions have been discharged prior to submission., to inform the EPSL application. Biological records data will also need to be obtained to inform the application.</p> <p><b>B2: One bat emergence survey is required during the active bat season (optimal May to August, suboptimal September) to confirm presence or likely-absence of a bat roost in the building.</b> Infra-red cameras should be used as an aid. Two surveyors are required to provide full coverage of the building. If the absence of a bat roost cannot be determined during the first visit, then further surveys will be required.</p> <p><b>If bat roosts are confirmed in the building additional surveys may be required to characterise the roost and to inform an EPSL application to Natural England.</b> Surveys should be a minimum of three weeks apart. The EPSL application requires that surveys have been undertaken within the most recent active bat season and planning permission must have been granted and all relevant wildlife-related conditions have been discharged prior to submission., to inform the EPSL application. Biological records data will also need to be obtained to inform the application.</p> |

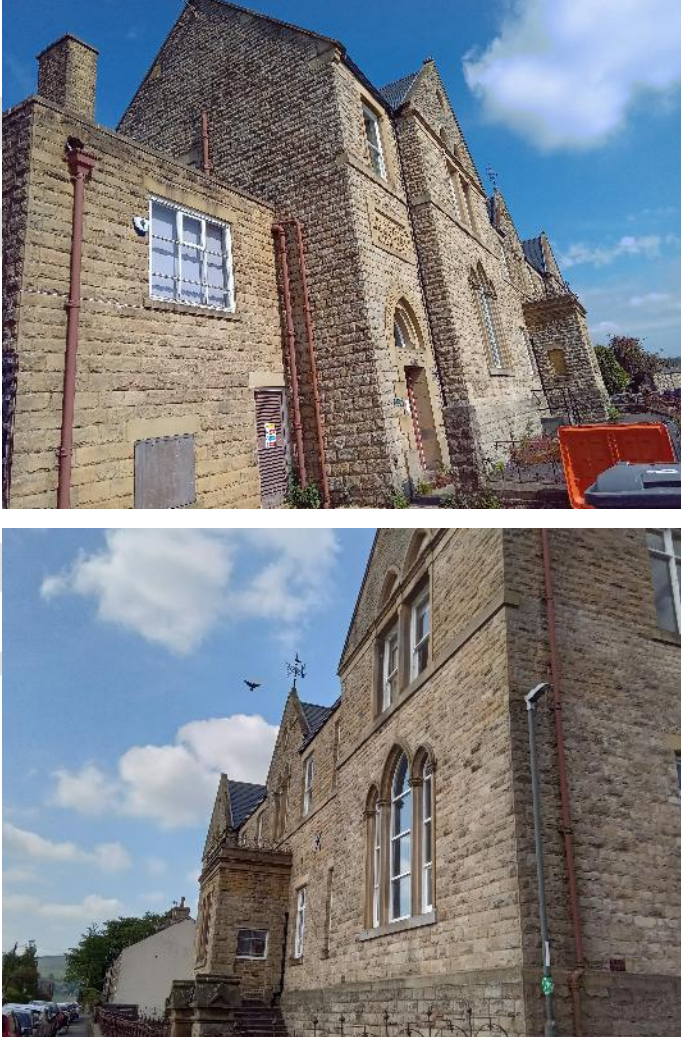
| Walls | Stone and mortar | <p><b>Condition/description:</b></p> <p>No suitable crevices or cavities were recorded along the supporting walls, which were found to be intact and in very good condition.</p> <p><b>Suitability/access/evidence of bats:</b></p> <p>No suitable features or evidence were recorded.</p> | |

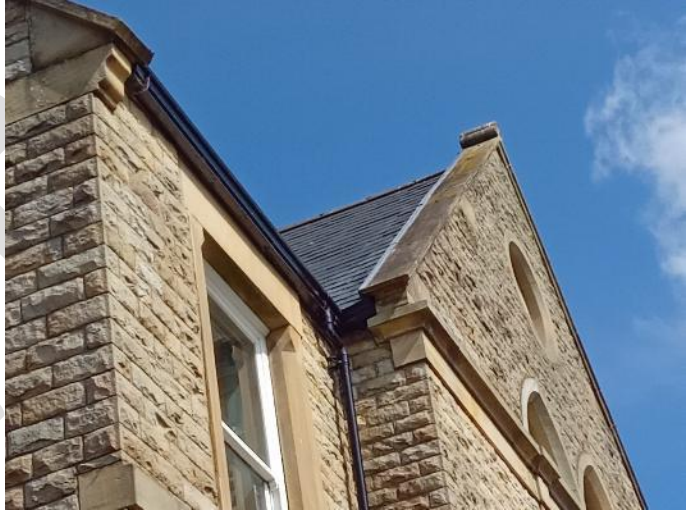
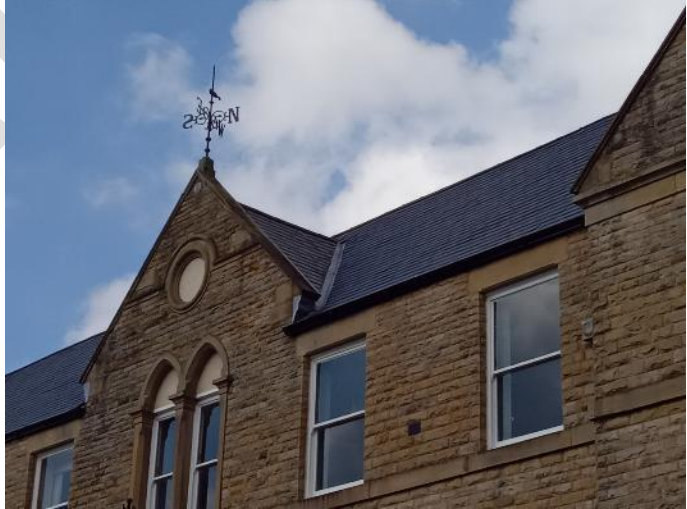
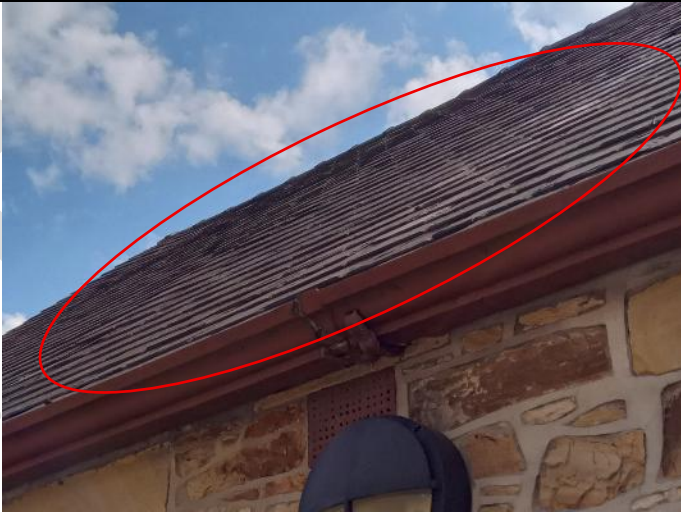
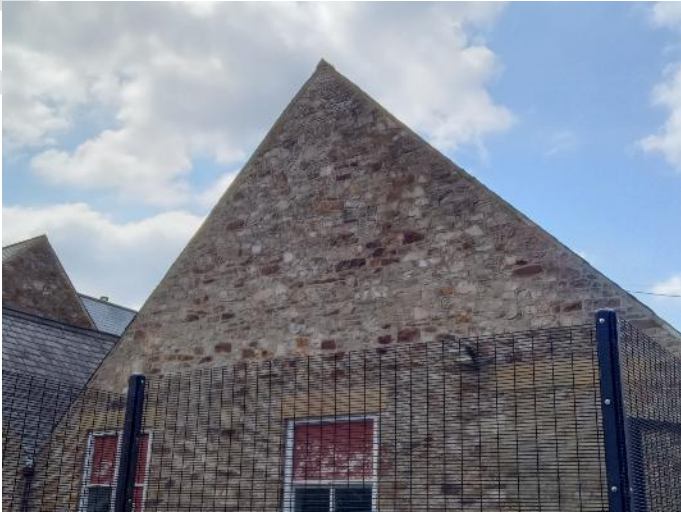
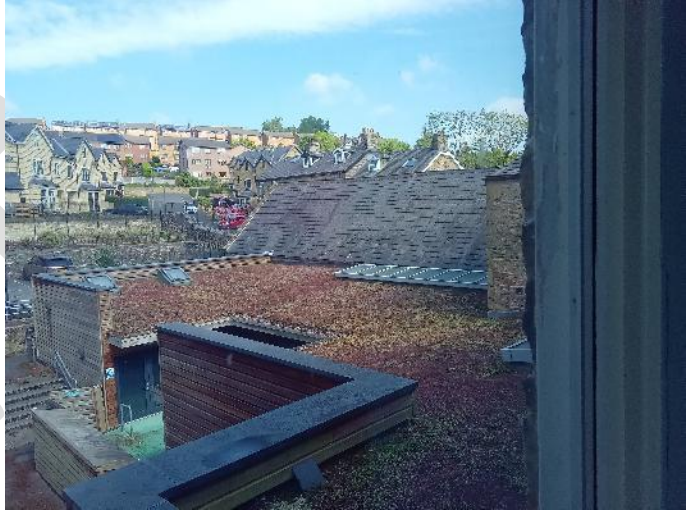
| Roof | Slate and bitumen | <p><b>Condition/description:</b></p> <p>The majority of the roof tiles were found to be in excellent condition, with a new roof recently installed in places. However, slight gapping was recorded along a section of the west elevation roof structure which could support low numbers of crevice-dwelling species (e.g., pipistrelles). The mortar along roof verges and flat areas of bitumen roof were found to be intact and in very good condition.</p> <p><b>Suitability/access/evidence of bats:</b></p> <p>Space under tiles could accommodate crevice-dwelling bat ingress with roosting opportunities between the roof tiles. Could support low numbers of crevice-dwelling species.</p> | |

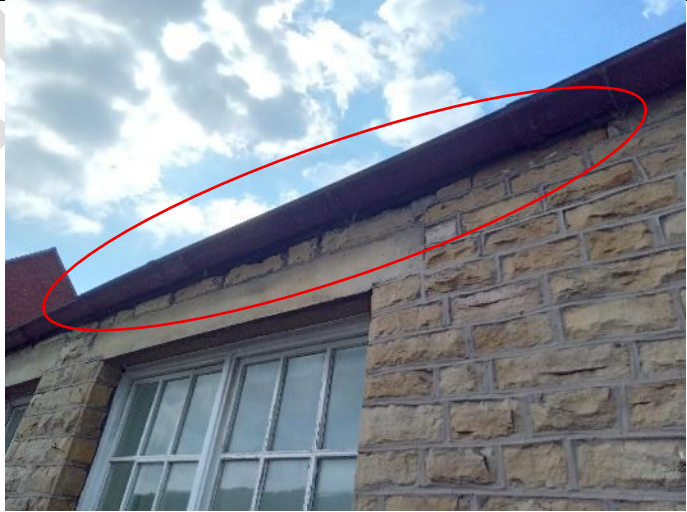
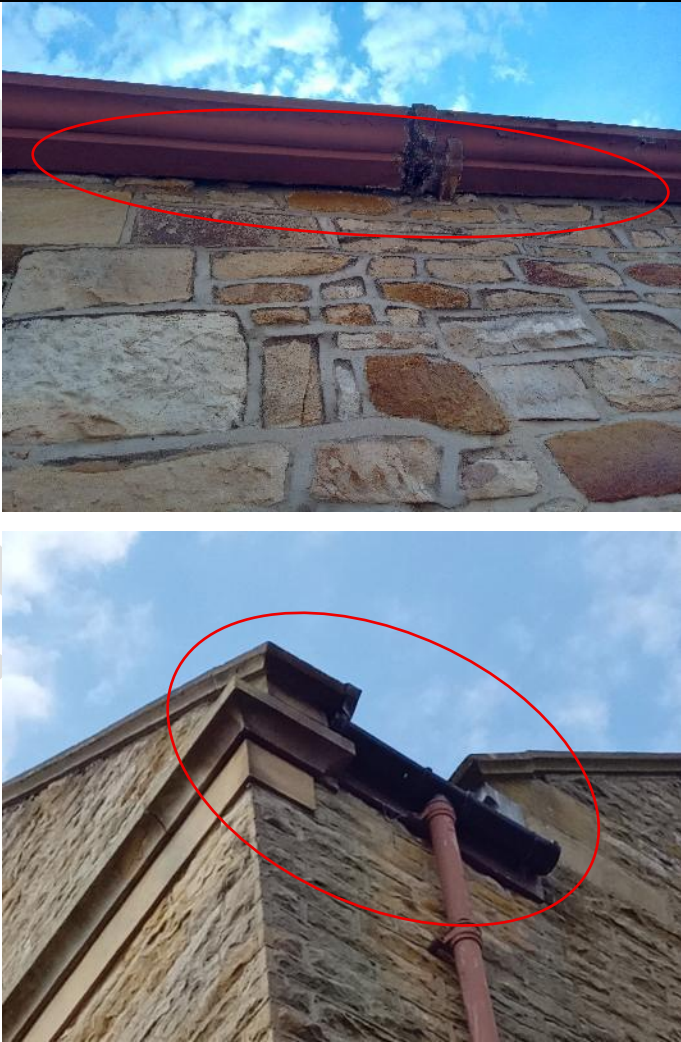
| Eaves | Open | <p><b>Condition/description:</b></p> <p>Gaps were recorded along the north and west elevation eaves, which could support low numbers of void or crevice-dwelling species for roosting along crevices/cavities along the wall tops.</p> <p><b>Suitability/access/evidence of bats</b></p> <p>Provides possible bat access into internal voids and crevices along the wall tops. Could support low numbers of void or crevice-dwelling species.</p> | |

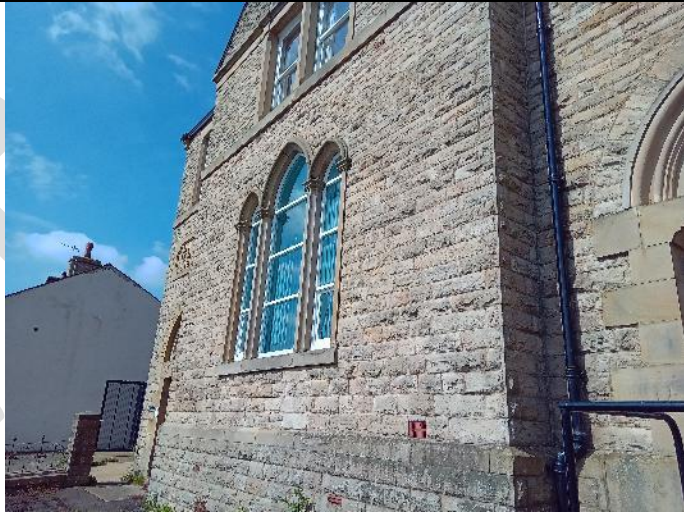
| Window/ door frames | Wooden | <p><b>Condition/description:</b></p> <p>Tight fitting.</p> <p><b>Suitability/access/evidence of bats:</b></p> <p>No suitable features or evidence were recorded.</p> | |

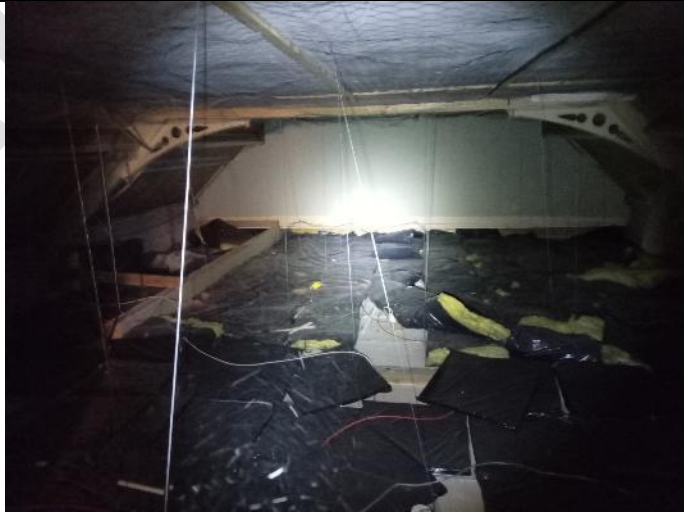
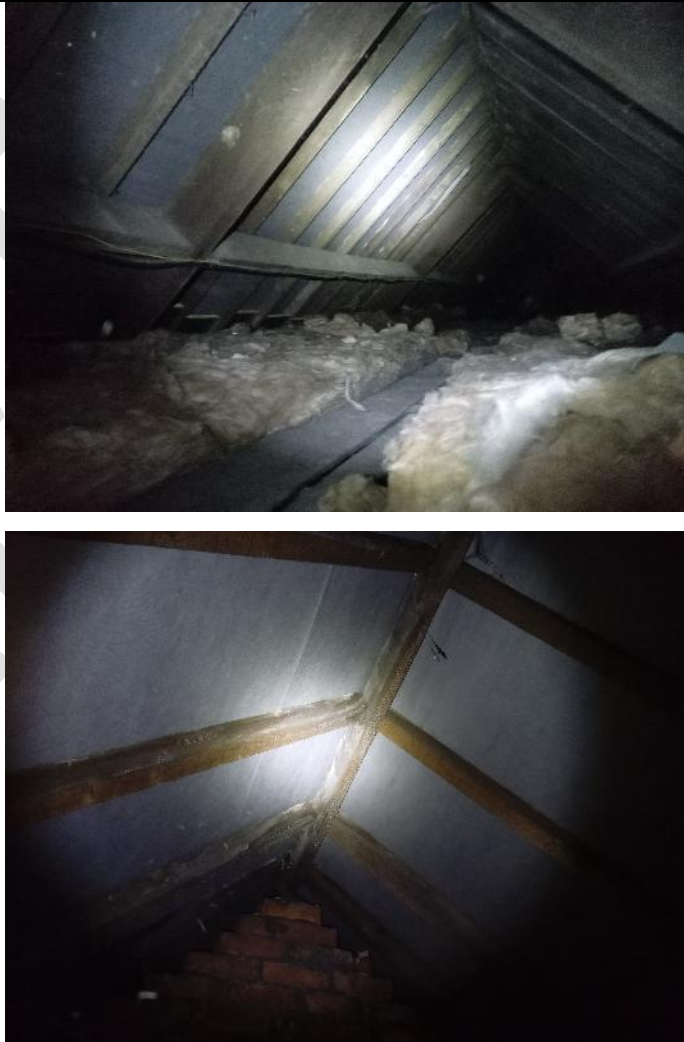
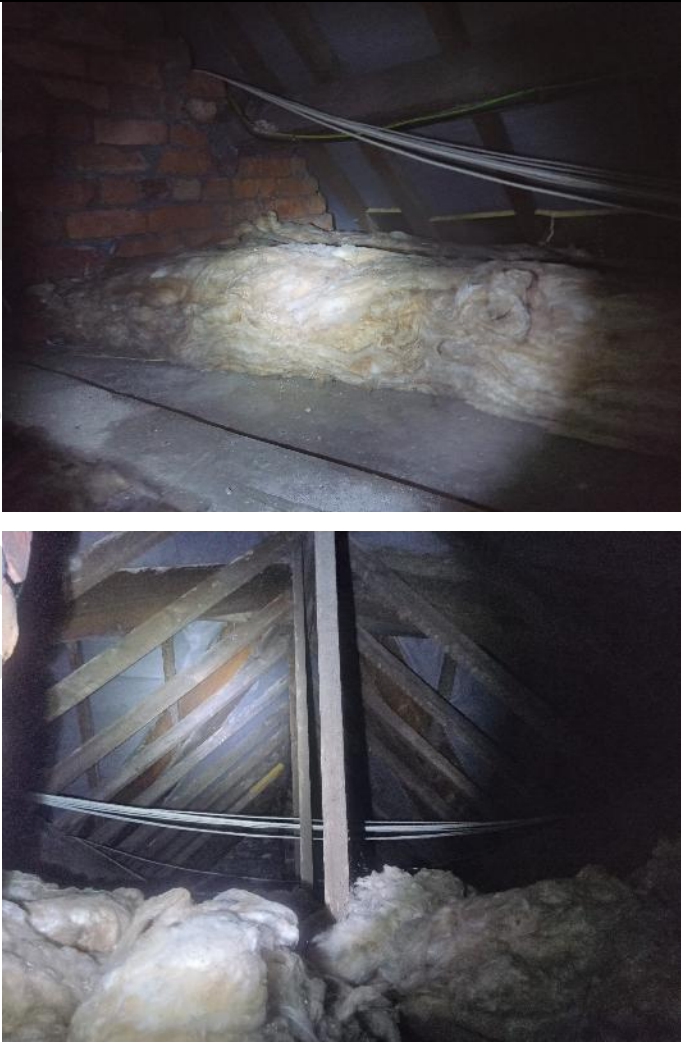
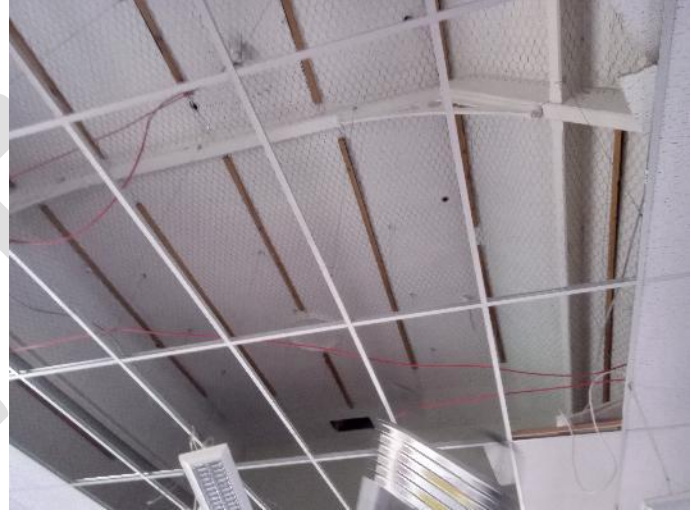
| Internal voids | <p>Timber rafters and ridge beams.</p> <p>Open floor to ridge.</p> <p>Breathable membrane roof lining.</p> <p>Fibre wool insulation.</p> | <p><b>Condition/description:</b></p> <p>There are two accessible loft voids within B1, with other areas of the roof structure vaulted or with suspended ceilings. Internal spaces measure approximately ~16-25m long, ~4m wide, floor to ridge height ~1.5m. The roof structures are lined with breathable membrane which appears tight fitting. The void is suitable for void-dwelling species, though no points of ingress or bat droppings were recorded internally of the voids.</p> <ul style="list-style-type: none"> <li>❖ Temperature readings: 23.5-29.8°C</li> <li>❖ Humidity readings: 55.656.6%</li> </ul> | |

| | | <p><b>Suitability/access/evidence of bats:</b></p> <p>No evidence of roosting bats was recorded within the loft voids, though evidence could be concealed between the roof tiles and roof lining.</p> | |

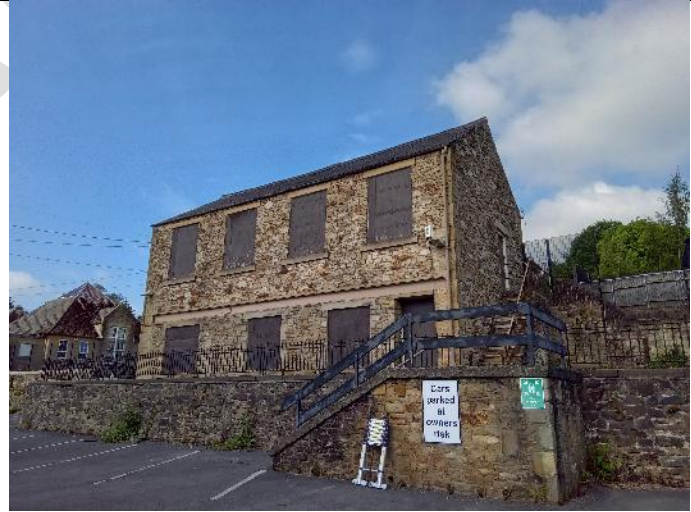
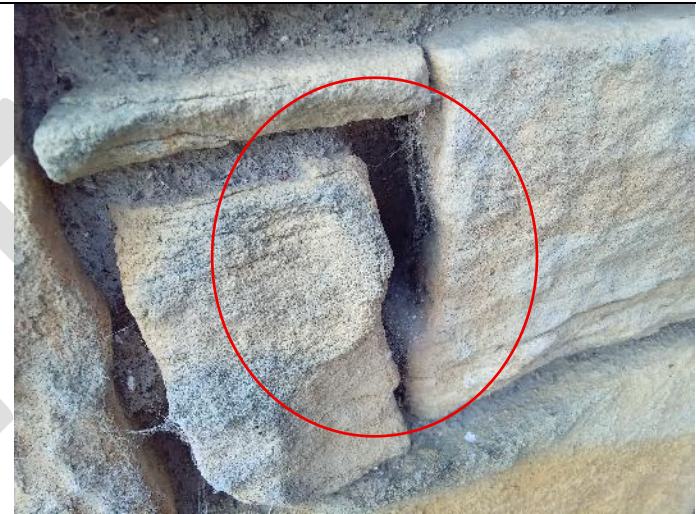
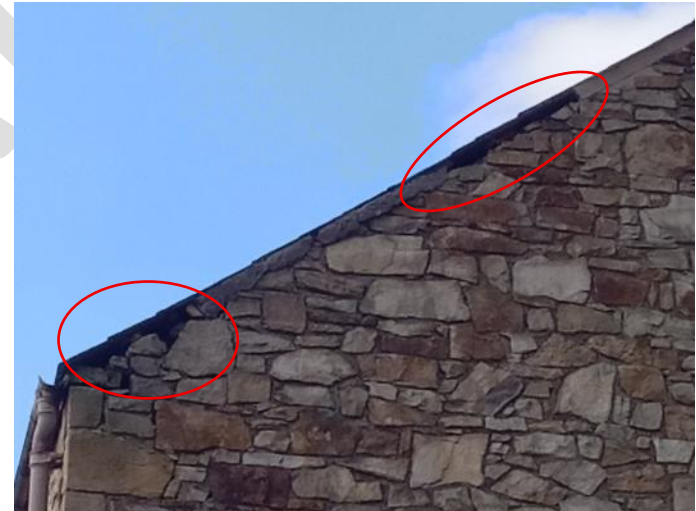
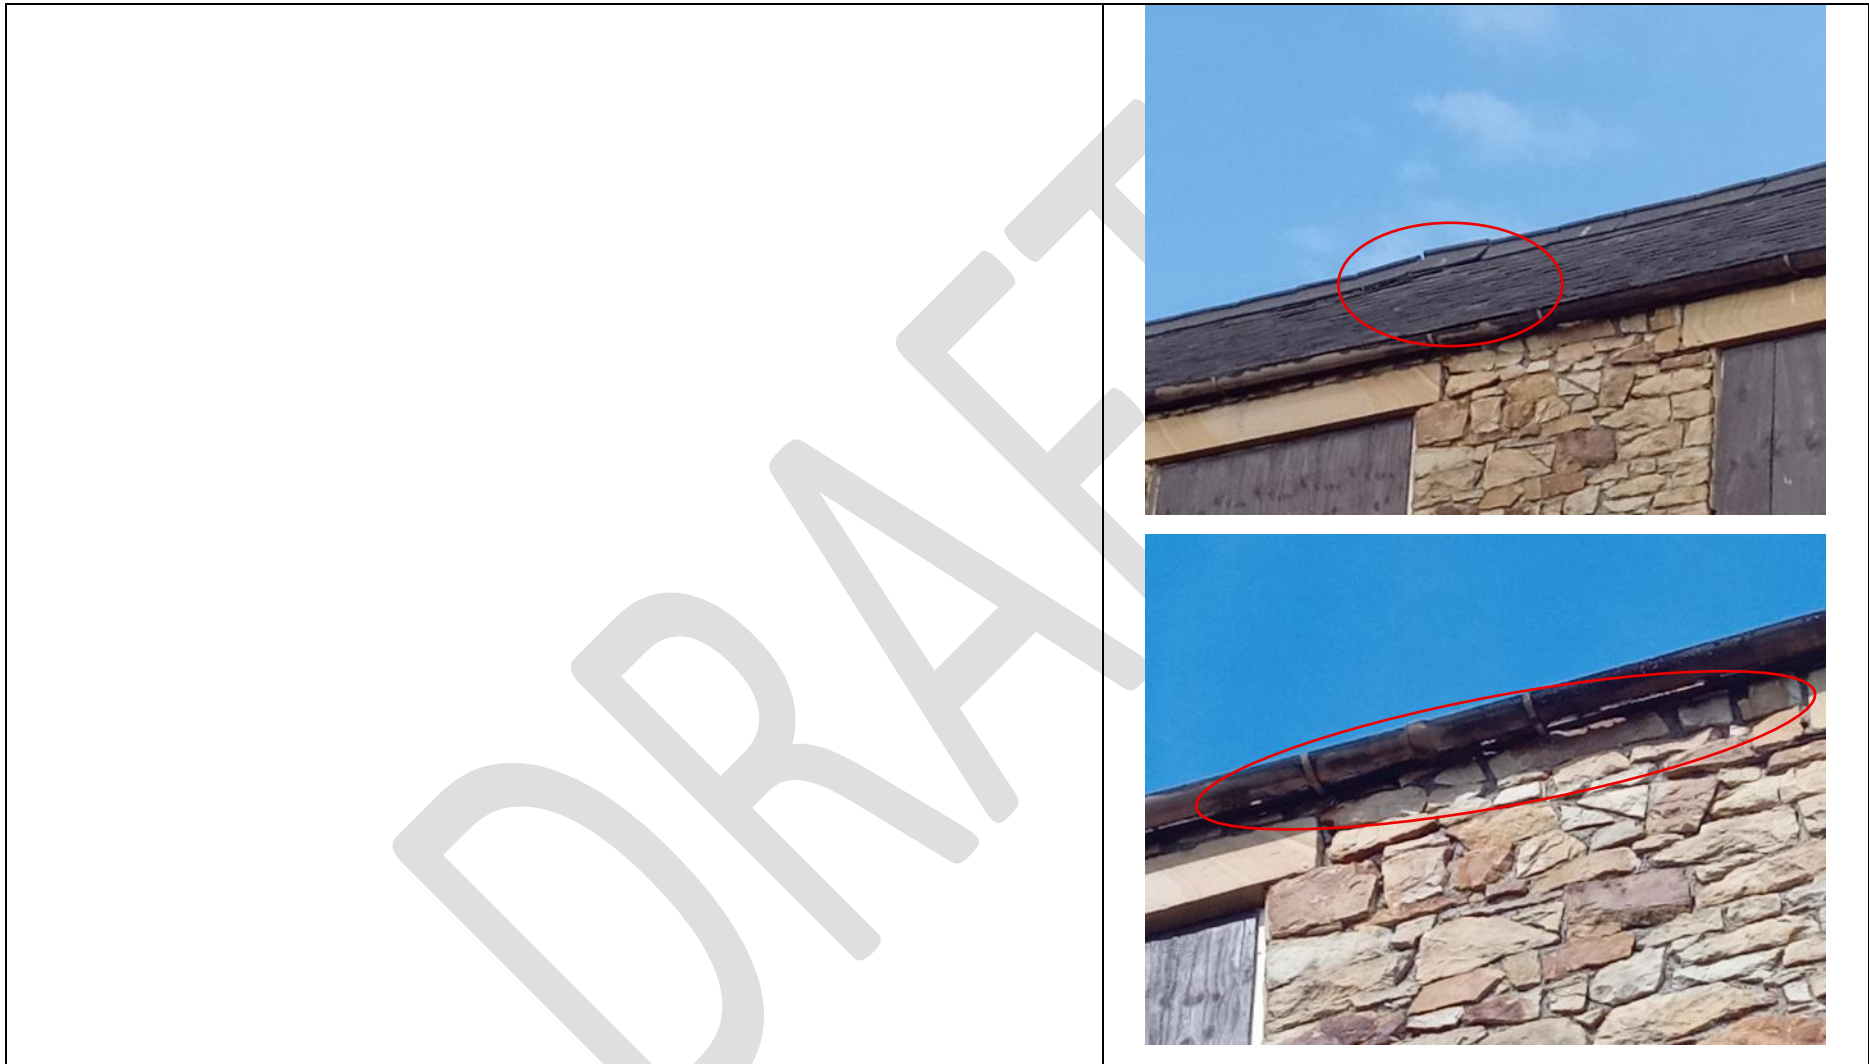
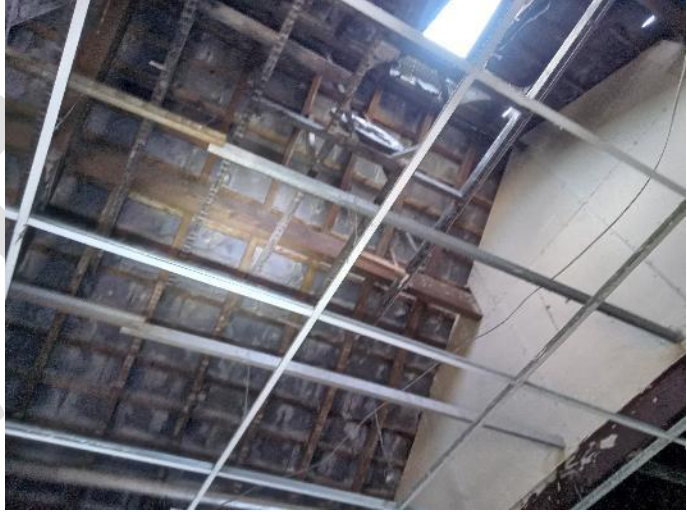
| | | | |
|---|--|--|---|
| <p><i>Summary</i></p> <p>B2 is a vacant stone-built outbuilding with a pitched and gabled roof clad in slate roof tiles. The building will be converted into apartments as part of the proposed works. Shallow crevices were recorded along the north elevation supporting wall, which could support low numbers of crevice-dwelling species. Missing mortar along the roof verges of the north and south elevations was also recorded, which could support low numbers of void or crevice-dwelling species roosting along the supporting wall tops. A lifted ridge tile was also recorded centrally of the building, with potential gapping along the eaves of the east elevation, which could support low numbers of crevice-dwelling species (ridge tile), or void or crevice-dwelling species (gaps along eaves). The windows have boarding across which appears tight fitting with no suitable features recorded. The internal void measures</p> | | | |

approximately ~13m long, by ~8m wide, floor to ridge height ~10m. The void is open, with roof tiles unlined. No droppings or other evidence of roosting bats were recorded internally. Daylight spill enters the space via a skylight which could deter void-dwelling species internally of the void. The building is unlikely to support a maternity or hibernation roost. Based on the features present, suitable for low numbers of void or crevice-dwelling species, the building has **low roost value**.

| <p><i>Summary of Survey Findings</i></p> | <p><b><u>Nesting birds:</u></b></p> <p>One house sparrows nest was recorded within B2, and both buildings are considered suitable for nesting for species such as house sparrows and swifts, with anecdotal evidence provided of these species nesting along the on-site buildings.</p> <p>No habitat for Schedule 1 birds was recorded.</p> <p><b><u>Barn owls:</u></b></p> <p>The site does not appear to provide any suitable nesting sites for barn owls.</p> <p><b><u>Overwintering birds:</u></b></p> <p>Due to the small size of the site and the extent and type of the habitats recorded, the site not considered suitable to support a significant assemblage of protected and/or notable birds.</p> |
