**Buxton Football Club Limited**  
**The Tarmac Silverlands Stadium**  
**Buxton, Derbyshire, SK17 6QH**

**Floodlighting at Buxton FC**

Prepared by Colin Mullins, Managing Director, Mullins Associates

Planning Reference: HPK/2018/0496 – Condition 9

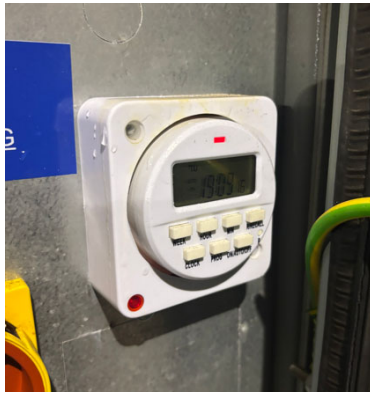
Image 1

Image 1: Timeclock device controlling the floodlighting, set to automatically switch off the lights at 21:55 when in operation.

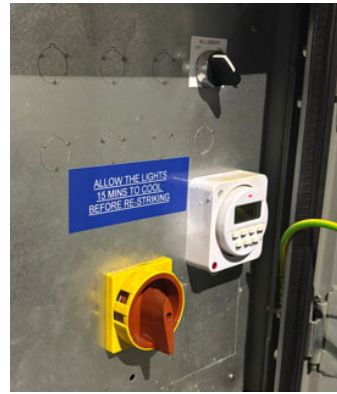
Image 2

Image 2: Manual override switch, allowing authorised personnel to operate the floodlighting outside of the preset schedule if necessary.

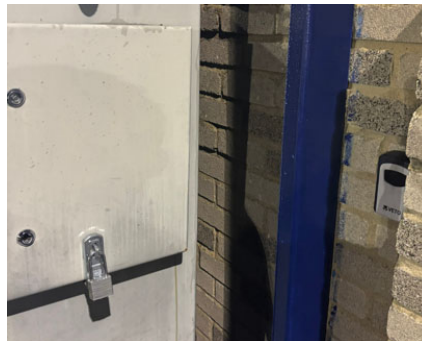
Image 3

Image 3: Shows the locked timeclock control panel, accessible only to authorised personnel. The local key is securely stored in a code-protected safe box to ensure controlled access.

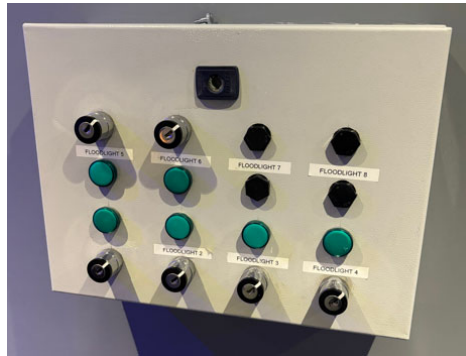
Image 5

Image 5: Manual key-operated floodlighting control panel located within a secure corridor in the main stand. Access is restricted to authorised personnel only, who must possess the key to operate the system.

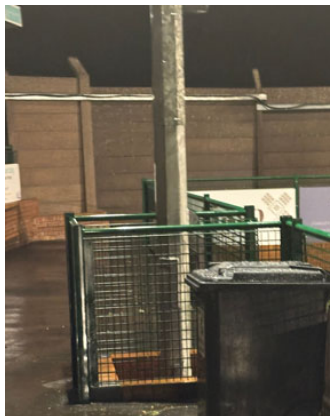
Image 7

Image 7: Typical view showing the mounting and arrangement of the floodlighting columns around the pitch.
