## GeoEnvironmental Site Investigation Report

Glossop Road

Charlesworth

**Report Ref: A6549/25/SI**

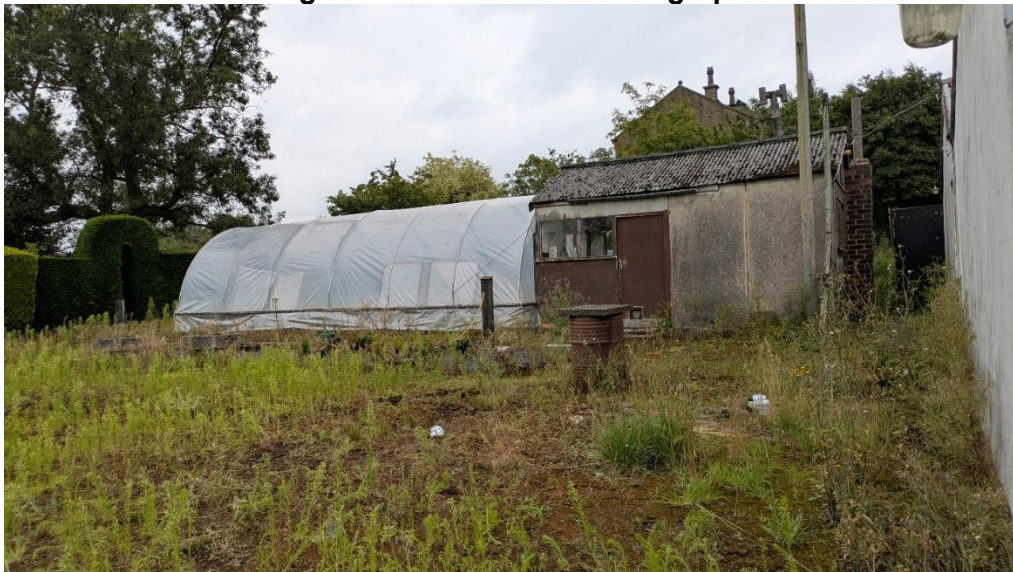
**Figure 2: General Site Photograph**

A general site photograph is presented in Figure 2 overleaf.

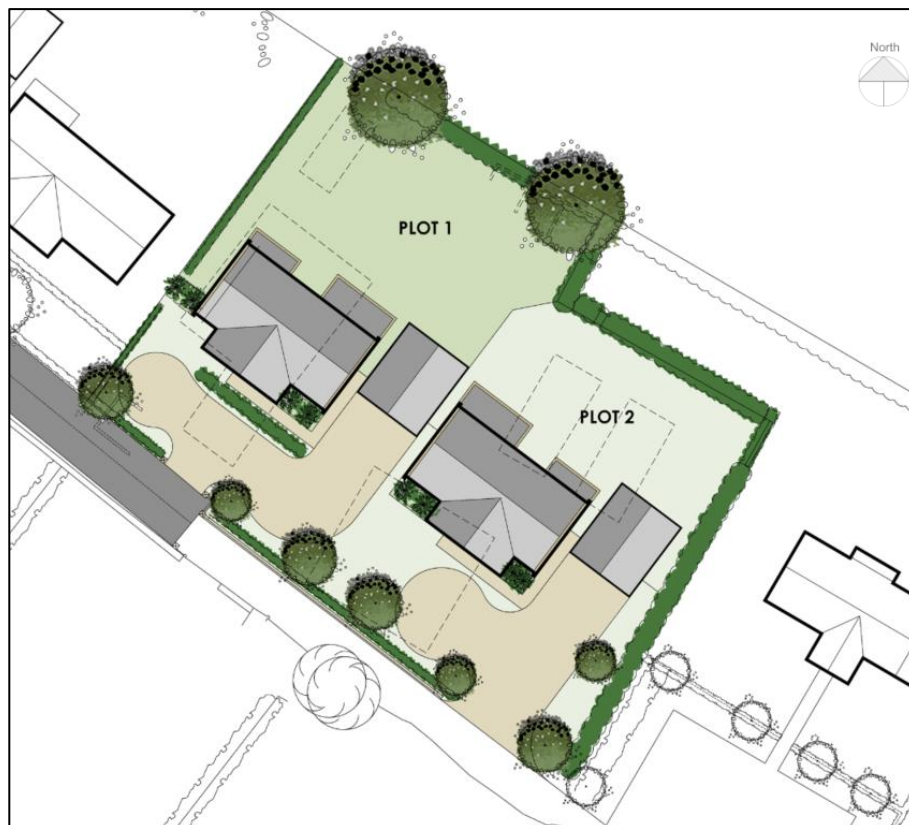
**Figure 3: Proposed Development Plan**

The client has submitted proposed development plans, and it is understood that the client wishes to construct two residential dwellings on-site, with parking and soft landscaping.

The proposed development plan is illustrated in Figure 3, below.

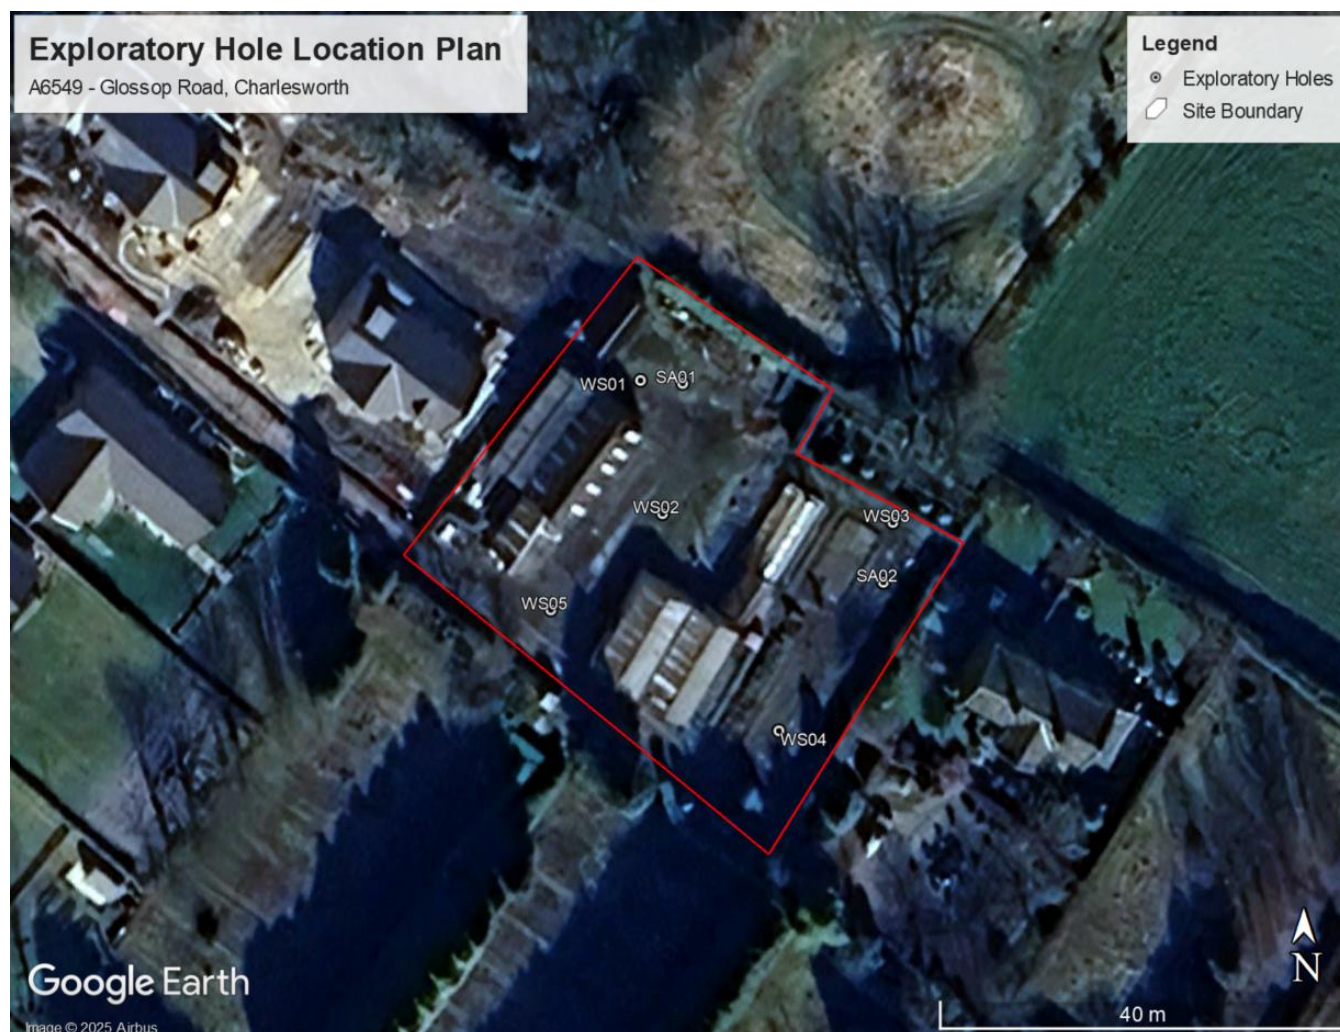
**Figure 4: Exploratory Hole Location Plan**

An Exploratory Hole Location Plan is presented as Figure 4, overleaf.
