## 7 Conclusions

### 7.1 Contamination Assessment

| Site:<br><b>Reliance Garage, Glossop</b> | | | | Scale (see scale bar):<br><b>1:25,000 &amp; 1:1,000 @ A4</b> | | |
| Job No.:<br><b>LKC 21 1086</b> | Drawn By:<br><b>HM</b> | Checked By:<br><b>CH</b> | Drawn:<br><b>Mar 2021</b> | Figure:<br><b>1</b> | Revision: | |

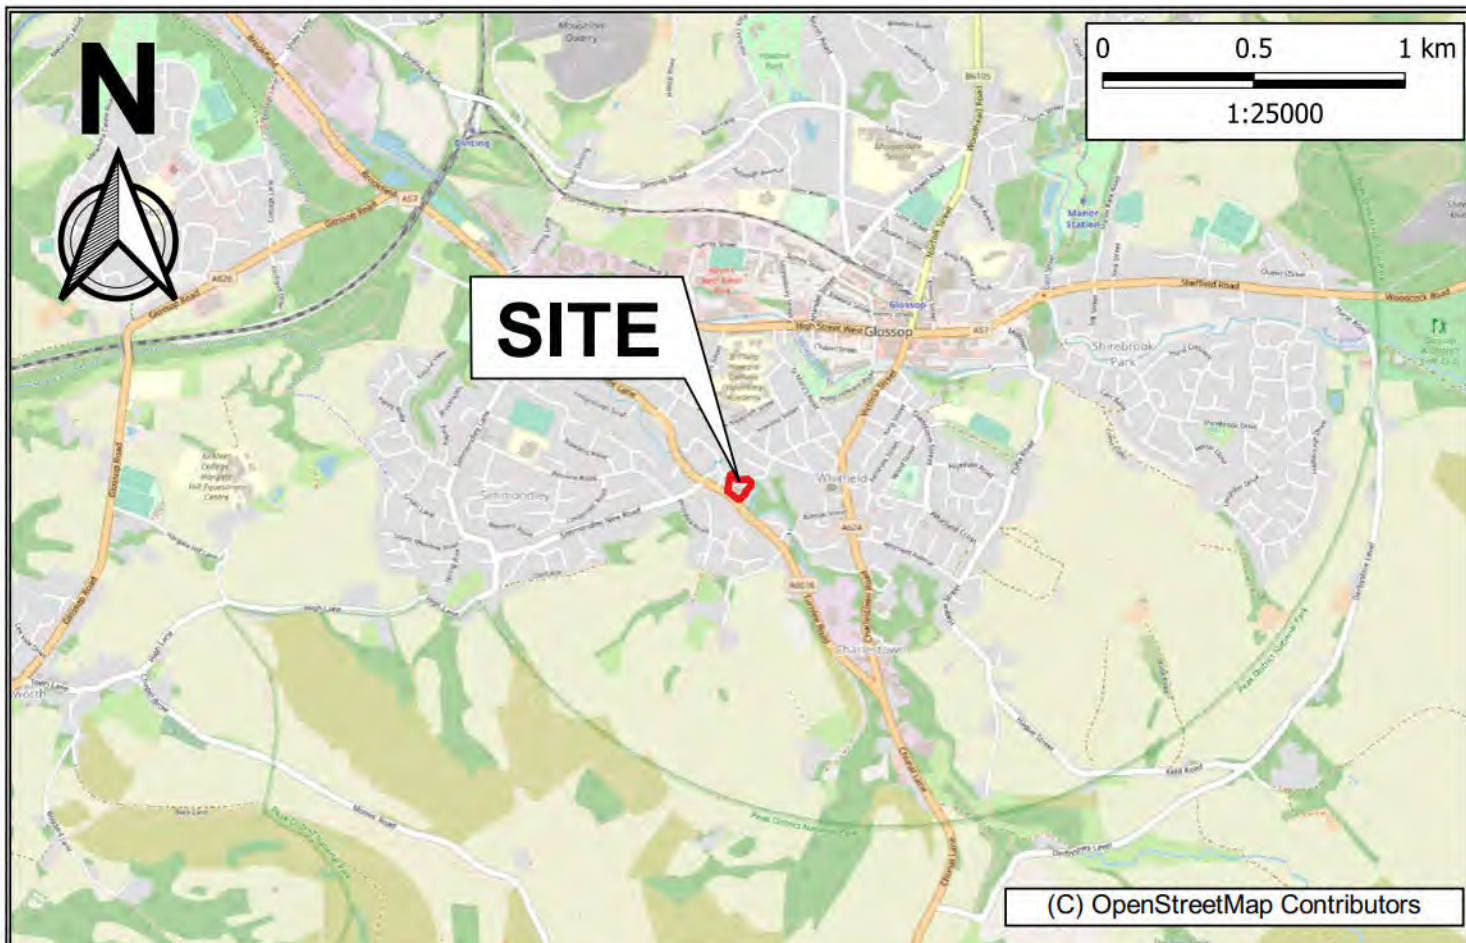
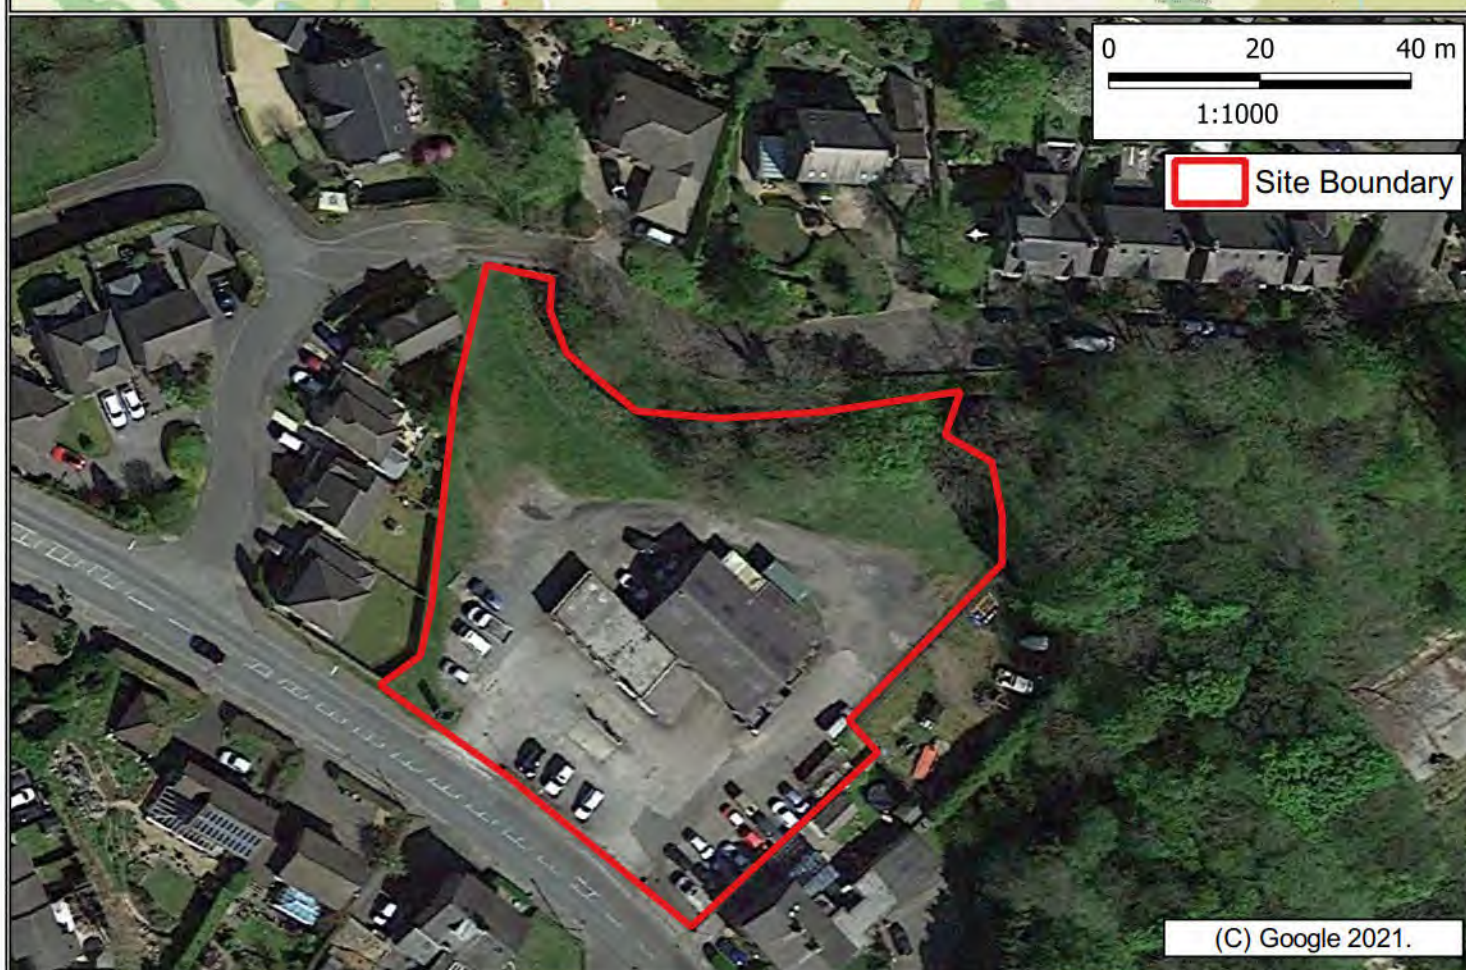
| Client:<br><b>Mr Peter Shaw</b> | | | | File:<br><b>Site Location &amp; Boundary Plan</b> | | |
