Eagle Parade Conduit  
Eagle Parade  
Buxton  
Derbyshire  
SK17 6EQ

EXISTING  
SOUTH ELEVATION - CENOTAPH  
CONDITION SURVEY (1 OF 2)

24233-E-034A

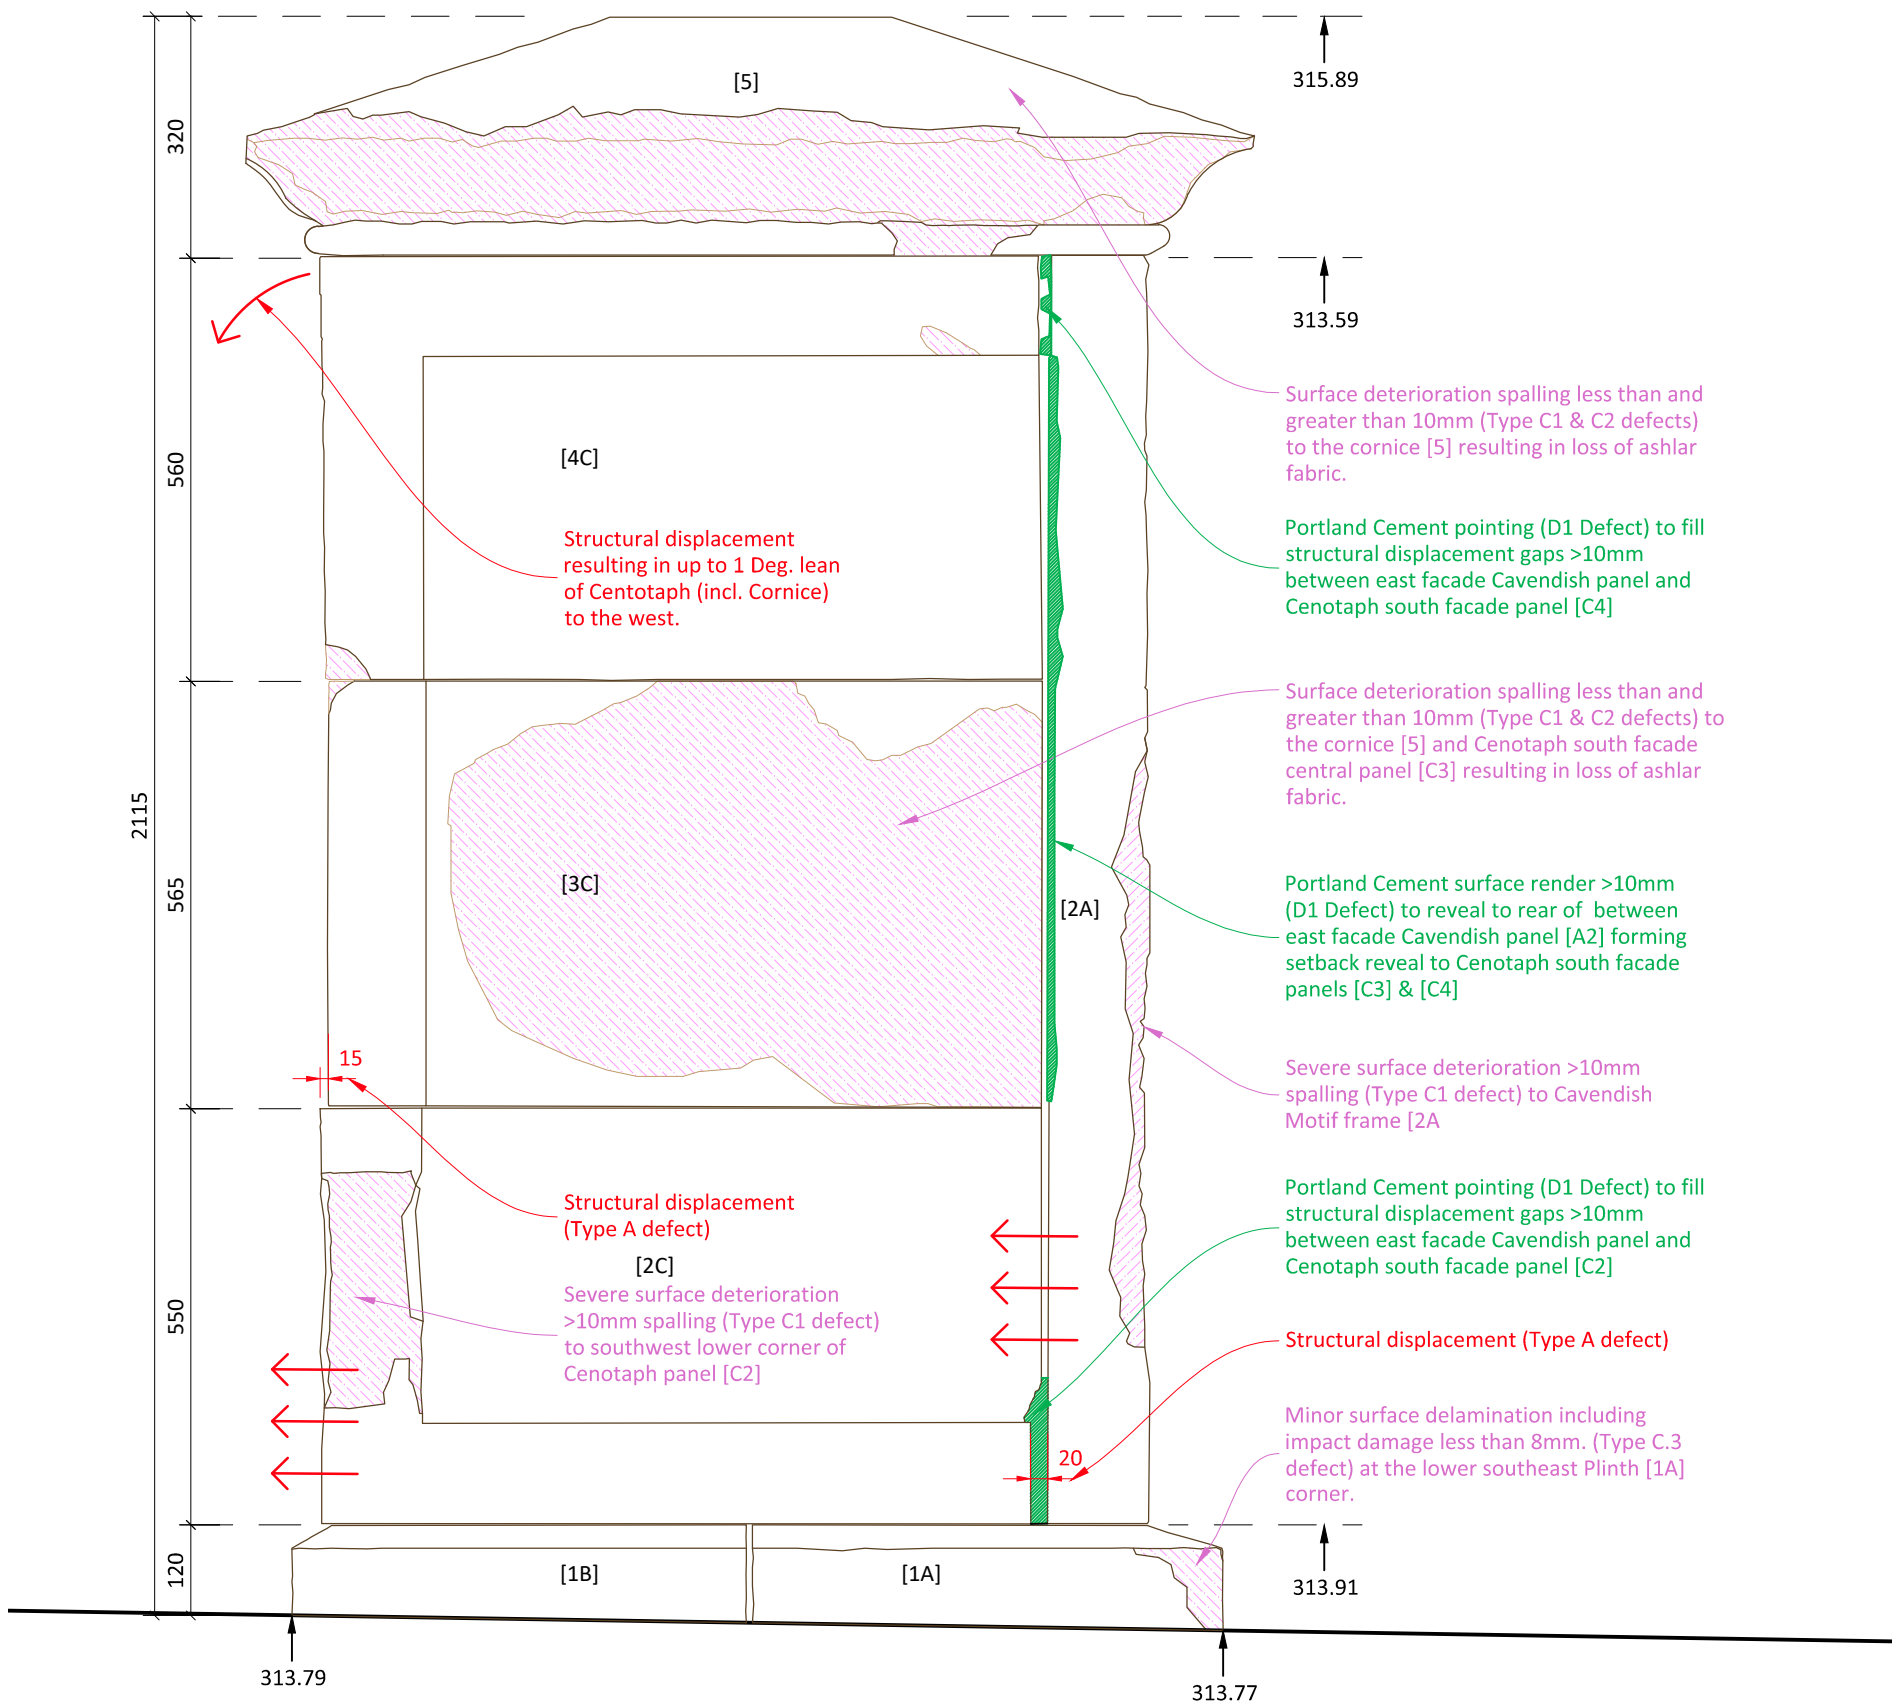
South Elevation  
Existing Survey  
(1:10)

- Type A - DISPLACEMENTS - indicating continued and worsening structural movement.
- Type B - CRACKS/FRACTURES - caused by structural movement or freeze-thaw salt crystallization.

- Type C - SURFACE LOSS - greater than 8mm and up to 15mm with delamination and 'contour-scaling', which has been followed by further crumbling and flaking of the ashlar.
- TYPE C.3. Minor surface delaminating including impact damage less than 8mm.

- Type D - CEMENTITIOUS MORTAR
