# Eagle Parade Water Cistern

## The Market Place

### Buxton

#### A Report on the Archaeological Monitoring

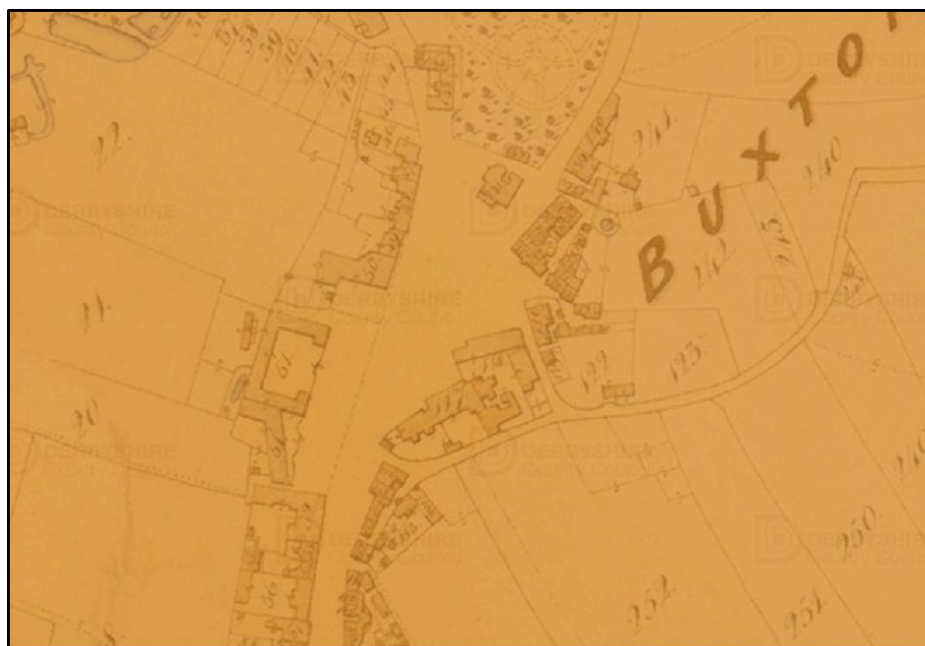
Figure 3. Detail of Market Place, Buxton, 1878 Ordnance Survey map.

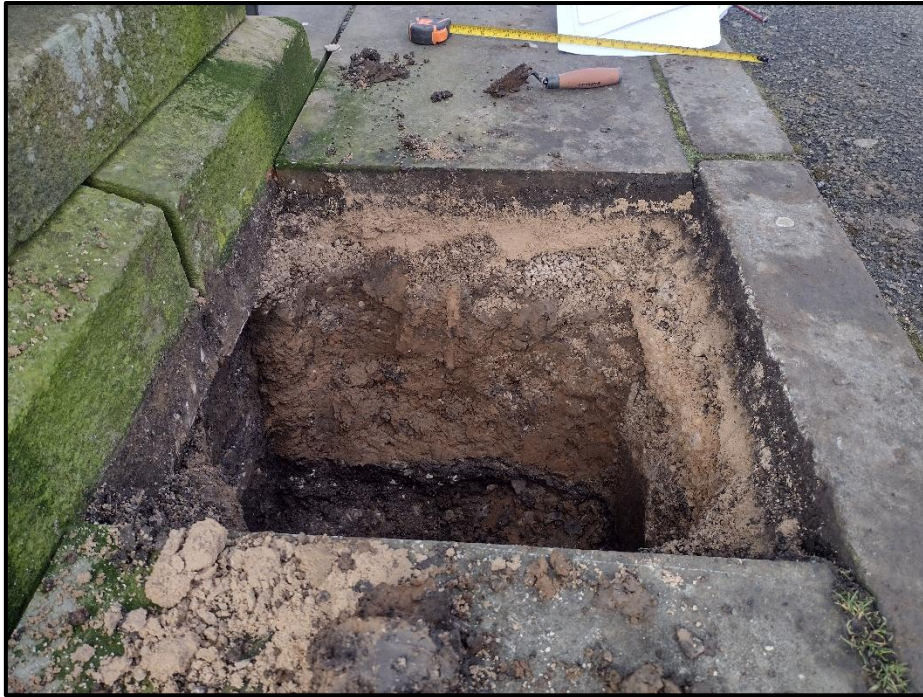
- 7.2. The removal of the concrete on both sides exposed the below ground faces of the structure and the edges of the original retaining wall. Between these was a deposit of stiff mid-brown clay (see Fig. 5.).

- 7.6. In both trial trenches the E facing and W facing sections contained only the stiff mid-brown clay.
- 7.7. There were no small finds recovered from the excavation.

*Figure 6. West facing section of Trench b during excavation.*

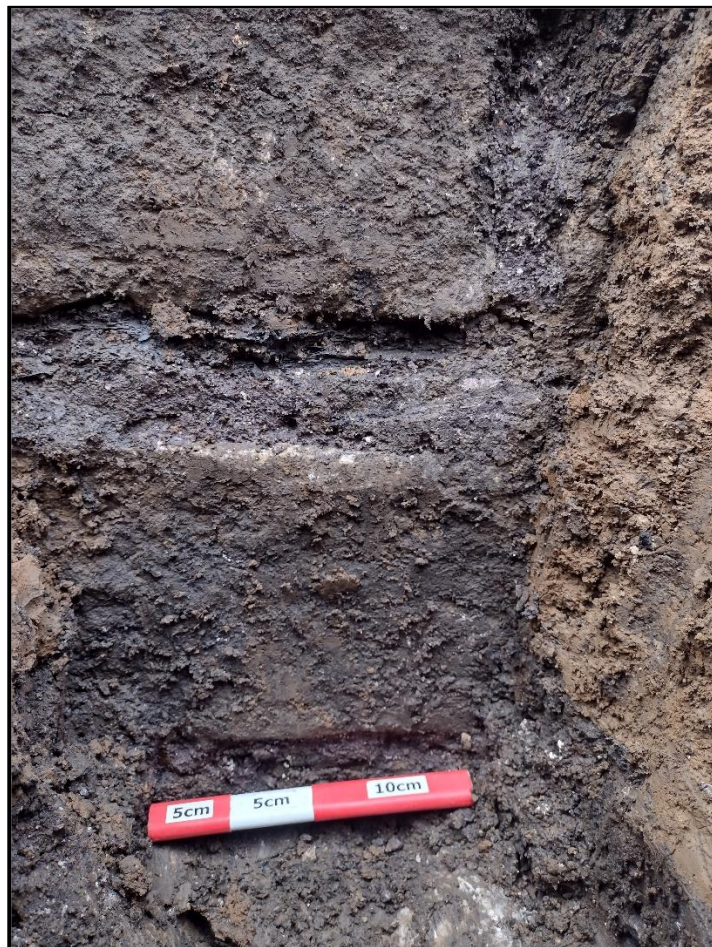
- 7.4. On both the northern and southern faces of the cistern there were traces of badly degraded metal running between both horizontal and vertical joins of the foundations (see Fig. 6.).

- 8.1. The trial excavations revealed the extent of the foundations of the cistern which are undisturbed. There are remains of badly degraded ironwork in-situ which strongly suggests that the original pipework for the cistern passed through the stonework of the foundations and into the cistern itself. The deposit of clay in both trenches between the cistern and the outer wall coupled with its sterile character suggests that this is made-up ground which was added to the structure during construction.

*Figure 6. Detail of base of foundations showing badly degraded pipework (Trench a).*
