Eagle Parade Conduit  
Eagle Parade  
Buxton  
Derbyshire  
SK17 6EQ

EXISTING  
EAST ELEVATION - CENOTAPH  
CONDITION SURVEY (1 OF 2)

24233-E-036B

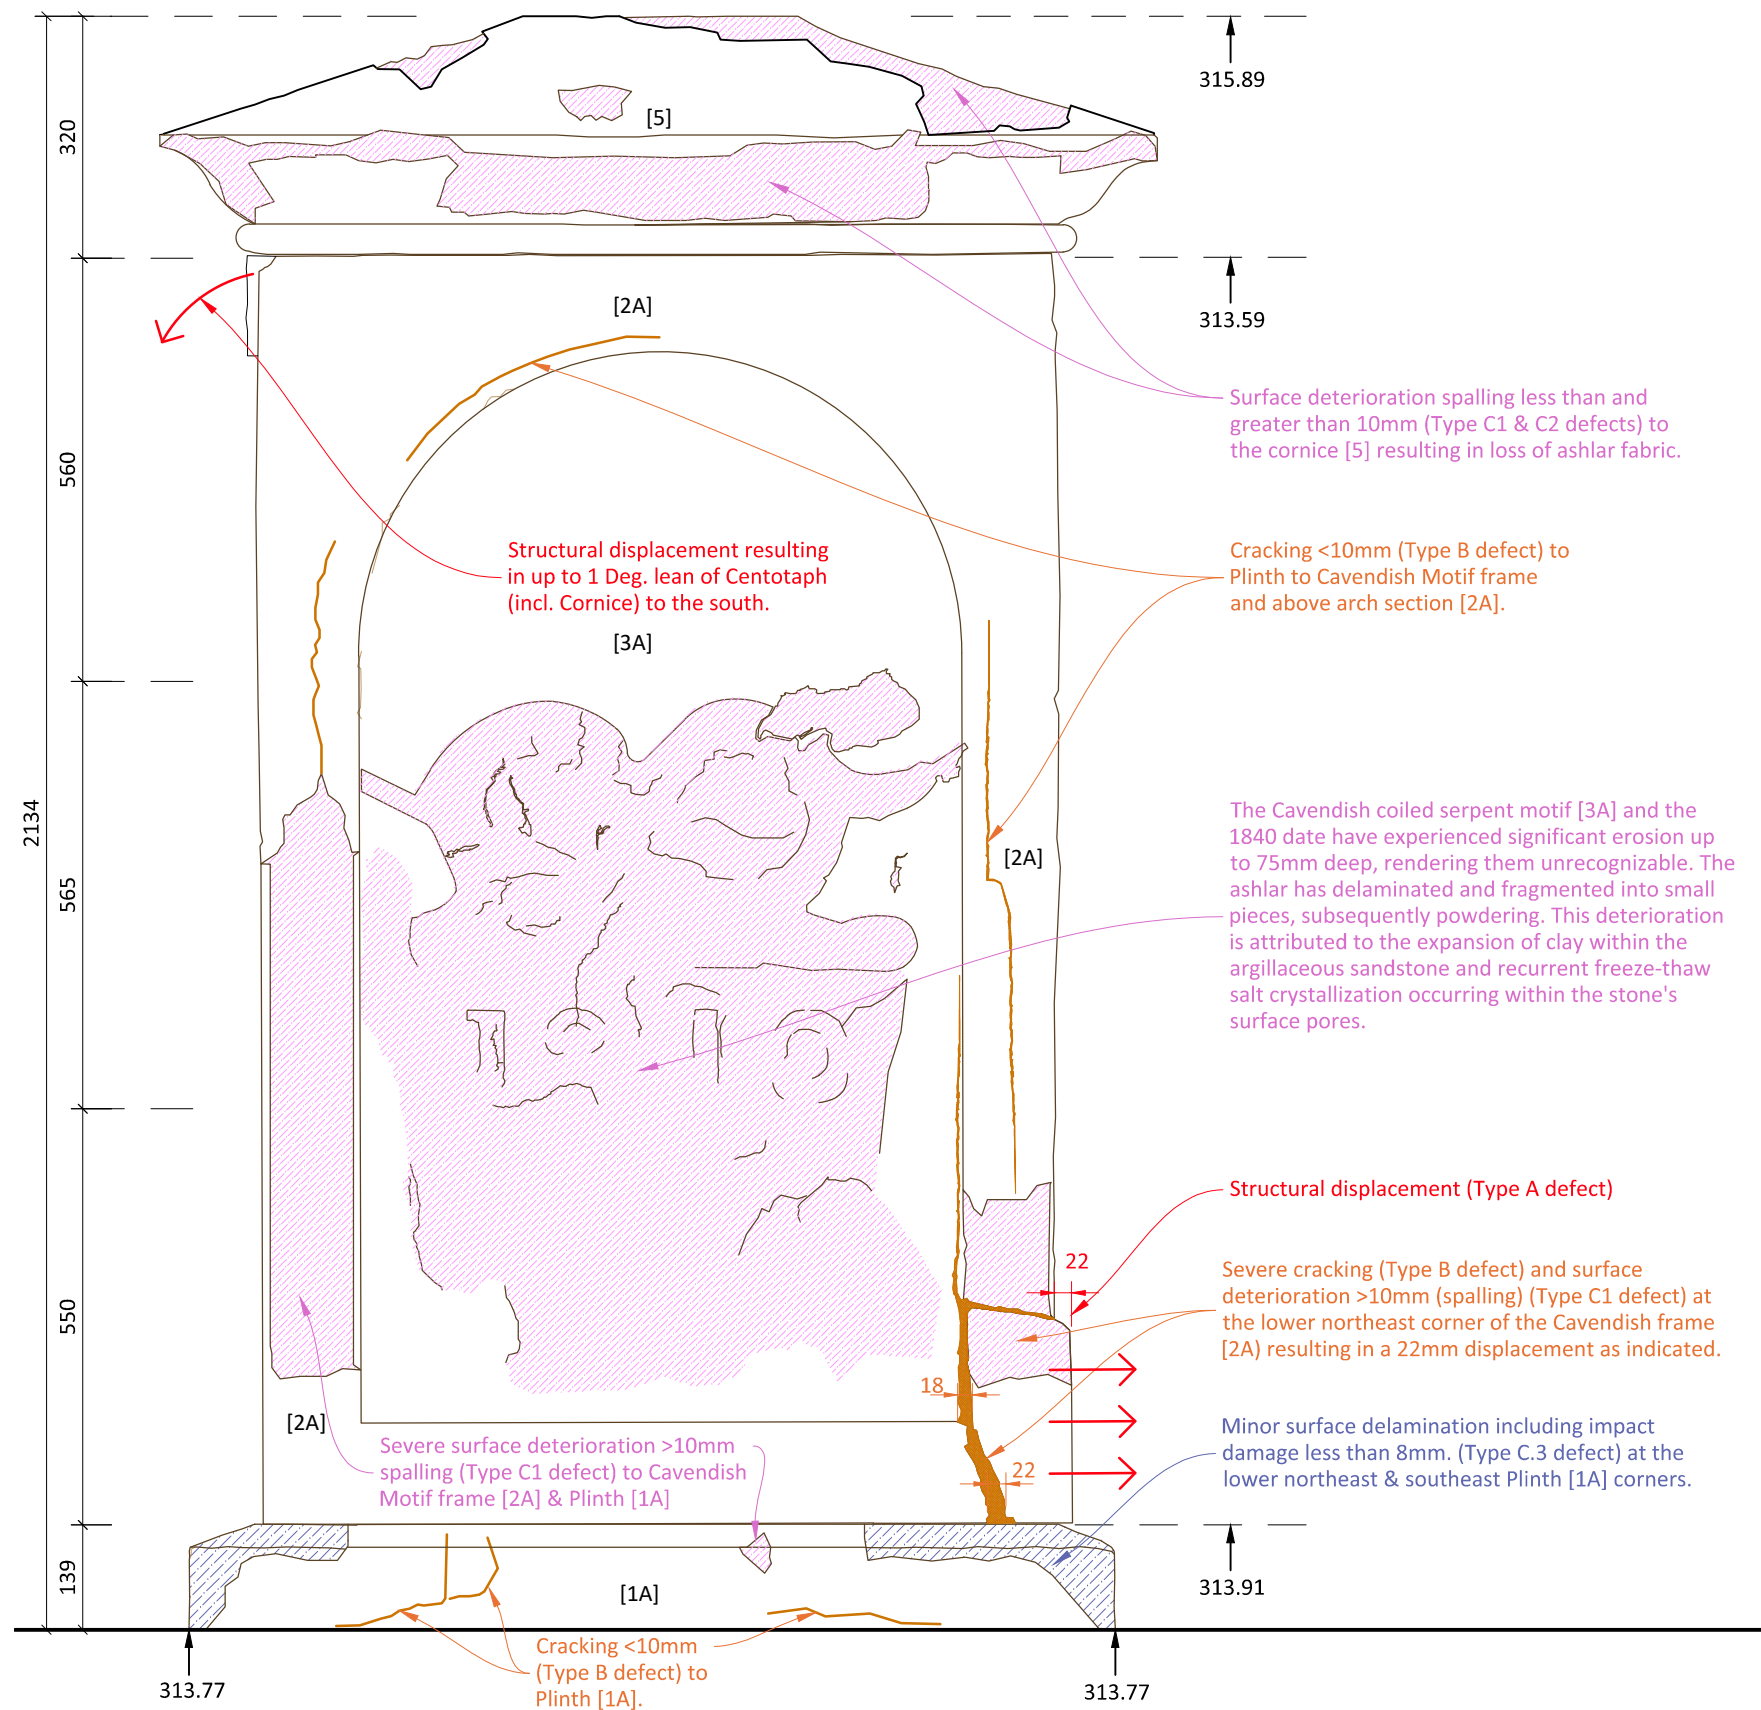
East Elevation  
Existing Survey  
(1:10)

Key to DECAY TYPES.

- Type A - DISPLACEMENTS - indicating continued and worsening structural movement.
- Type B - CRACKS/FRACTURES - caused by structural movement or freeze-thaw salt crystallization.

- Type C - SURFACE LOSS - greater than 8mm and up to 15mm with delamination and 'contour-scaling', which has been followed by further crumbling and flaking of the ashlar.
- TYPE C.3. Minor surface delaminating including impact damage less than 8mm.

- Type D - CEMENTITIOUS MORTAR
