Project No: 12986  
Project: Eagle Parade, Drinking Cistern  
Engineer: Stephen Swinbank  
Date of visit: 16/03/26  
Present: Adam Bench / Warren McFadden  
Weather: Cold but dry

Report No: **12986/0551**  
Page: Page 1 of 5

Mann Williams have been engaged by Buxton Civic Association to undertake an inspection of the historic drinking cistern located on Eagle Parade, Buxton.

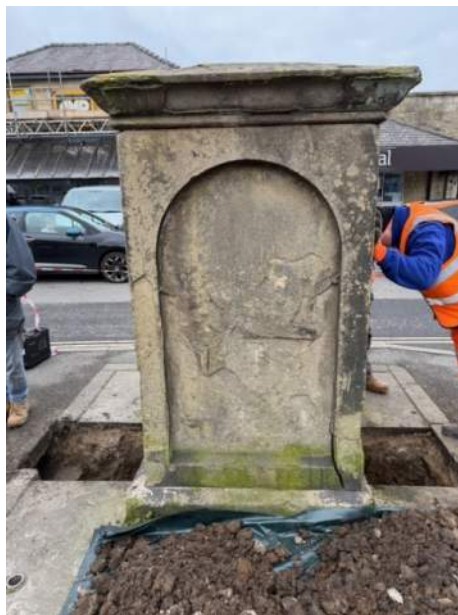
The cistern (Photo 1) is Historic England Grade II listed and dates from early C19.

Photo 1 – East elevation of cistern

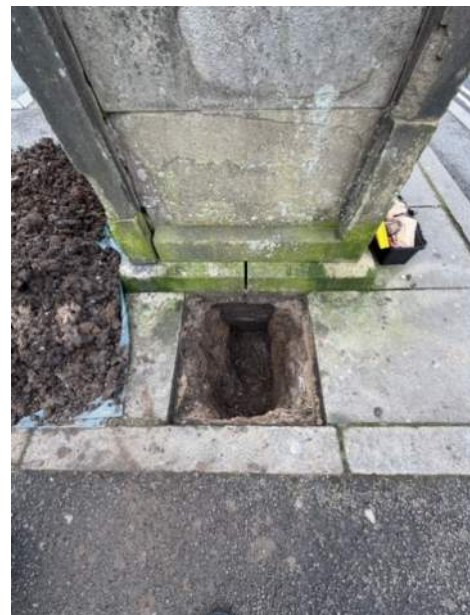
Trial pits, archaeologically recorded, were excavated ahead of our visit adjacent north and south sides of the cistern masonry. The north side of the cistern is founded at approximately 650mm below the current finished ground level (Photo 2). The cistern was shown to be founded on the natural bedrock in both trial pits. The foundation depth was marginally shallower on the south side (Photo 3) owing to variation in the bedrock profile. There are some open joints beneath the base stones and the rock profile.

The perimeter of the cistern has a previously disturbed backfill beyond its perimeter comprising predominantly clay. The perimeter stone slabs currently bear over this fill material.

Photo 2 – Trial pit to north side of cistern

Architectural proposals involve renewal of the paving to the perimeter of the cistern stonework. We advise the made ground, comprising predominantly clay, beneath the current paving be removed down to the bedrock (nominal 400mm layer) and replaced with Highways Agency Type 3 specification fill (graded granular stone with reduced fines) compacted in 150mm layers to provide a stable base for the paving.

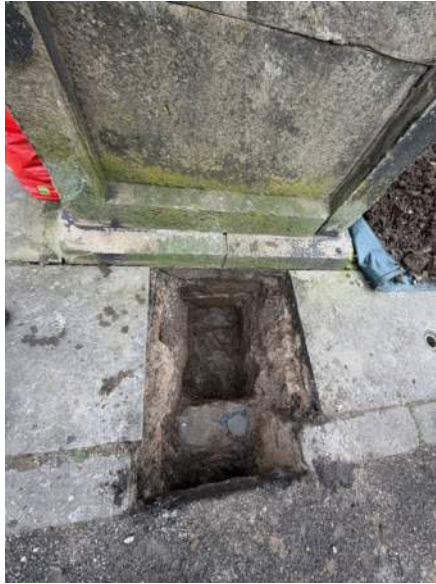
Photo 3 - Trial pit to south side of cistern

Open joints in the founding stones should be deep pack pointed in hydraulic lime mortar as should the bedding joint over the bedrock.

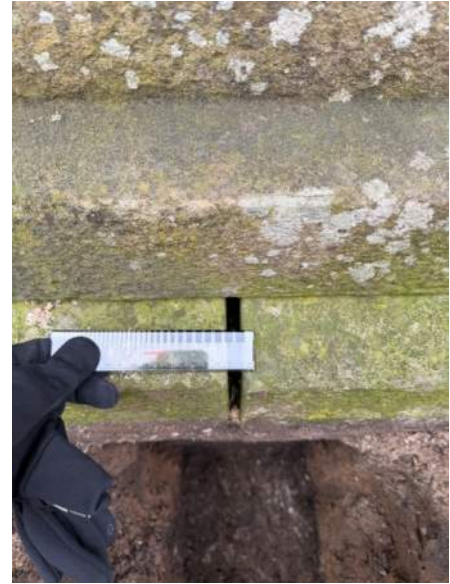
The exposed stone plinth to the base of the cistern comprises two large format stones around approximately 250mm high. These stones have separated in the region of 15mm (Photo 4). We suspect they have been jacked apart owing to corrosion (and expansion) of ferrous metalwork within the joint between them (possibly where pipework passed through under the cistern base). Movement of the plinth stones will also have resulted in separation of the ashlar side walls. Past repairs are evident, poorly executed in unsympathetic cementitious mortar; fractures and joints have opened up considerably since this cementitious mortar was applied (Photos 5 and 6).

Photo 4 – Separation of plinth stone

The expectation is that the plinth stones will need to be raised and re-bedded with any ferrous metalwork that is causing them to separate being removed. The plinth stones should be cramped together with a pair of inert grade 316 stainless steel cramps as noted on the architectural drawings.

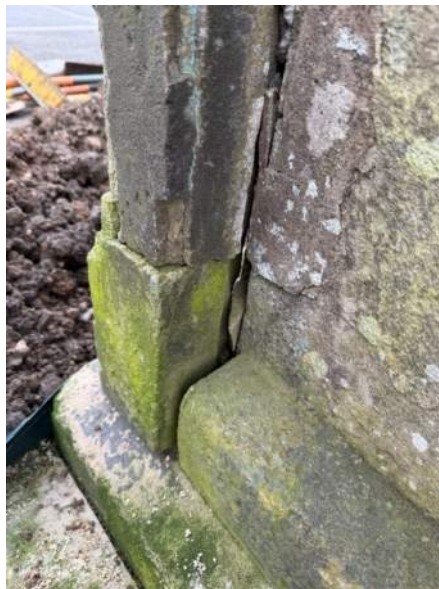
all integrity without fracturing the external exposed stone face. Loss of restraint has allowed the ashlar units to displace and some to fracture. It is likely that the mass of the stone cap keeping the bulk of the stone in compression is currently the key component in preventing the cistern from collapse.

Photo 5 – Severe displacement and fracturing to north-east corner of cistern; past cementitious repairs noted

The cistern is potentially unstable and it is clear careful dismantling and repair is an urgent priority. A temporary lifting frame will be needed to safely dismantle the structure.

Temporary strapping around the cistern in the form of nylon ratchet straps is needed to avoid uncontrolled collapse during dismantling. Without temporary strapping in place, when the stone cap is lifted the structure would likely collapse. Soft packing should be introduced beneath the straps at corner positions to prevent damage to the stone. Before the straps are fastened, timber wedges should be placed into the open joints in the stonework to avoid displacement of the stone.

With the capping stone removed, the stone mason undertaking this work will need to introduce temporary lateral restraints to the elevations of the cistern (utilization of tubular scaffold, with soft protective packs at interfaces with the stone is envisaged for this purpose) such that the ratchet straps can be progressively removed and the ashlar side walls dismantled stone by stone. Any tubular scaffold arrangement would also best incorporate a lifting beam to allow controlled lifting and lowering of all stones.

It is recognised that even after these works are completed isolated stone repairs will be needed to the cistern in years to come. It is therefore proposed to construct an internal brick core to the structure that the perimeter stone units can be cramped back to utilising inert grade 316 stainless steel cramps. This approach allows future removal of individual stones for repair / replacement without further wholesale dismantling of the cistern. The presence of the brickwork will also improve the overall

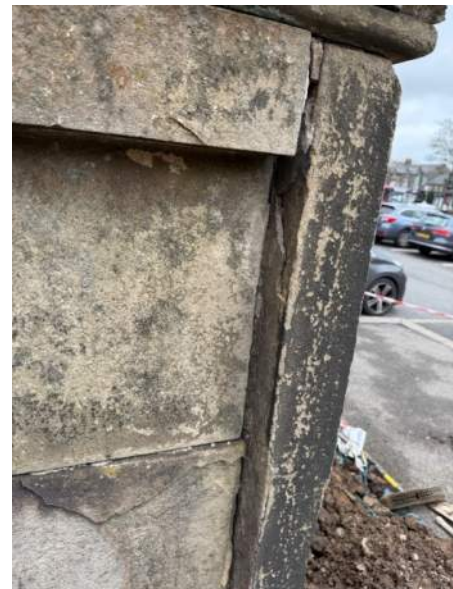
Photo 6 – Severe displacement to south-east corner of cistern; past cementitious repairs noted
