## Conservation Management Plan.

Land west of A6, north of Buxton, Derbyshire.

On behalf of Greenergy Renewables UK.

Date: 25/06/2026 | Pegasus Ref: P24-1678

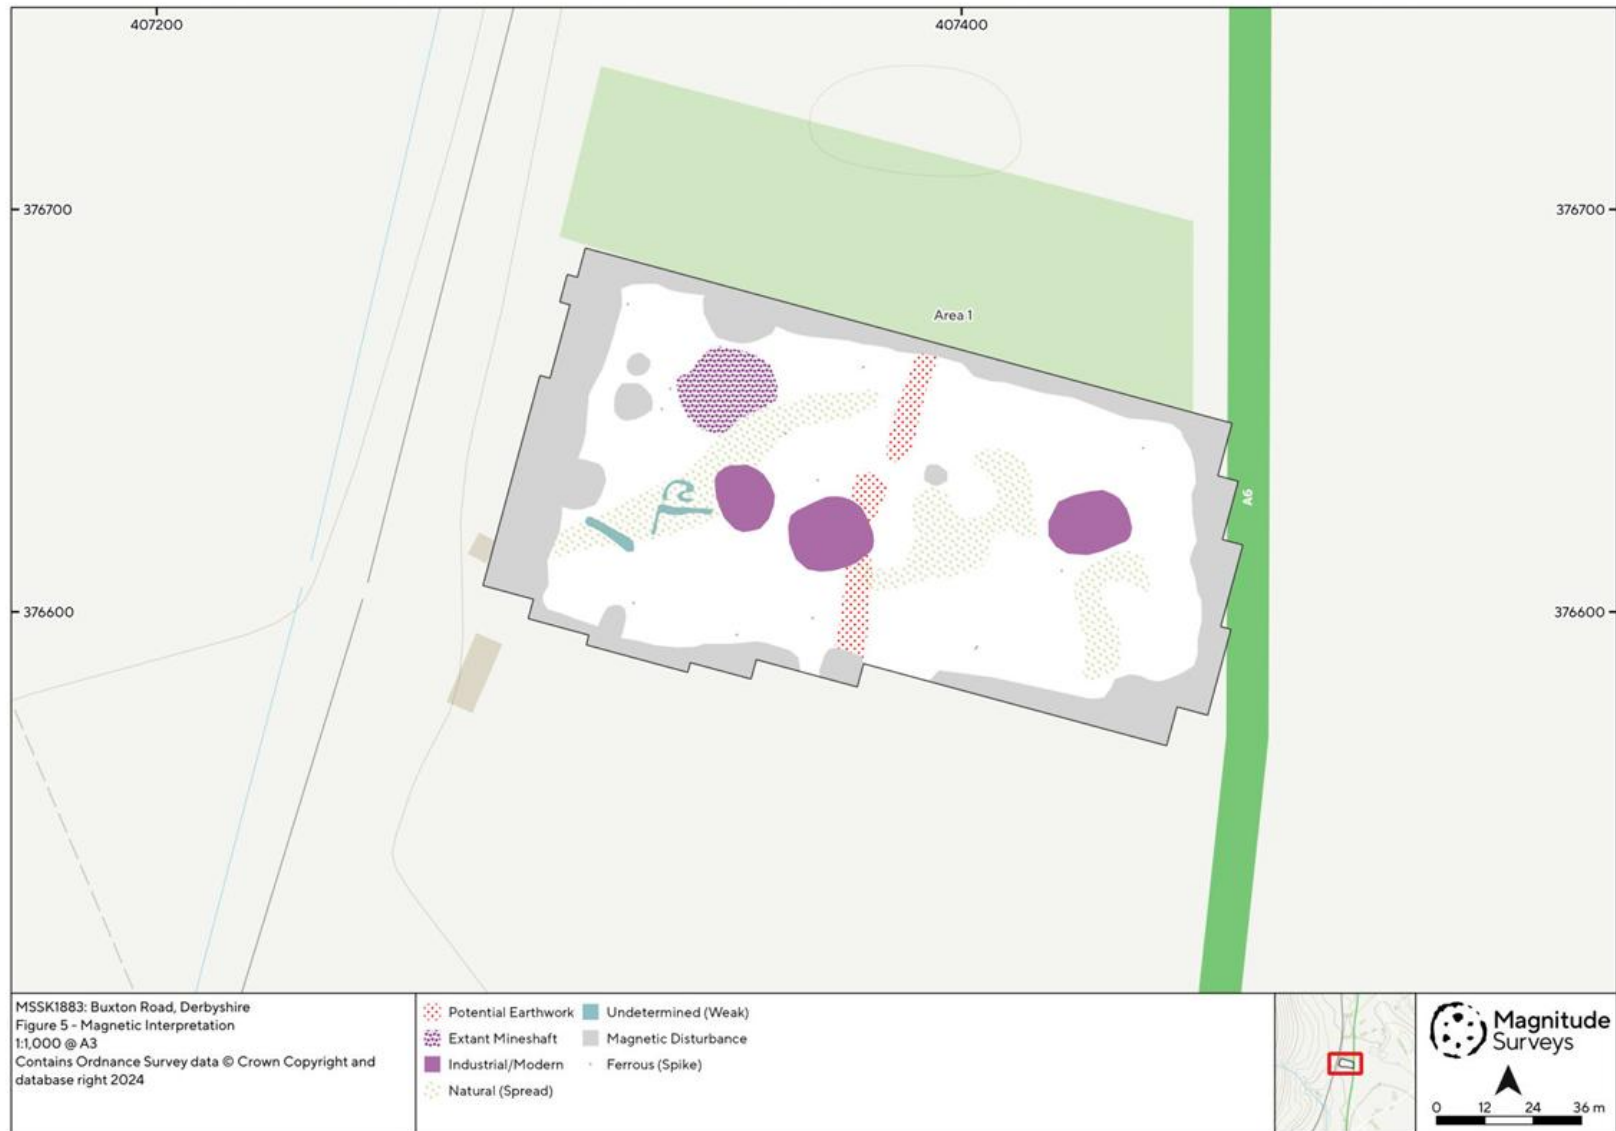
Plate 3: Geophysical Survey Interpretation Drawing

- 3.8. The geophysical survey has detected three weakly enhanced zones running on a linear alignment across the survey area north to south. These anomalies largely correspond with an area of raised ground noted at the time of survey and within LiDAR imagery, suggestive of a possible earthwork. A Roman road has previously been recorded running through the survey area.

- 3.9. A strongly enhanced, dipolar anomaly corresponding with an extant mineshaft was recorded within the northwest of the survey area. Three further strongly enhanced, dipolar anomalies were also recorded within the centre and east of the survey area suggestive of further former mineshafts. Alternatively, infilled ponds have been

recorded c. 85m and c. 115m south of the survey area, and these anomalies may result from similar features.

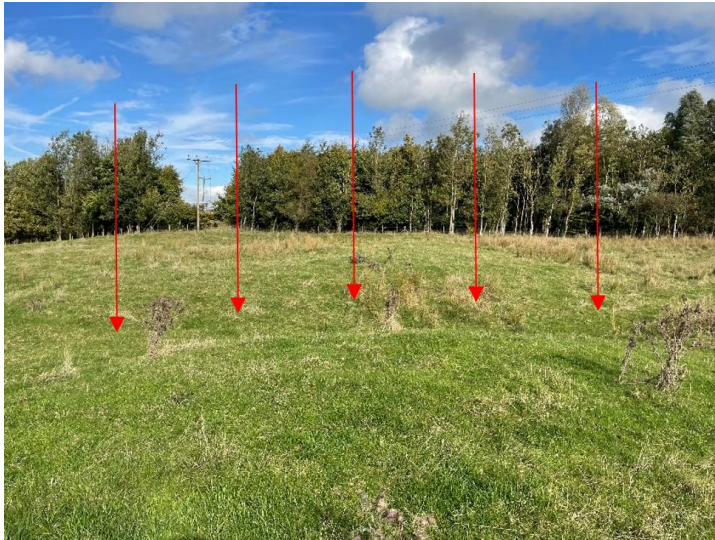
Plate 4: Proposed crossing point showing quarrying scarring (red arrows) 3.5m wide

- A 5m managed area on both sides of the road, well demarcated by appropriate fencing;
- A crossing point c. 26m x 3.5m that utilises the previously quarried areas of the site for access;
- The use of lightweight, heavy-duty, plastic track-matting along the entirety of the crossing point including the managed area;
- The number of crossings will be kept to the minimum required for effective management of tree planting and landscaping to the west and for the maintenance of the agger.

- 4.6. The crossing point identified in this document is the same used during the trial trenching. This is shown on plates 4-7. Gates will be installed at the designated crossing point to allow maintenance access.

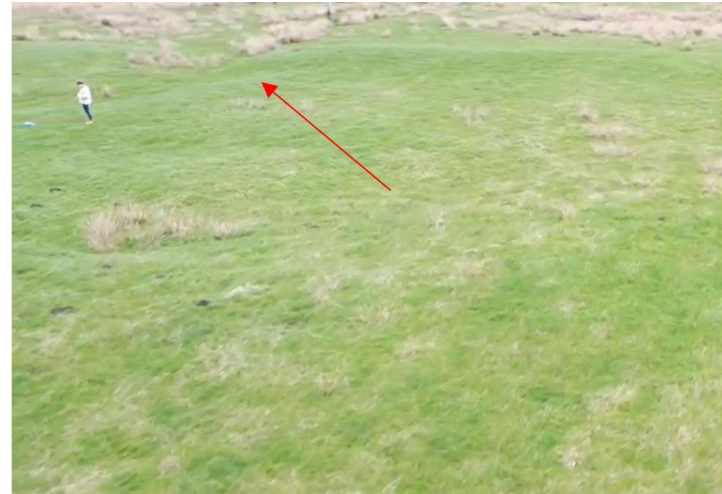
Plate 6: Proposed crossing point showing quarrying scarring (red arrow) 3.5m wide

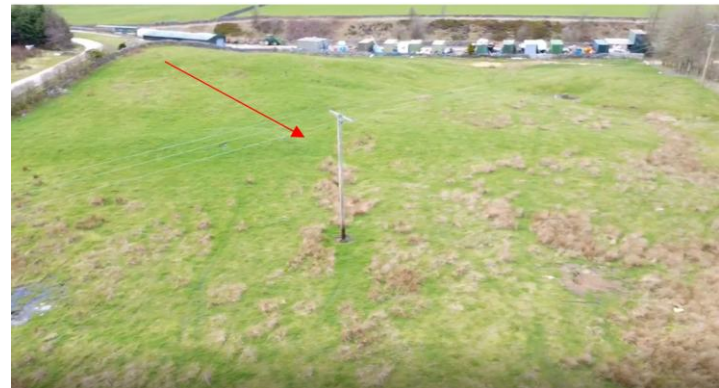
Plate 7: Proposed crossing point showing quarrying scarring (red arrow) 3.5m wide

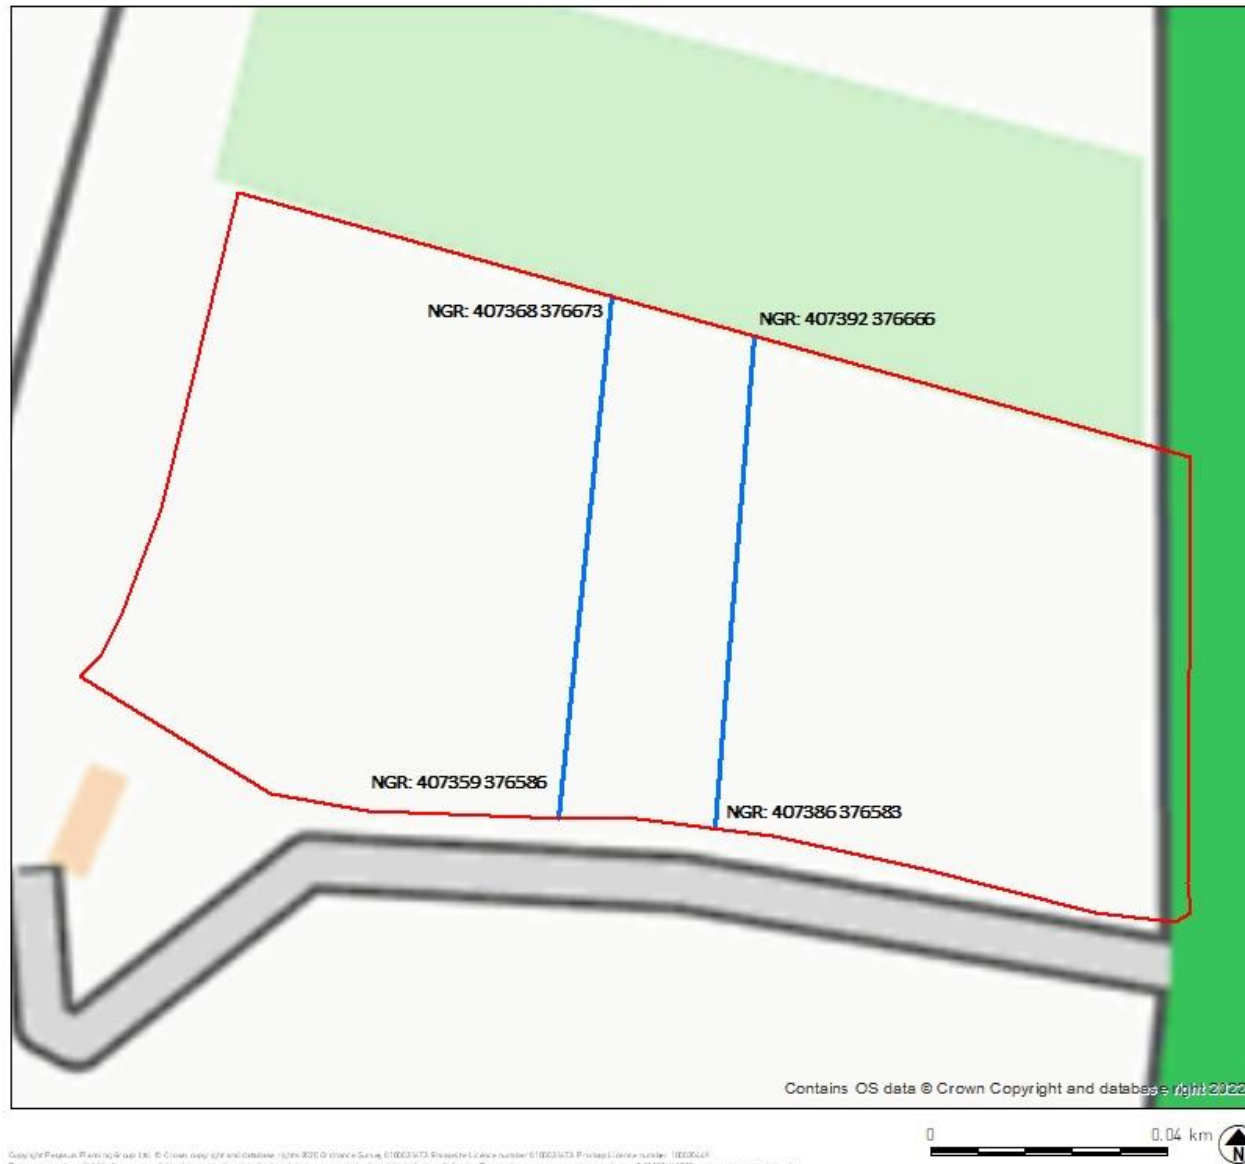
*Plate 8: Extent of  
Managed Area*

- 4.1. The extent of the area of the site that is subject to this Conservation Management Plan includes the extent of the earthwork remains and a 5m buffer either side which is deemed necessary to ensure the preservation of the agger.
- 4.2. The extents of the managed area shall be positioned to an accuracy of  $\pm 100\text{mm}$  of the specified location using survey-grade GPS or equivalent metric-survey equipment.
- 4.3. The corners of the managed area are located at the Ordnance Survey grid references detailed in Table 1, below.

| Location | X | Y |
| North-west corner | 407368 | 376673 |
| North-east corner | 407392 | 376666 |
| South-west corner | 407359 | 376586 |
| South-east corner | 407386 | 376583 |

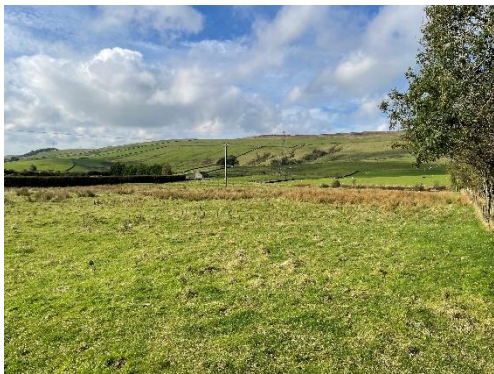
| Description | Upstanding section of the Roman road from Buxton to Glossop (Aquae Arnemetiae to Melandra), some areas have been adversely affected by historic quarrying of the gravel used to build the Agger. Some evidence of water running through the previously quarried sections of the Agger which increase the chances of erosion in the future. | |
| Height (m) | 0.8m | Management Recommendations |
| Condition | Fair | Monitor surface water impacts |
| Stability | Stable | Mow rough grass |
| Impacts | Quarrying (historic);<br>Surface water run-off;<br>Rough grass growth | |
