# Bat Survey Report

Outbuilding at Thorncroft, Lower Hague, New Mills,  
SK22 3AP

Revision A – July 2024

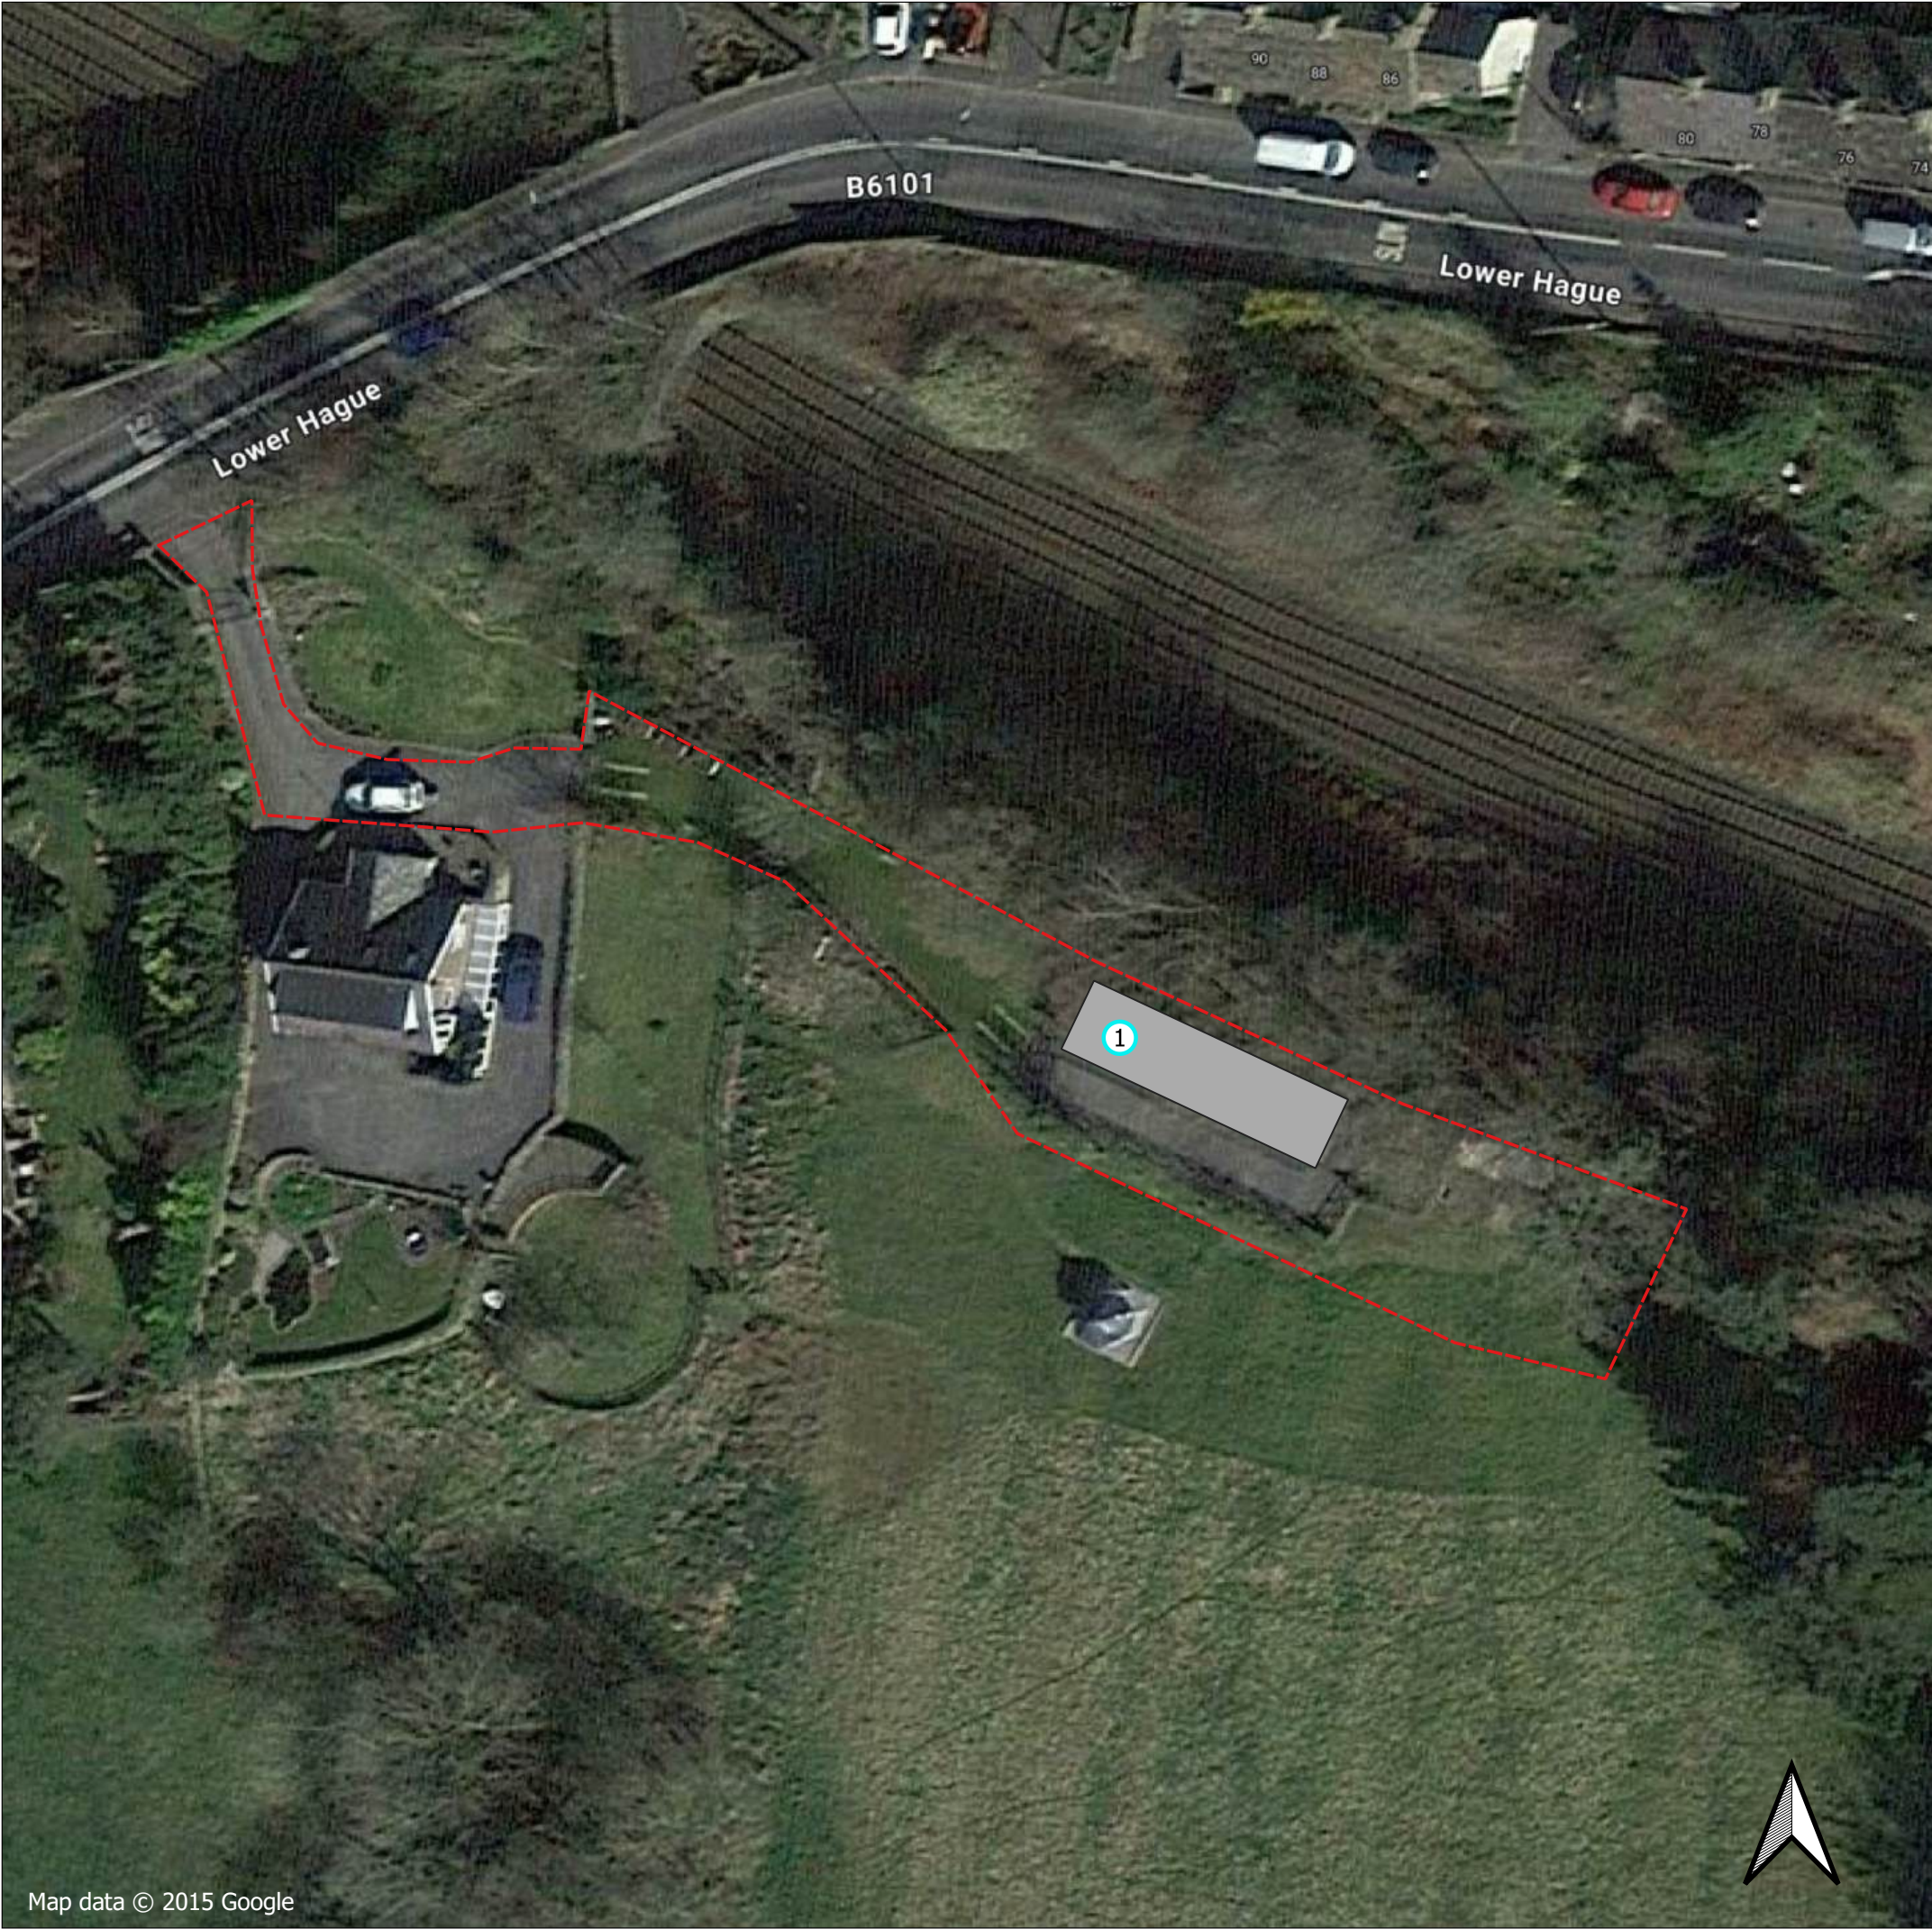
| Title | A.2 Building ID |

- 30 Building 1 is located to the east of the existing dwelling (Thorncroft). It is accessed from the tarmac drive of this dwelling, which becomes a grassy track until it meets the concrete slab that the building sits upon.

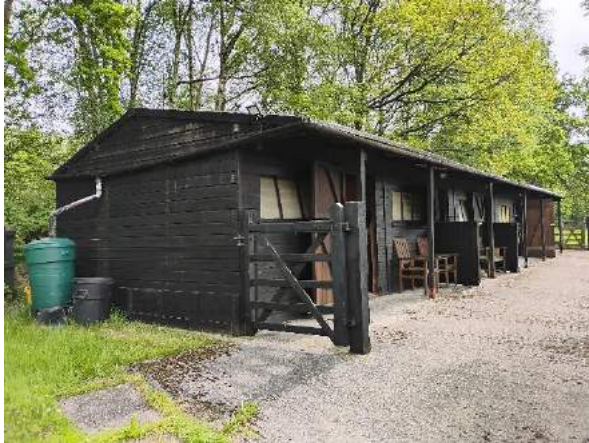
- 31 It is a modern timber-framed outbuilding clad in timber tongue-and-groove panelling. It has a shallow pitched particle board roof covered with bitumen felt, which has been replaced by plastic sheeting where the felt has been damaged. Four timber doors and a number of plastic windows are present on the south elevation. The east and west facing gables have timber barge boards, and a louvred air vent is present on the east elevation. The roof overhangs the eaves on the south elevation and the rafters are boxed in with tongue-and-groove panelling.

1. South elevation and west gable of Building 1.

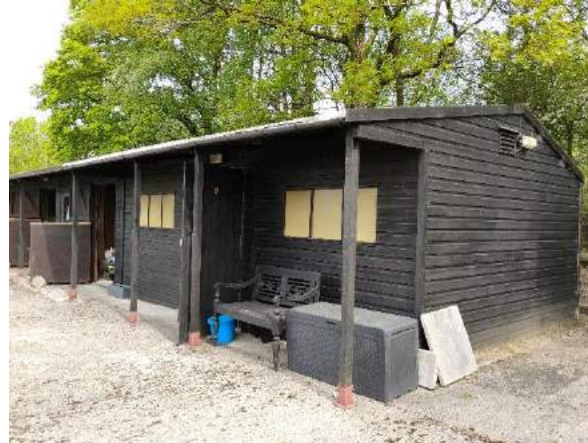
2. South elevation and east gable.

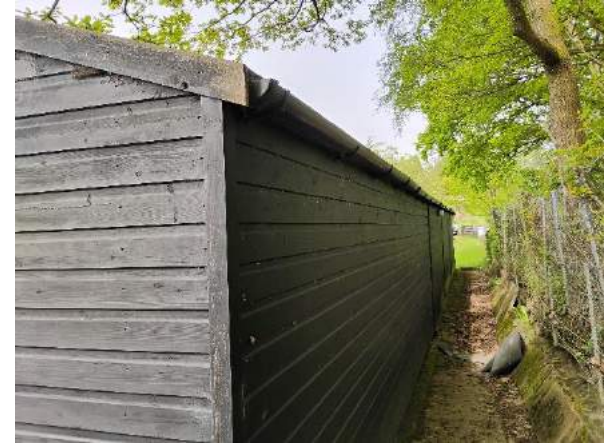
3. North elevation.

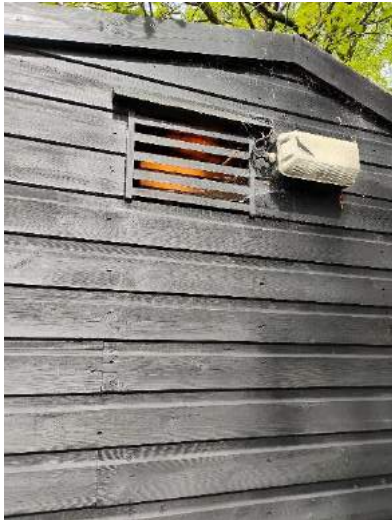
- 35 One bird record was provided by DRBC of a swift *Apus apus* from 2014 located over 1km from the site.
- 36 A few bird droppings were present on one of the stall partitions, suggesting that a small bird likely entered the building, probably through the louvred vent on the east elevation, to perch at some point. Although no evidence of nesting activity was observed, there are opportunities for small nests to be built in the roof frame.

4. Louvered vent on east gable.

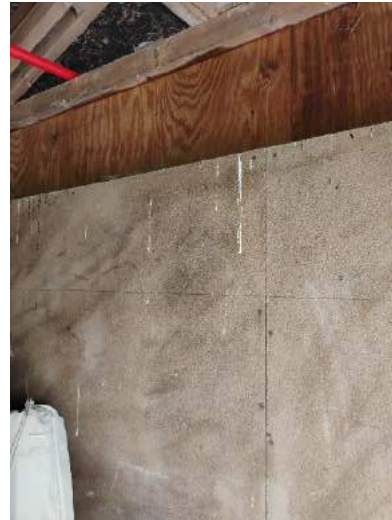
5. Bird droppings on internal partition.

43 Therefore, the following reasonable avoidance measures will be put in place to ensure the protection of nesting birds throughout the proposed demolition of Building 1:

- In order to minimise the risk to nesting birds demolition will, where possible, commence outside the main bird nesting season. The main bird nesting season runs from March to August inclusive.
- It may be possible to commence works within the main bird nesting season; however, it will be assumed that birds are nesting in Building 1 unless a recent survey has been undertaken by a suitably qualified person who has determined that nests are not present within the building.

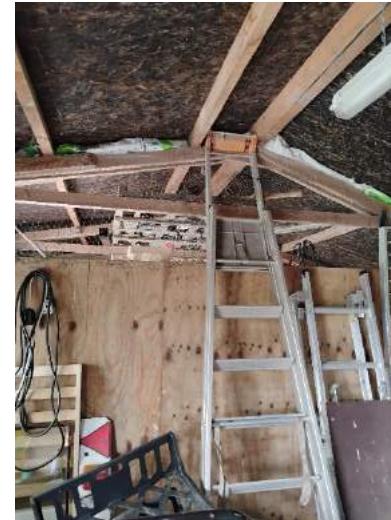
- 32 Internally, the building is open to the ridge and the roof is supported by a simple timber frame. The building is separated into four stalls by timber partitions that are as high as the rafter ties, leaving a space of no more than 30cm between the rafter tie and ridge beam, spanning the full length of the building. Part of this space is currently used for storage ladders and other bulky items, and the space above one of the partitions has been fenced with chicken wire. The stalls are cluttered with stored items.

6. Chicken wire installed across roof timbers.

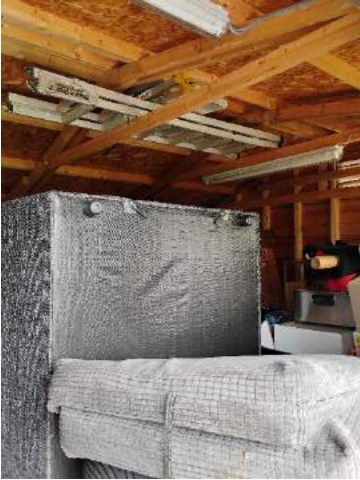
7. Items stored in roof timbers, and bulky stored items in stalls.

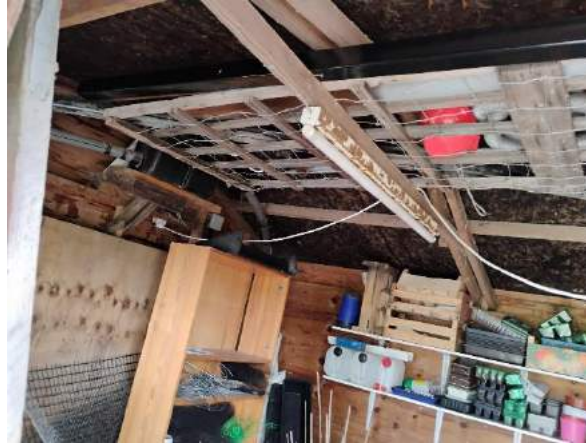
8. Bulky items stored in roof timbers.

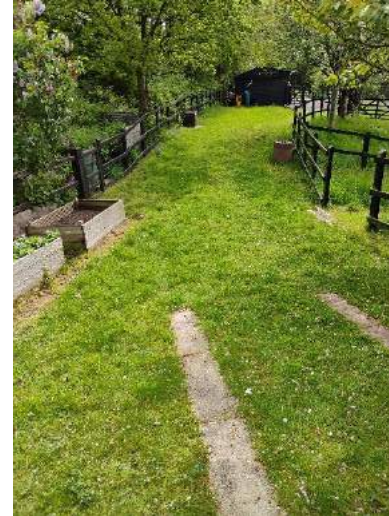
9. Grassy track leading to Building 1.
