# FAUNA FOREST

### Bat and Bird Survey Report

Prepared for Kinder Mountain Rescue

| Document Number: | FFE-01073 |

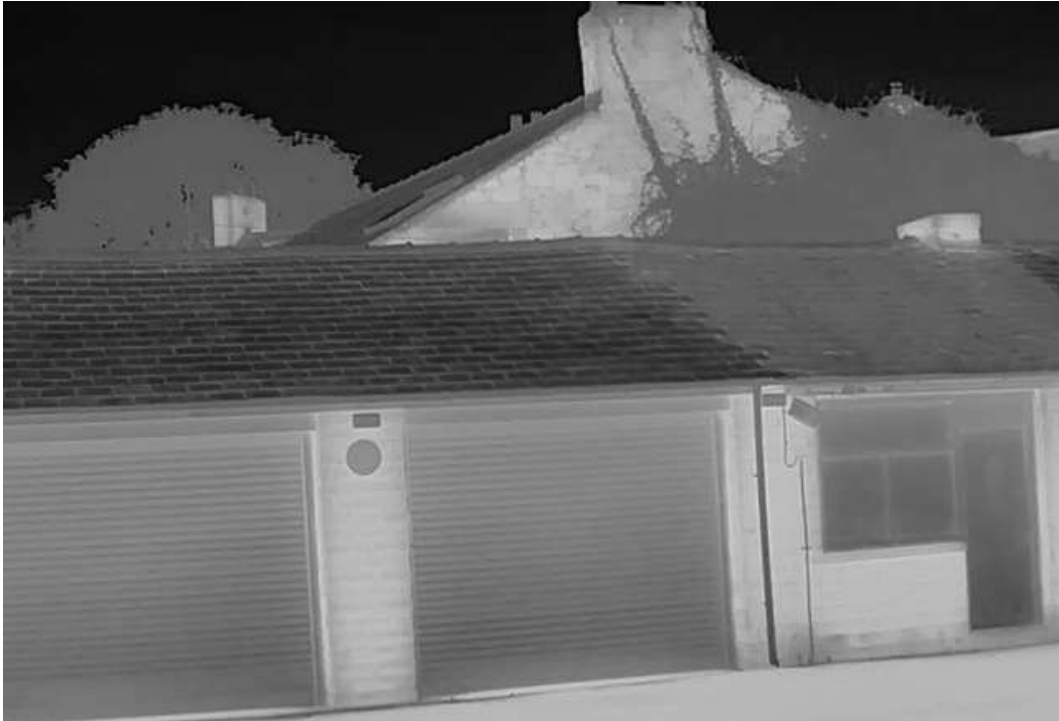
Image 1: screen shot from the thermal scope of the southwestern side aspect, taken during the darkest part of the night

- 4.6 Footage watched back from the NVAs (including the stand-alone unit) confirmed no bats emerged from or entered the building during the nocturnal bat surveys.

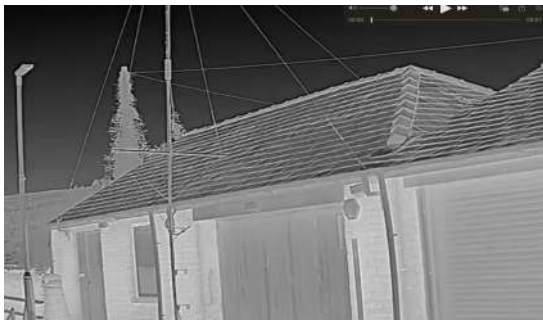
Image 2: screen shot from the thermal scope of the southwestern side aspect, taken during the darkest part of the night

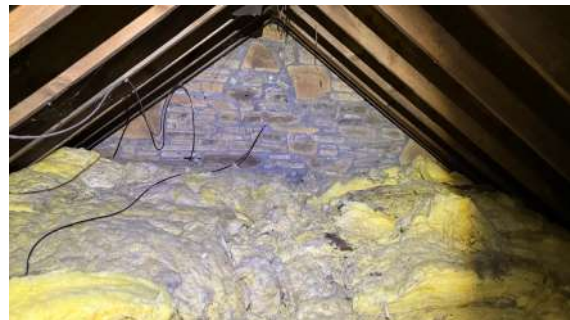
- 3.3 The building was a single-storey stone structure with a timber-framed pitched roof clad with slate, with a single ridge covered with concrete overlapping ridge tiles. The building included two garage doors, with windows and access doors for staff. Bargeboards were present to the front and rear elevations, and the eaves featured fixed soffits and fascias. Internally, the building contained three accessible roof voids extending across the roof space. The roof was lined and insulated, with exposed timber roof joists and internal masonry walls.

Image 3: the loft above the building

- 4.10 No evidence of nesting birds was found although the possibility of some small species gaining access to the loft should not be discounted. No specific surveys are recommended, however, best practice would be for works to be undertaken outside of the bird nesting period. Birds typically nest between February through to September. If the works must be undertaken during the bird nesting period, work

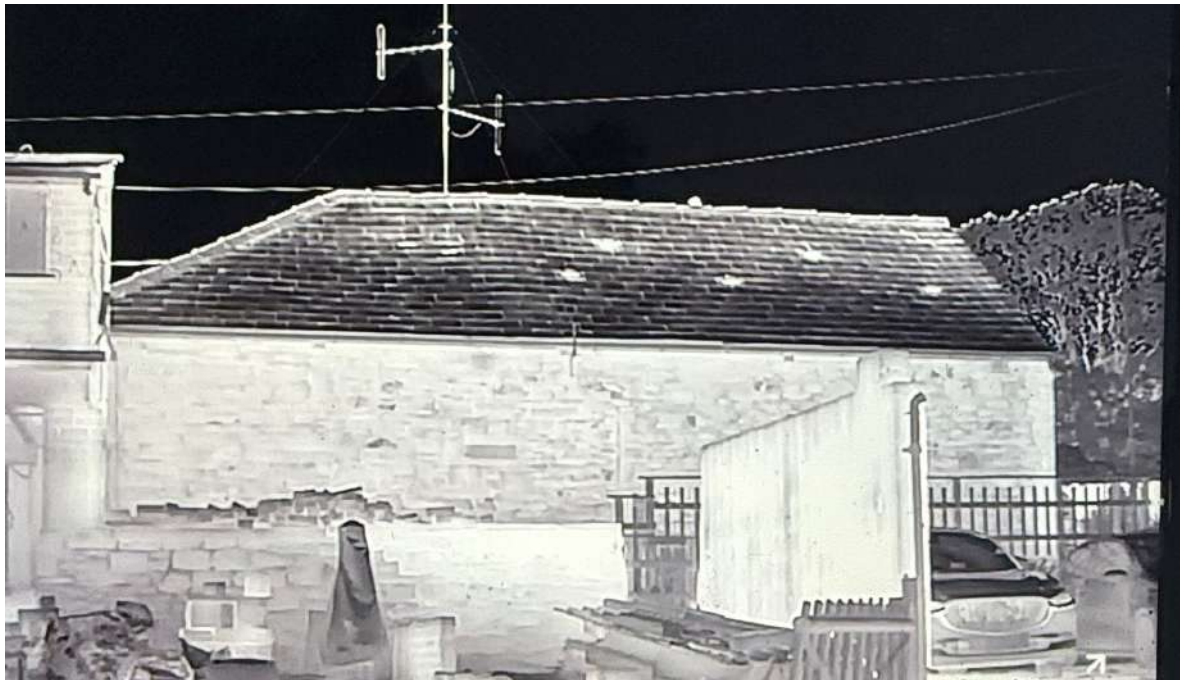
Image 4: screen shot from the thermal scope of the northern side aspect, taken during the darkest part of the night
