**Macclesfield Old Road, Buxton
Further Survey Work**

August 2008

Client	Grontmij
Job Name	Macclesfield Old Road, Buxton
Report title	Further Survey Work
File reference	3207.01_002_rep_sm_gmj.doc

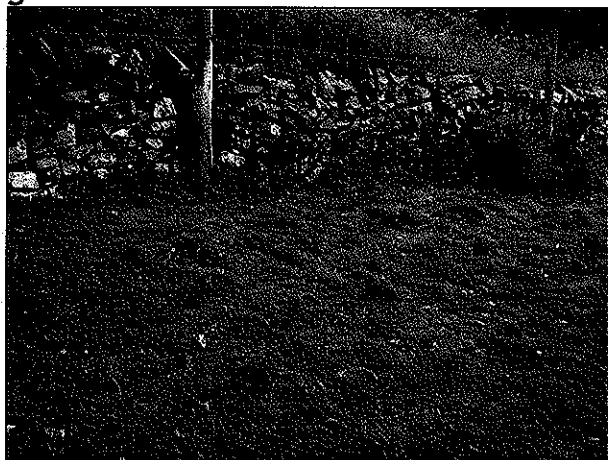
The area surveyed is an area of neutral grassland. The ground is undulating with rocky outcrops in the vicinity. Yorkshire fog *Holcus lanatus* and common bent grass *Agrostis capillaris* are dominant in the area, with other species in the sward including red fescue *Festuca rubra*, white clover *Trifolium pratense*, and occasional common vetch *Vicia sativa* and greater birds-foot trefoil *Lotus pedunculatus*. The full species list of the area, including the level of abundance of each species, is given in Table 2 (below). Photographs 1 and 2 show the area where the 2m x 2m quadrat was surveyed, with Photograph 2 showing the location of the inlet to the pipeline.

Photograph 1: Area of semi-improved grassland

It is recommended that the relining technique is used in order to prevent any loss to the neutral grassland habitat.

If the relaying technique is used, and trenches are to be excavated, it is recommended that in order to retain the grassland habitat the area should be turf stripped, the turfs stored and re-established after works have been completed. It is recommended that a specialist contractor is commissioned for this task.

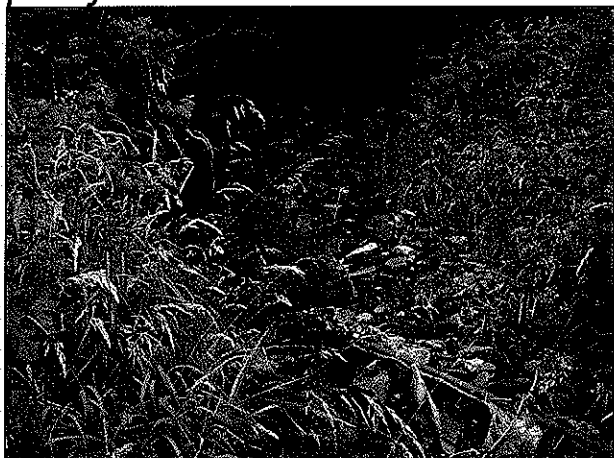
The stream is considered to be an optimal habitat for crayfish, with the boulders and pebbles (refer to Photograph 3) providing refugia for the crayfish, and the overhanging banks with dense vegetation cover potentially providing opportunities for the crayfish to burrow (refer to Photograph 4).

Photograph 3: View of the stream, showing pebbly substrate.

The habitat suitability assessment for white-clawed crayfish revealed that the watercourse within the site is optimal habitat for crayfish. If the works are to affect the watercourse directly, it is recommended that further survey work involving a manual daytime search for crayfish is carried out to determine the presence of crayfish in the stream, prior to the start of works. A torchlight survey for crayfish is also recommended, and would take place two hours after sunset using high powered torches. This further survey work would need to be undertaken before November, and in suitable weather conditions.

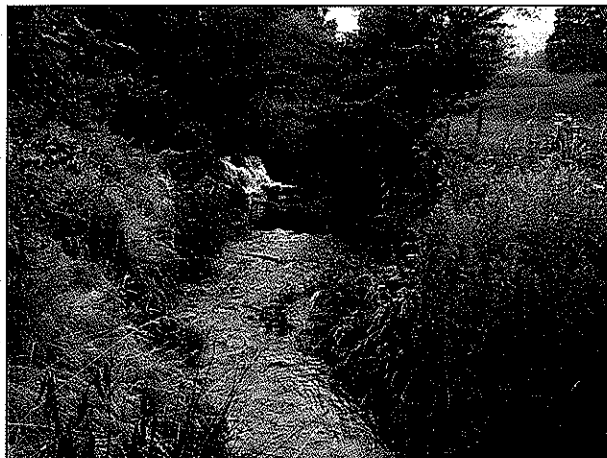
Photograph 4: View south over the stream.
