**Whitcher Wildlife Ltd.
Wildlife Consultants.**

ECCLES HOUSE.

BAT SURVEY.

Ref No:- 100219.

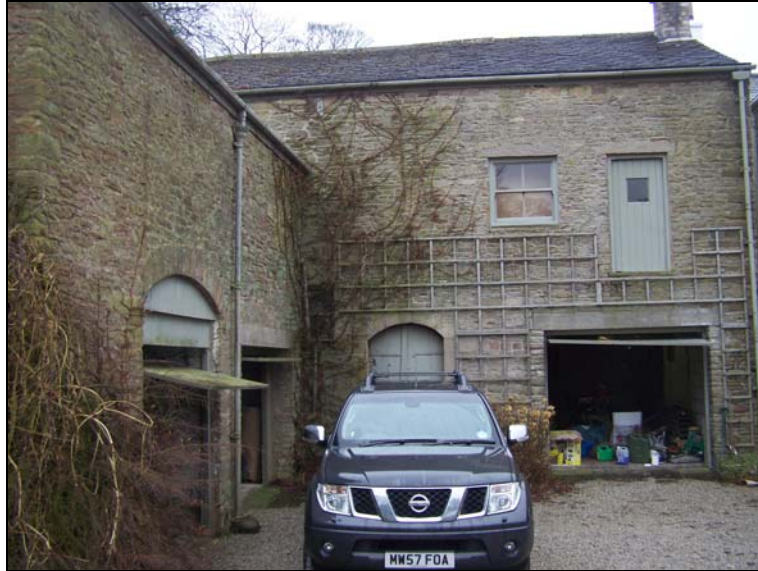
3.3.1. The photograph below shows the eastern aspect of the stable building.

3.3.2. The external stonework of the building is well pointed and tight fitting with no gaps or crevices leading into the rubble filled walls.

3.3.3. All doors and windows are tight fitting providing no gaps or crevices allowing access into walls or the roof of the building.

3.3.4. The roof of the building comprises stone tiles and stone ridge tiles all of which are in good condition with the exception of one area of missing pointing on the eastern aspect of the ridge.

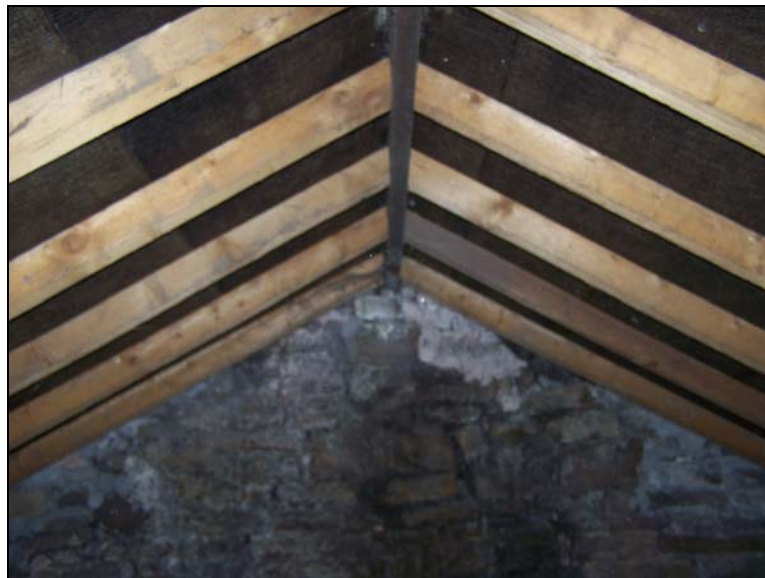
3.4.1. The inside of the building is open to the rafters and felt throughout the second storey. However, in the northern section there is an enclosed loft approximately 16ft long, 16ft wide and 7ft high.

3.4.2. The photograph below shows the rafters, ridge board, felt and the stone wall in the enclosed loft at the northern end of the building.

5.2. No work should be carried out on any aspect of the enclosed loft space during the proposed works. This includes work on the roof, chimney stack, flashings, gable end, barge boards and external stone work. This also includes the proposed sky light which has been discussed and agreed to be removed from the proposed plans.

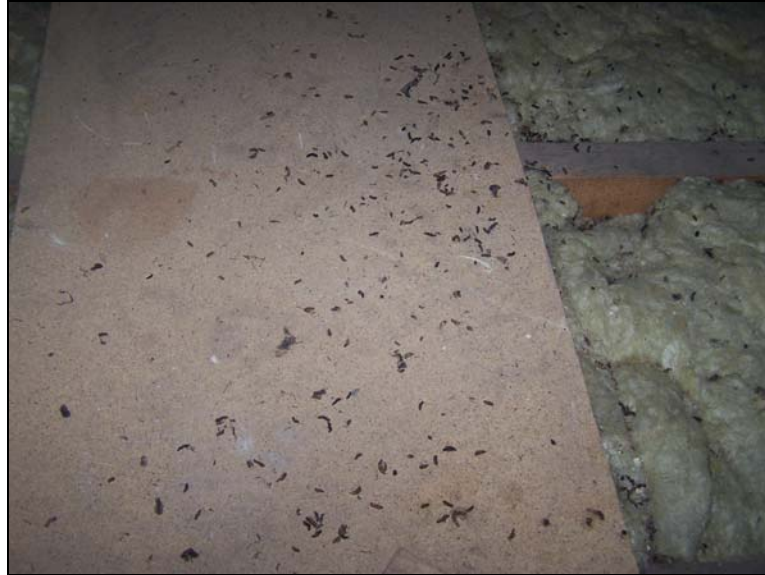
3.4.3. An internal inspection of the building identified a large quantity of bat droppings beneath the ridge on a crawl board in the enclosed section of loft. Approximately 200 droppings of varying ages were identified and when compared to library samples of bat droppings, these were assessed to be brown long eared bat droppings.

3.4.4. The photograph below shows the area of brown long eared bat droppings identified beneath the ridge in the enclosed loft space at the northern end of the building.

4.1. The stable building was fully assessed and one brown long eared bat roost was identified in the enclosed loft at the northern end of the structure. No other bat field signs were identified within the open section of the building.

4.2. Due to the time of year and the type of roost, no brown long eared bats were identified roosting in the enclosed loft space of the stable building during this survey. The roost is assessed as a summer roost which may only be occupied when brown long eared bats are active.

5.1. As the brown long eared bat roost was identified within an enclosed area of the loft that will remain completely unaffected by the proposed work, there will be no requirement for a Natural England European Protected Species Licence to cover the work.
