Client:	Mr and Mrs G A Hardy		
Job:	Refurbish Garage		
Drawing:	PHOTO CONPARISON		
Scale: 1:50	Date: Dec 2011	Drawn: ld	
Job No: 2932	Dwg No: 25	Rev: -

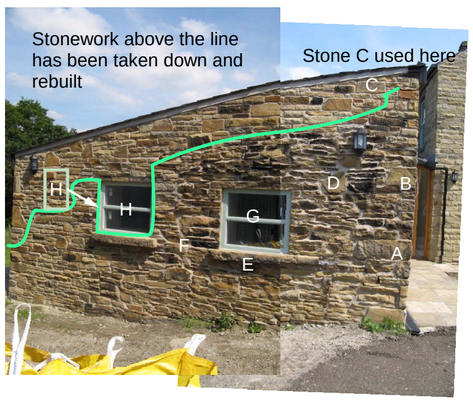
Front elevation to garage, Door moved over to give access becauce of extension. Timber lintel reused. Note stones A and B as original and line through Building height increased by approx 300mm to take new roof deck and slates (stone work not increased).

Stones A, B and D and window opening and cill E and G remain unchanges as does most of this elevation. C can be clearly identified as a stone reused as many others. Crack has just been filled. Window H has been moved to where the stone was not good.

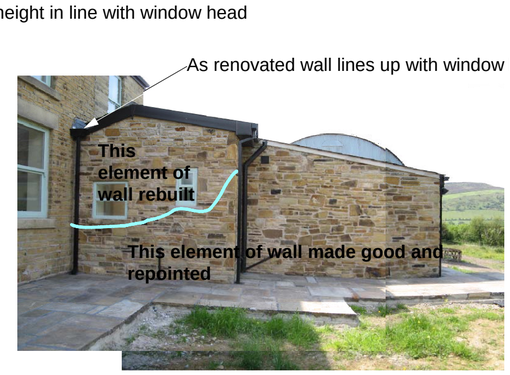
Wall as existing showing existing window The remainder of this wall was behind shrubbery.

With the removal of shrubbery this wall required considerable making good and repointing, the rear end being rebuilt
