Replacement windows

Existing window schedule

Marsh Hall Farm, Marsh Hall Lane

1123.04

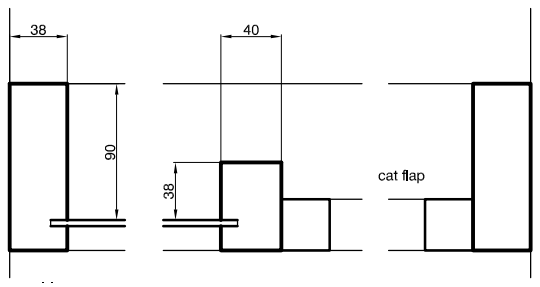
W3

North facing kitchen window.
Casement with 3 windows, central
opening light. Stone mullions between.

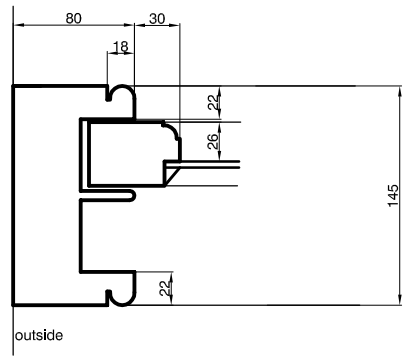
W5
W6

W5 Fixed light split into 8 panes
W6 Fixed light split into 4 panes

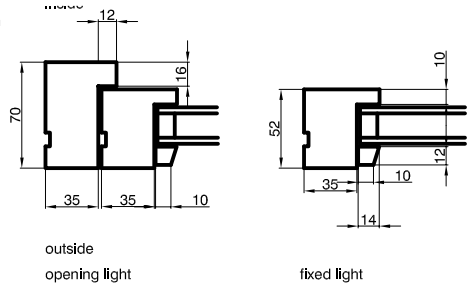
W7
W8
W9

Sliding sash.
Windows fitted in post 2002 but single
glazed and problems with water
ingress/ water damage to frame.

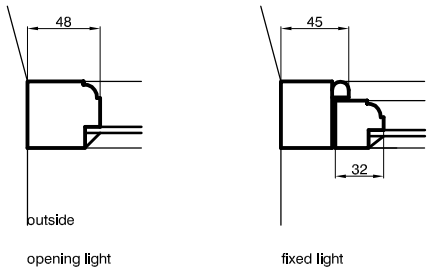
W10

New double glazed kitchen window.
Not to be replaced: new casement
details to match this.

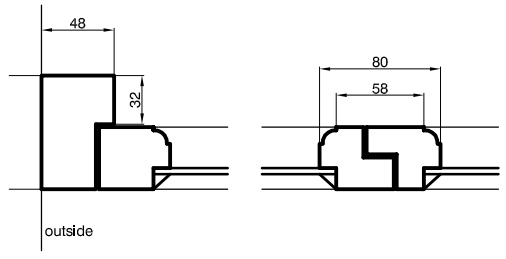
W11

Casement with 5 lights, including 1
opening. Stone mullions between.

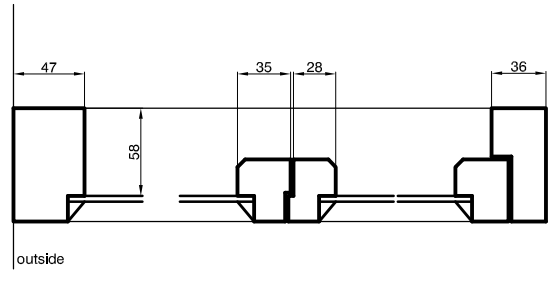
W12

Casement with 2 opening lights

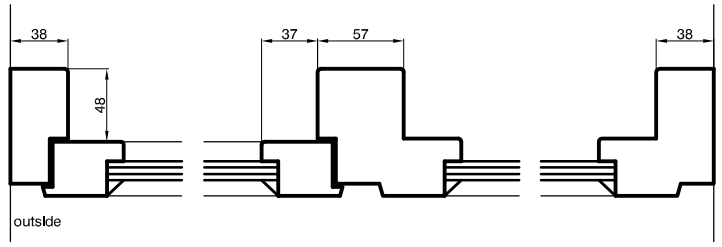
W13

Casement with 1 opening light, 1 fixed

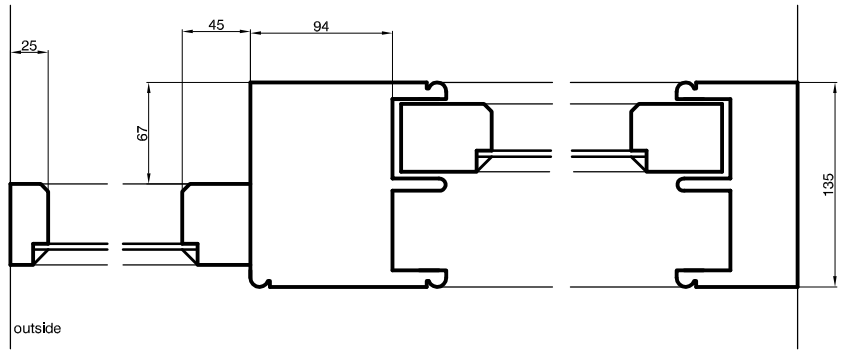
W14

1 opening light, 1 fixed
small double glazed unit

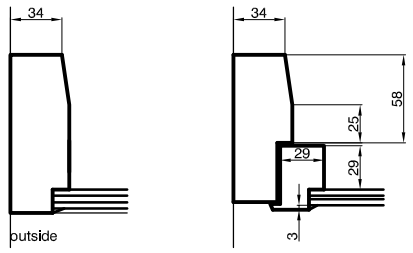
W15
W16

W15 - fixed light split into 4 panes plus sliding sash.
W16 sliding sash.
W15 and W16 separated by stone mullion.

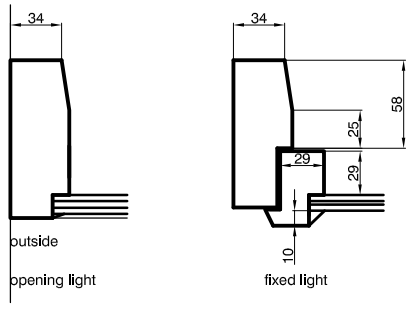
W17

3 casement windows separated by stone mullions.
Central casement opening.
DIY double glazing using tacks to separate the glass.
Condensation between glass.
