# PEATHILL FARM.

**BAT SURVEY.**

**Ref No:-** 120316.

**Date:** 14<sup>th</sup> March 2012.

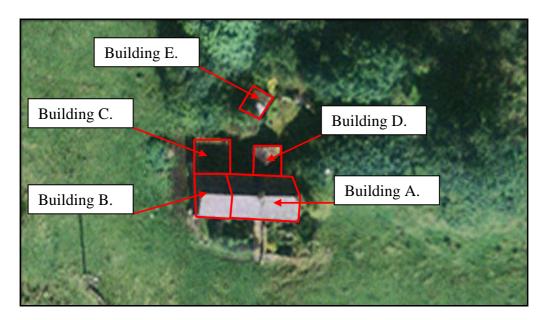
- 3.3.1. The surveyed buildings are split into five sections for the purpose of this report. All sections of the buildings were accessed during this survey.
- 3.3.2. The aerial photograph below shows the separate sections of the surveyed buildings.
