SURVEY FOR ASBESTOS CONTAINING MATERIALS

7 High Street West

Glossop
SK13 8AL

Project No: ES/51356

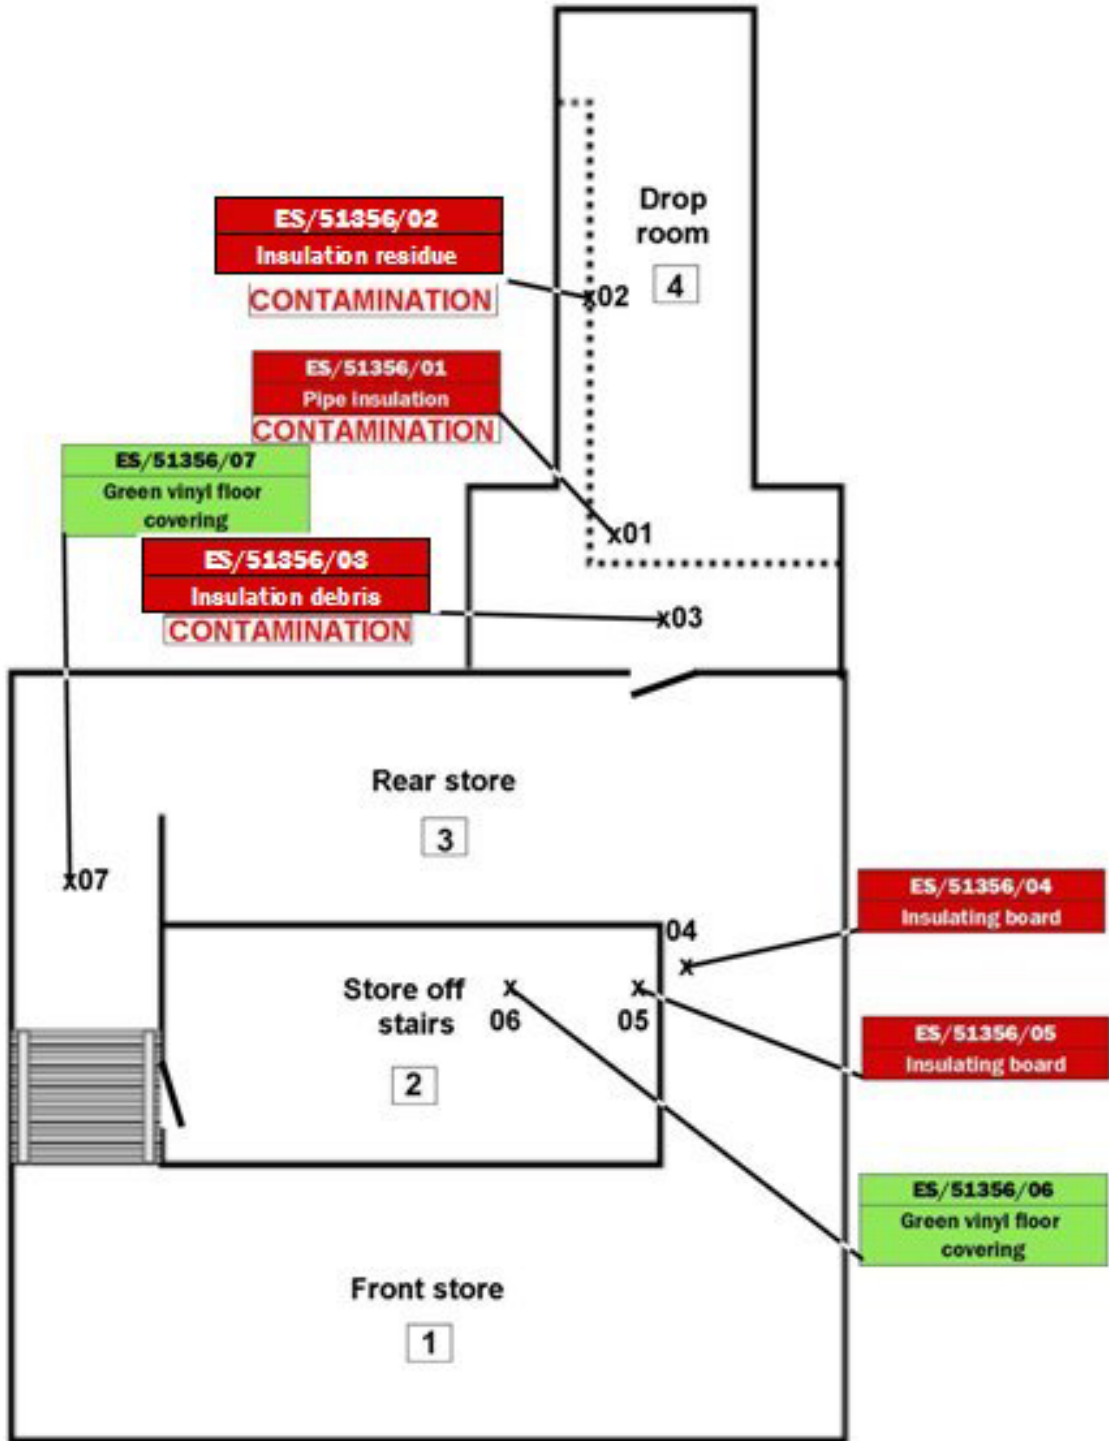
Sample No:	ES/51356/01		
Item:	Pipe insulation		
Location:	B/R004 - Basement - Drop room - To pipework		
Condition:	High Damage		
Extent:	~14 m lin		
Ease of access:	Easy	Surface treatment:	Unsealed
Lab reference:	T901/EUR1/496/001		
Results:	Chrysotile		
Algorithm:	Material	10	+ Priority 6 = 16
Recommendation:	Remove		
Urgency:	Medium (mid-term)		
Further Comments:	This area is contaminated and therefore access should be restricted until remedial works have been undertaken.

Sample No:	ES/51356/02		
Item:	Insulation residue		
Location:	B/R004 - Basement - Drop room - To walls and ceiling adjacent to pipework		
Condition:	Medium Damage		
Extent:	~8 m lin		
Ease of access:	Easy	Surface treatment:	Unsealed
Lab reference:	T901/EUR1/496/002		
Results:	Chrysotile		
Algorithm:	Material	10	+ Priority 6 = 16
Recommendation:	Remove		
Urgency:	Medium (mid-term)		
Further Comments:	The residue is present to the length of the pipework, 0.5m ² above and 0.5m ² below the pipework. This area is contaminated and therefore access should be restricted until remedial works have been undertaken.

Sample No: ES/51356/03
Item: Insulation debris
Location: B/R004 - Basement - Drop room - To floor
Condition: Low Damage
Extent: <1 m²
Ease of access: Easy **Surface treatment:** Unsealed
Lab reference: T901/EUR1/496/003
Results: Chrysotile
Algorithm: **Material** 10 + **Priority** 5 = 15
Recommendation: Environmental clean
Urgency: Medium (mid-term)
Further Comments: The total floor space is 11m². There are large amounts of rubbish in this area. This area is contaminated and therefore access should be restricted until remedial works have been undertaken.

Sample No: ES/51356/04
Item: Insulating board
Location: B/R003 - Basement - Rear store - To wall
Condition: Low Damage
Extent: ~1 m²
Ease of access: Easy **Surface treatment:** Sealed
Lab reference: T901/EUR1/496/004
Results: Chrysotile
Algorithm: **Material** 4 + **Priority** 5 = 9
Recommendation: Manage
Urgency: None (manage)
Further Comments:

Sample No: ES/51356/05
Item: Insulating board
Location: B/R002 - Basement - Store off stairs - To walls
Condition: Low Damage
Extent: ~1 m²
Ease of access: Easy **Surface treatment:** Sealed
Lab reference: No sample taken
Results: Strongly presumed to be Chrysotile
Algorithm: **Material** 4 + **Priority** 5 = 9
Recommendation: Manage
Urgency: None (manage)
Further Comments: Strongly presumed to be as sample ES/51356/04.

Site Details	7 High Street Glossop Basement		
Key:	Asbestos found	No asbestos found	Areas not surveyed
	C Column	H Hatch	X Lift - - - Beam Pipe run
Note/s	Drawing not to scale		There is no drawing for the first floor as no suspected ACM's were identified
