Re: BT Repeater Station, Manchester Road, Longhill, Fernilee, Buxton, SK17 6ST

This report is a Brief Building Survey in accordance with a request by the loan facilitator's Chartered Surveyors, Edward Cooper Young. I spoke to Stuart Sherwood (Chartered Surveyor) of the aforementioned firm and confirmed that my report will be suitable for their purposes and can be used by their firm in formulating their report and advice to their clients your loan facilitator.

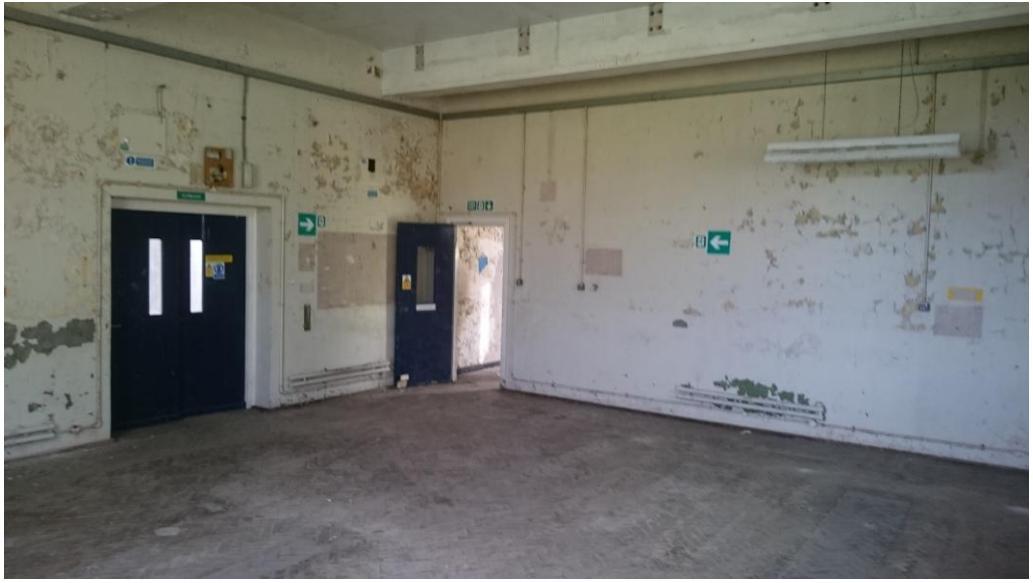
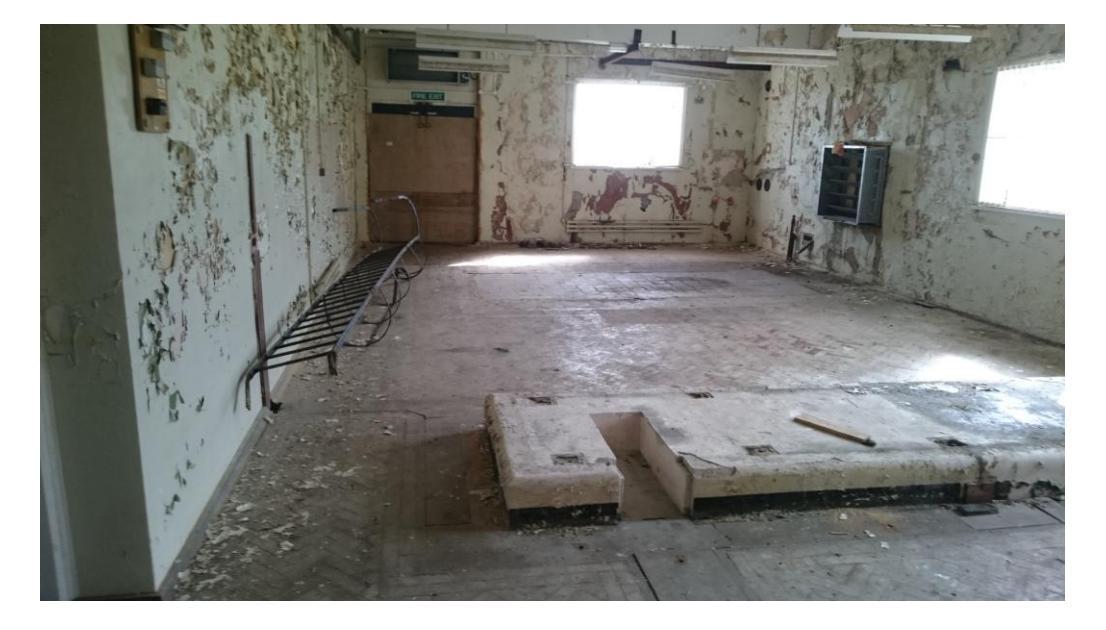
Double doors to **Room 3**:

There has been damp ingress under the east and south facing windows of Room 3 which has been remedied by the insertion of a damp proof membrane under the stone sills as shown in the photograph. Dampness is still penetrating the structure beneath the south window. This requires the replacement of the window and resealing to its reveals and an inspection of the damp proof membrane to ensure that it is shedding water out of the structure.

There is hollowness to the floors of Room 3 and 4 either side of the internal divisional wall approximately 2 metres from the southern gable. I am of the opinion that this is related to settlement of the sub floor fill and is unlikely to continue further. I however recommend that the floor is opened up and the void examined prior to rebuilding with hardcore up to the existing asphalt level.

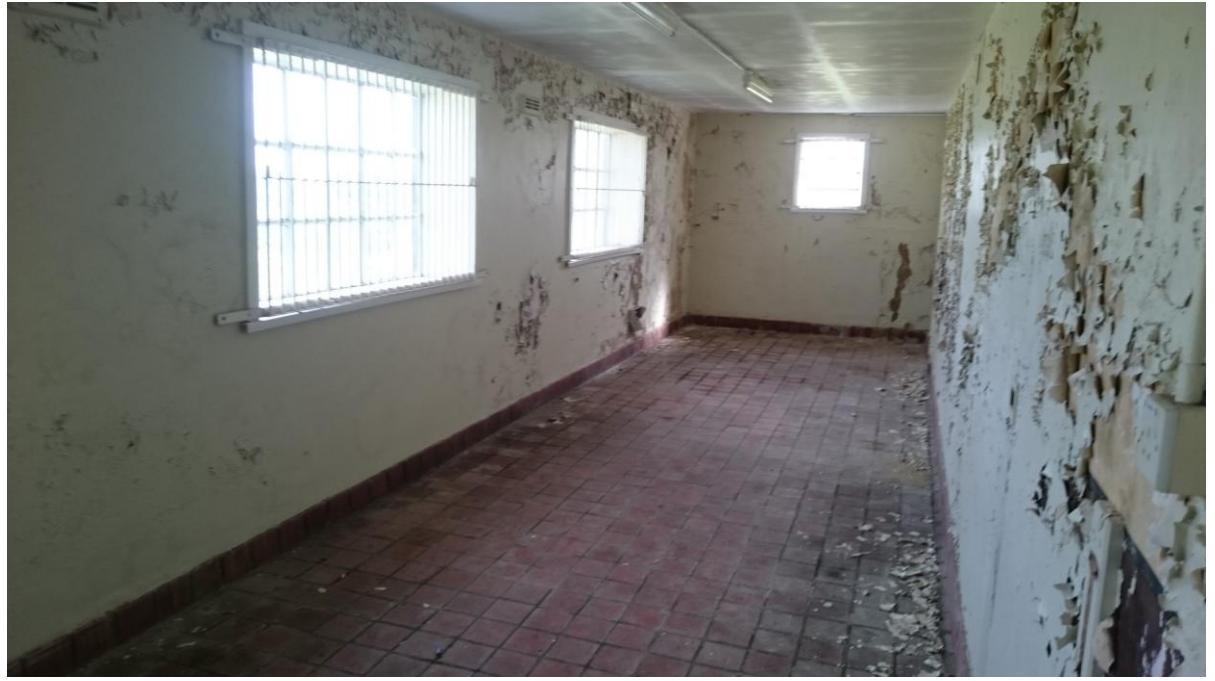
#### Room 4:

There is a missing downspout to the south corner of the building that is causing damp penetration into Room 4.
