Consultant's Advice Note – Derby House

Structural Condition Report

Consultant's Advice Note – Derby House – Final Option

Structural Commentary to Conversion Proposal

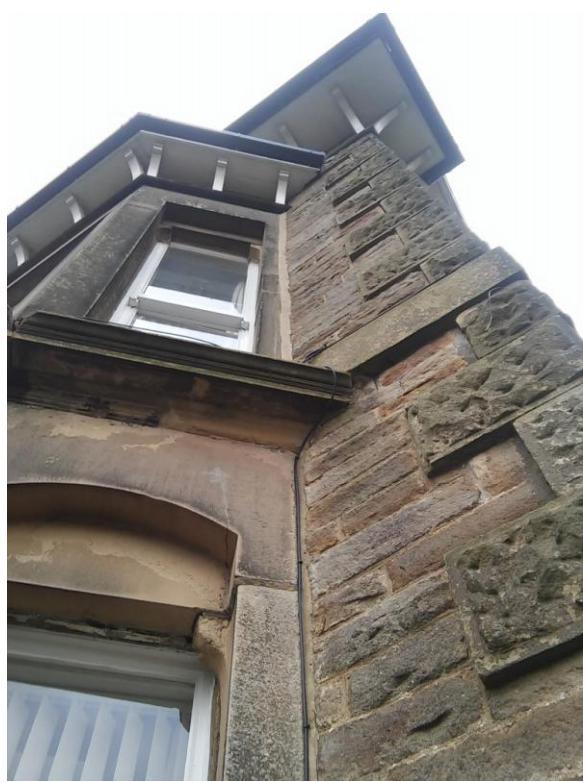
Around the bay windows there is evidence of moderate movement of some of the large stone mullions and lintel units. Often in buildings of this age there is little or no tying in of such components to the main structure. It is therefore not uncommon for there to be small relative

Recent patch repairs to bay window butt joint

Displaced stone masonry units and cracking to bay window

movements which can be ongoing. Annual and diurnal temperature variations cause regular expansion and contraction of masonry. These movements can be taken up locally in soft mortar joints, but can also sometimes affect whole wall panels especially if the mortar joints are hard. For example a south facing stone wall in summer could reach 35 degrees centigrade, and yet be around 0 degrees in winter. For a solid stone wall this correlates to an unrestrained movement of about 11mm in a wall length of 30m. Solid stone projecting feature bay windows (of which there are 4 on Derby House) are vulnerable to such thermal movements as they can be pushed / twisted by expanded planar walls in summer. When the wall subsequently shrinks back in cold weather vertical butt joints tend to open up. If these are then mortar filled to seal out possible rain ingress, a hard spot is created, and the pattern of movement can repeat. During the conversion works consideration should be given to stitching some of the bay window units using stainless steel bars to stabilise displaced / cracked items.
