# **Tree Survey BS 5837:2012**

George and Dragon, Glossop Road, Charlesworth

Project Reference: 1387

Published: February 2018

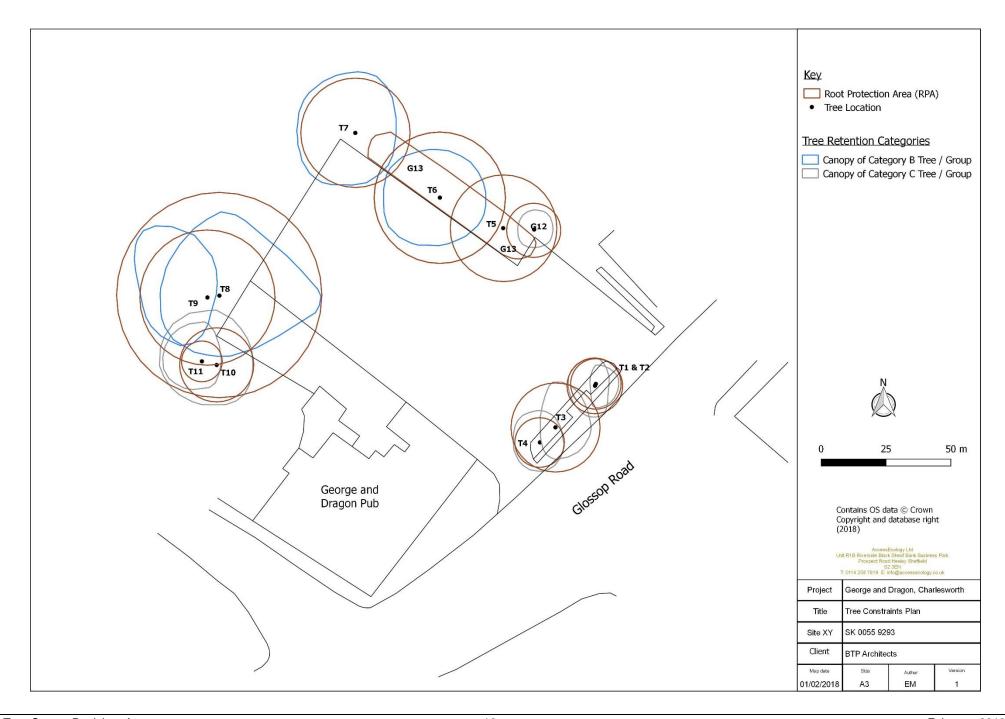
## E.1 Tree Constraints Plan

- The root protection areas (RPA) of T1 T4 are closest to the proposed location of the new houses, meaning the foundations of these buildings may extend slightly into their RPAs. However, this is considered to be a minor incursion, reduced further as the area in question is already hardstanding. Due to its poor growth form and negative impact on the adjacent cherry tree, the self-seeded ash (T2) should be considered for removal. The cherry (T1) appears to be a poor quality specimen and could also be considered for removal and replacement with a more suitable tree.

As the trees are to be retained and the majority of the site is already hardstanding, mitigation requirements are limited. It is recommended that the edges of the car park where the trees are located are temporarily fenced off during the construction phase to prevent damage to the trees and any sections of RPA not already covered by tarmac. There must be no storage of
