## **A.J.S ARCHITECTURE**

### **CONDITION SURVEY AND REPORT:**

## **CONVERSION OF FORMER WHITE LION PUBLIC HOUSE AND ASSOCIATED OUTBUILDINGS TO REAR TO FORM 13 APARTMENTS.**

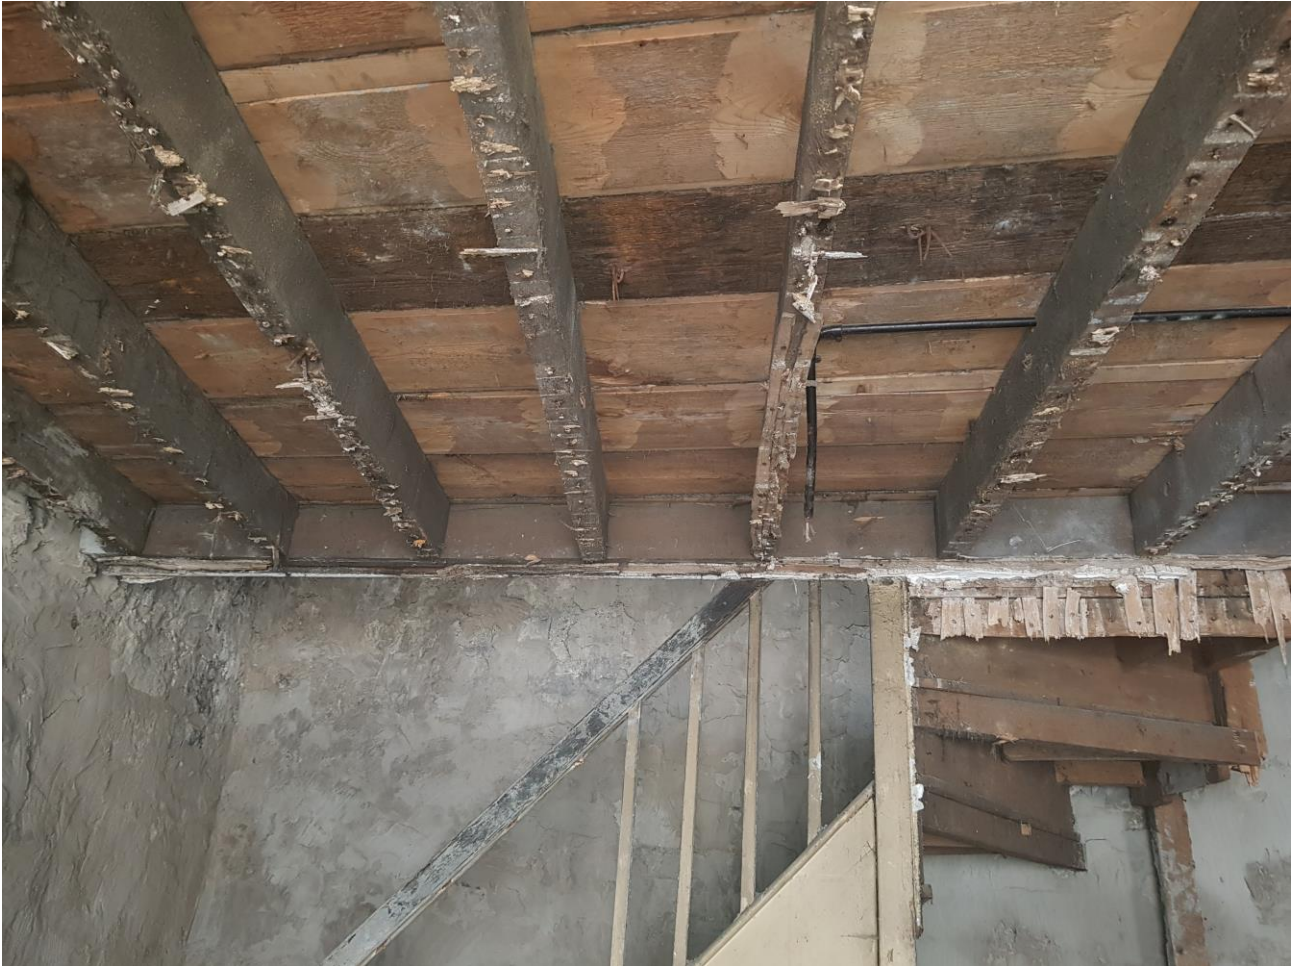
The front room is again of reasonable condition with some structural works already having taken place to allow for movement within the gable wall thereto. These works seem to have prevented further structural problems thereto. The staircase to the floor above, which will form the upper part of the maisonette, is clearly only a make shift addition rather than any permanent provision to provide access thereto and as such will be replaced with a new purpose made unit. This will also allow for remedial works to take place to the floor structure thereto. Although the timber joists are of reasonable condition they are clearly not of sufficient depth to allow for any permanent domestic use over and certain joists appear to have broken their back, hence the works suggest on doubling up of the floor with new joists either side to allow for the intended use. As before, the fact that all ceiling and wall finishes have been removed will allow for the Building Regulation compliant works to take place without any detriment to the listed status thereto.

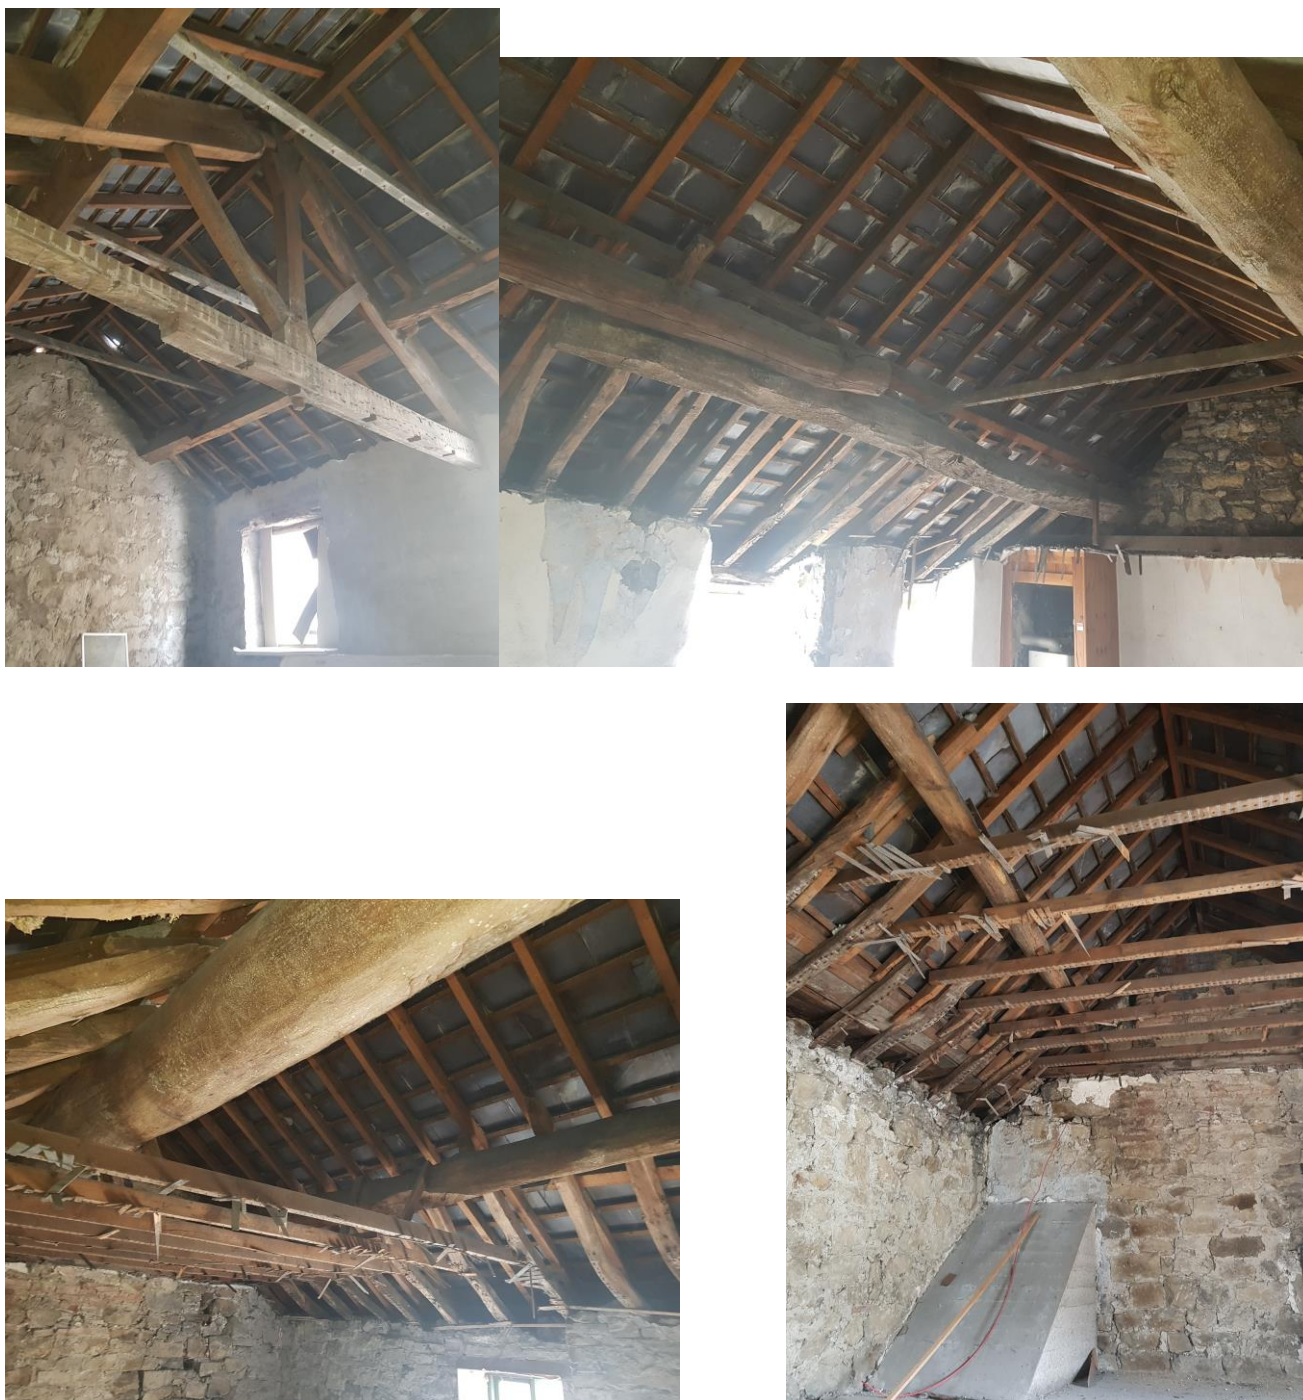
To the right hand side of the second floor, once again all roof timbers are exposed. This clearly indicates that although the roof timber layouts are somewhat haphazard, they are relatively sound in nature and all original timber may be retained (it is clear that the building has been re-roofed in this area over the decades). Original purlins and king post trusses are in place in these areas and again following remedial timber treatment they are worthy of retention.

Once again a significant area of fabric finishes have been removed meaning that no areas are retained as character relating to the listing. New fabric finishes will thus once again comply with Building Regulations thereto.

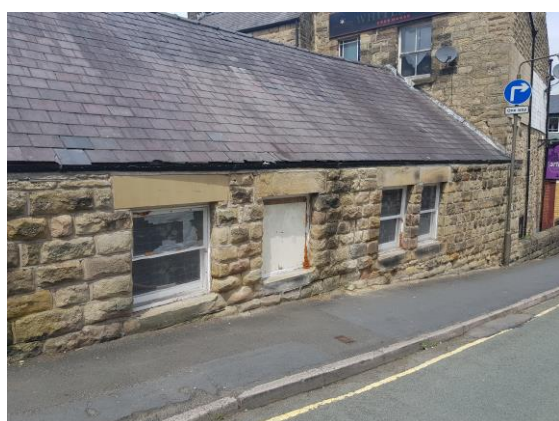
To the rear many windows are poor quality softwood plain casement units that are without doubt not original in either style or form to the original building. Their retention does not to enhance the appearance of the building or to respect its listing, thus all windows to the rear will be replaced with new sliding sash hardwood units as outlined above.

The function room building will retain the original windows that are in place to the side elevations. These units will be refurbished, treated and made good as required. Internally all units will be thermally upgraded through the use of secondary glazing.
