HPK/2025/0015 and HPK/2025/0016

**Proposed Internal Alterations at:**  
17 Broad Walk, Buxton SK17 6JR

# Your survey report

Flat 1., 17 Broad Walk, Buxton, Derbyshire, SK17 6JR

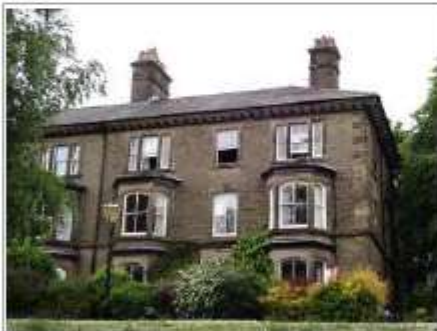
Front elevation

The front elevation has gaps to the stone bay sills and these need to be repaired.

The ground floor left bay has a cracked lintel.

There is an eroded band course to the top left above the bay. There is an eroded arch above the front door and spalling, loose and cracked stonework which may fall.

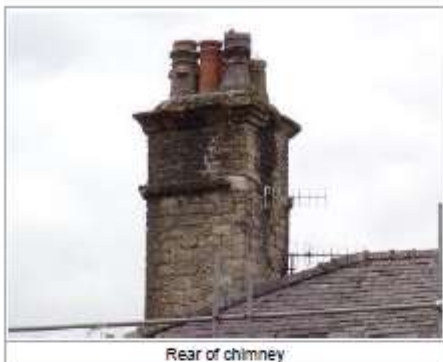
Rear of chimney

The left chimney of the building is shared with the neighbouring property. There are six flues and six chimney pots and there is a lead flashing at the join of the roof covering. The stone coping is eroded. This should be repaired soon. **2**

The right chimney is built of stone and has six flues and six chimney pots with a lead flashing at the join of the roof covering. There are gaps to the coving to the top right. Patch repairs have been carried out. Parts of the stone are eroded or missing on the left-hand side.

Repair chimneys soon.

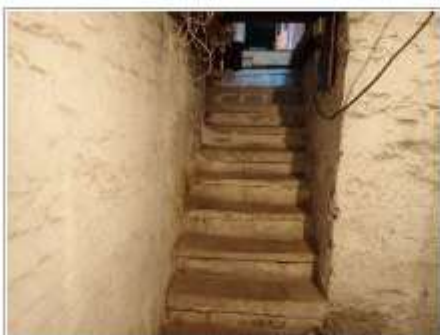
Steps to cellar

infested timber, for example old door frames etc., to prevent a spread of rot and decay elsewhere.
