Eagle Parade Conduit  
Eagle Parade  
Buxton  
Derbyshire  
SK17 6EQ

EXISTING  
COMPONENT ANALYSIS  
DETAIL PLAN 05 & 06

24233-E-044B

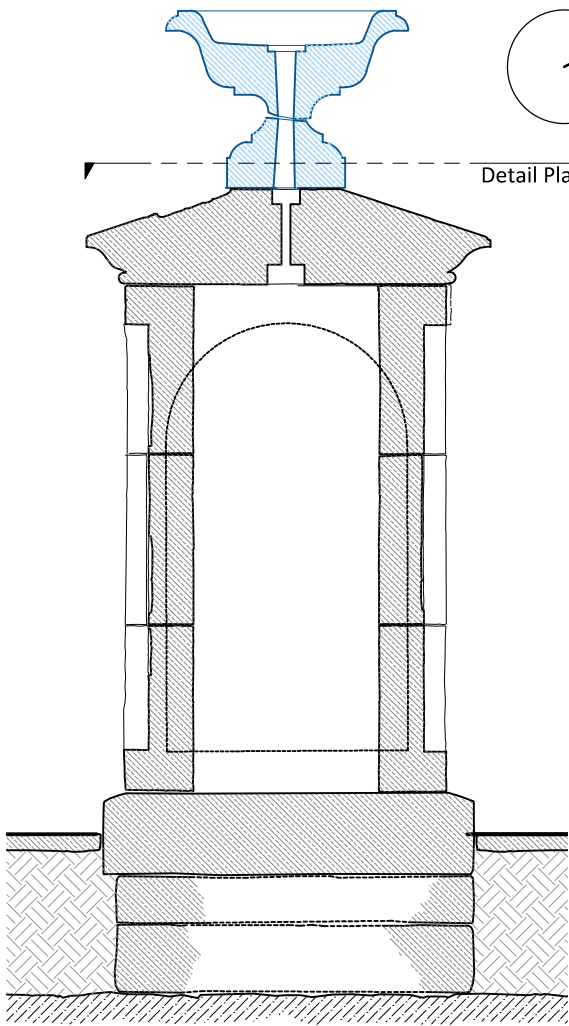
Detail Plan 05

Outline (in yellow) of  
original Urn and Pedestal  
above.

Current microbiological  
growth.

Examples of surface deterioration spalling less  
than & greater than 10mm (Type C1 & C2  
defects) to the cornice [5] resulting in loss of  
ashlar fabric .
