**STIRLING LLOYD, BIRCH VALE.**

**BAT SURVEY.**

**Ref No:- 091212.**

**Date: 15<sup>th</sup> December 2009.**

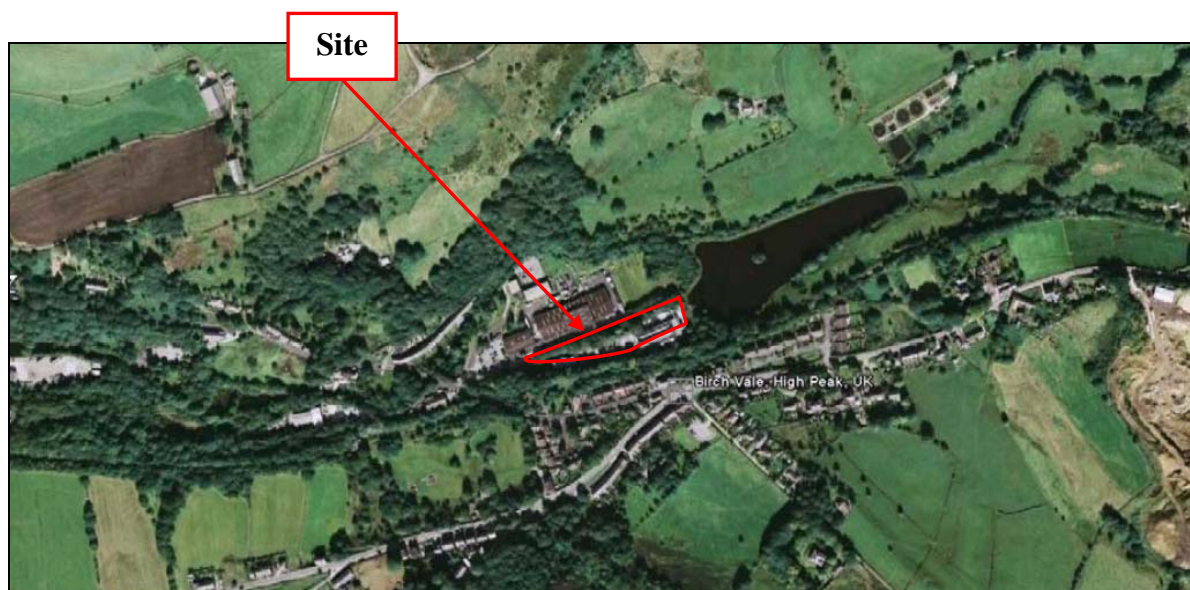
3.2.2. Aerial view to show the site and surrounding area.

3.2.1. The site is located in Birch Vale and is surrounded by another industrial unit to the north, a reservoir to the east and the Sett Valley Trail along the south boundary of the site.

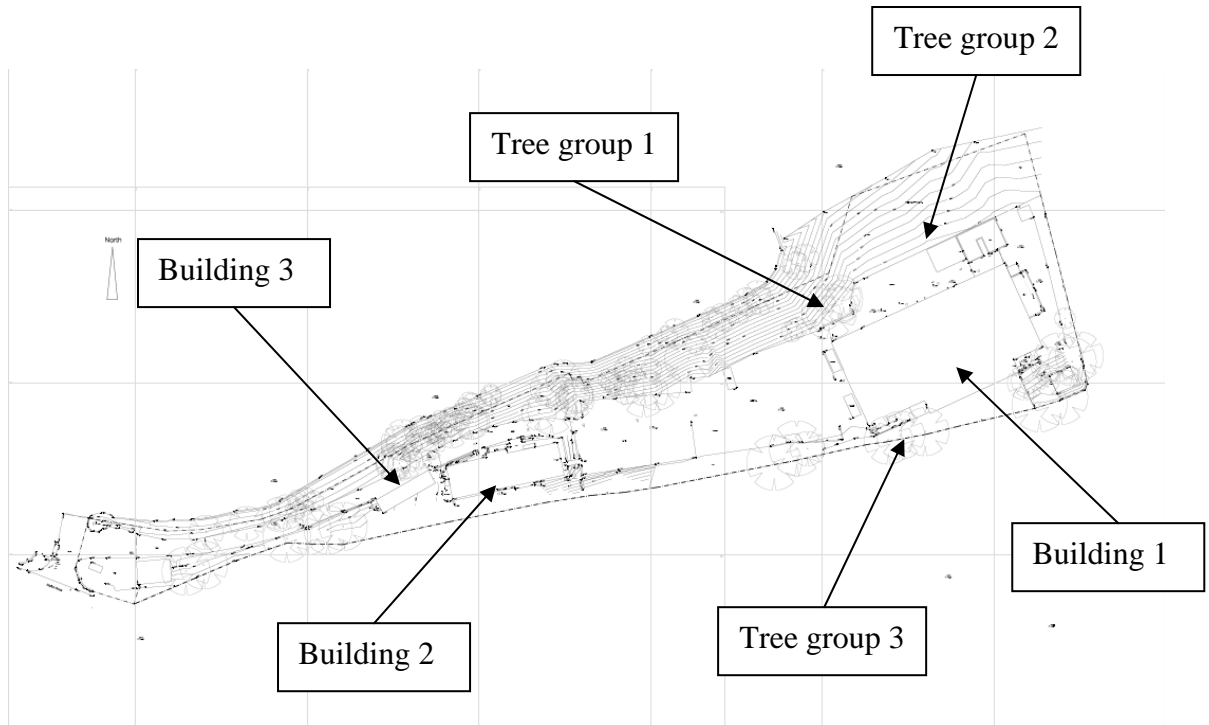
3.2.3. The buildings and trees surveyed are shown on the site plan below and are labeled for the purpose of this report.
