Design and Access Statement

Listed Building Application for replacement windows and doors

Marsh Hall Farm
Marsh Hall Lane, Chapel en le Frith

Ref 1123.Db.01
Rev A

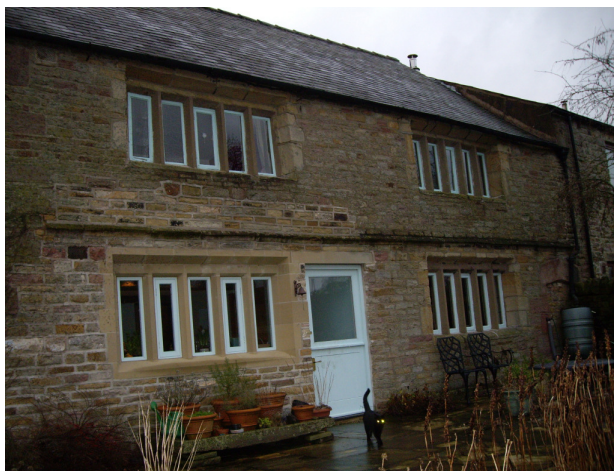
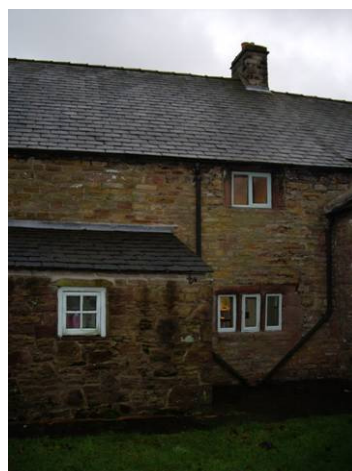
The building is attractive with a distinct C17 side with stone mullioned windows particularly on the south elevation, and an C18 portion with larger sash windows. Over the years, the building has been added to, extended and openings changed.

It is likely that some of the stone mullions have been removed over the years, particularly at W12, W13 and W14, but the window / opening has also been altered at W15, W16, W5 and W6. Together, W15, W16 and W5 make an attractive 'collection', but W5 seems to be a 'newer' window, replaced at the same time as W6..
