WINDOW [W/SG.1] - EXTERNAL ELEVATION

WINDOW [W/SG.1] - SECTION A-A

BENCH  
ARCHITECTS

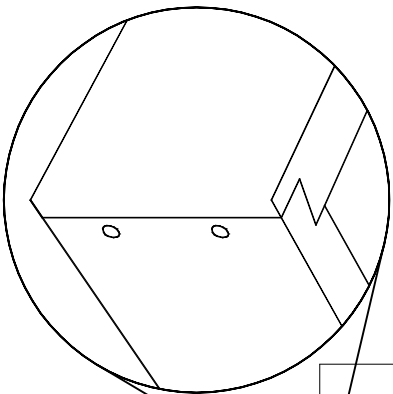
RABBETED DOVETAIL JOINT  
1:2 Scale - [cl. 270.4]

[cl. 270.4] - 32mm Accoya lining [or similar approved hardwood] externally, mechanically fixed flush with stonework and adjacent timber. Rabbeted dovetail joints - see detail.

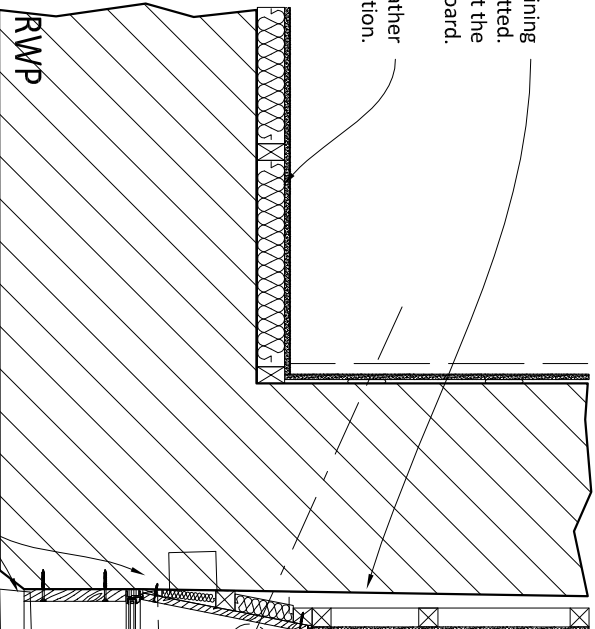
[cl. 270.1] - Obscure laminate double glazed unit supplied by vale.

[cl. 270.1] - Replace existing decayed beam with new H200 x W75mm & H25 x W150 mm accoya and H200 x W50 softwood beams over opening. 2mm thick stainless steel angle screwed to top, projecting to form drip detail. DPC installed over stainless steel, taped to beam behind.

Masonry leans out - repointed as required. Window surround to be set 50mm back from face of new beam.

[cl. 270.1] - Double glazed bronze window frame by Vale 'Advanced System'. Bronze angle profile used as spacer to the bottom rail.

[cl. 270.4] - Accoya [or similar approved hardwood] sill projects 25mm from face of masonry with 2° fall to top edge and drip detail.

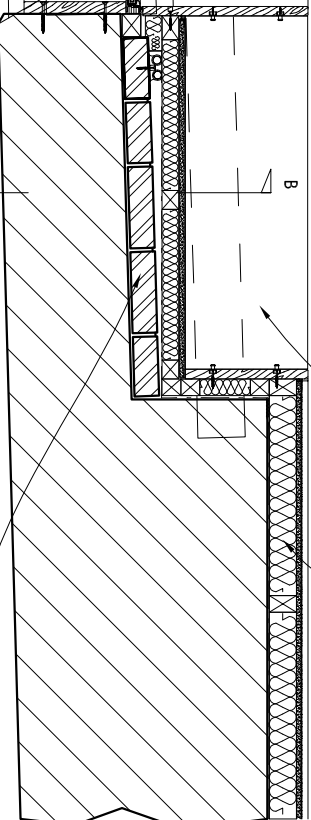
New sawn softwood studs with 50mm insulation [Kingspan K12 Framing Board] & plasterboard [cl.450c] fixed to brickwork. New radiator [cl. 630.7].

Insulation used to fill voids [Kingspan K12 Framing Board].

Steel beam over - exposed & painted in intumescent paint. Douglass-fir lining cut around.

Accoya lining [or similar approved hardwood] and sill to window externally [cl. 270.4]. Douglass-fir or oak internal lining [cl. 600] with insulation cut to fit behind [Kingspan K12 Framing Board].

Existing brick inner leaf. New softwood framing, 50mm insulation [Kingspan K12 Framing Board] and plasterboard [cl.450c] to form back of shelving [cl. 600.1].
