Proposed Installation of Gas Fuelled Central Heating System and Associated External Flue

## Hall Bank Clinic, 1 The Savoy, Hall Bank, Buxton

Design and Access Statement  
Heritage Statement  
Heritage Features & Impact Assessment

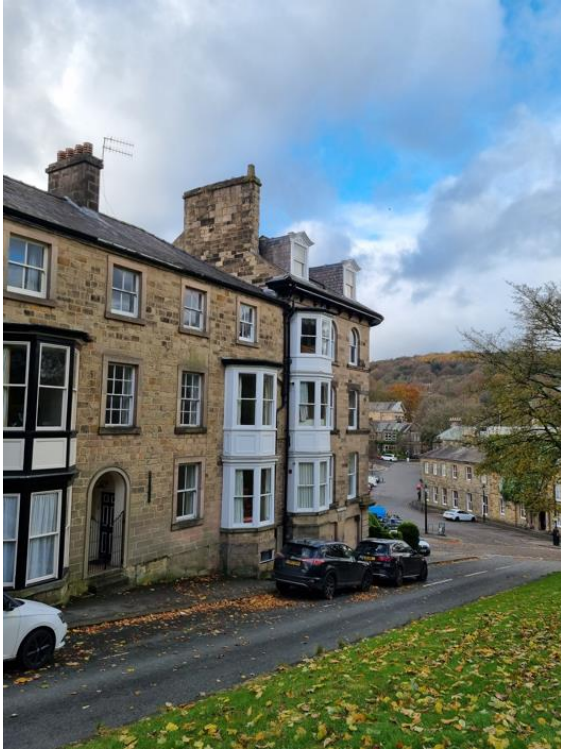
**Figure 6:** View from Buxton Slopes to Hall Bank.

As part of the mitigation assessment the location of the flue was viewed from an elevated part of the Slopes near to the building and is shown in figure 6 to the left. As can be seen the flue and guard are visible but make little visual impact given the placement of the flue in the corner of the recessed panel. There are other modern additions to this elevation including security grilles to windows and extract only vents, with another flue visible at the corner of one of the bay windows. As with the new flue these have no real impact on the streetscene and do not represent a deterioration in the setting or the enjoyment of Buxton's heritage views from the Slopes.

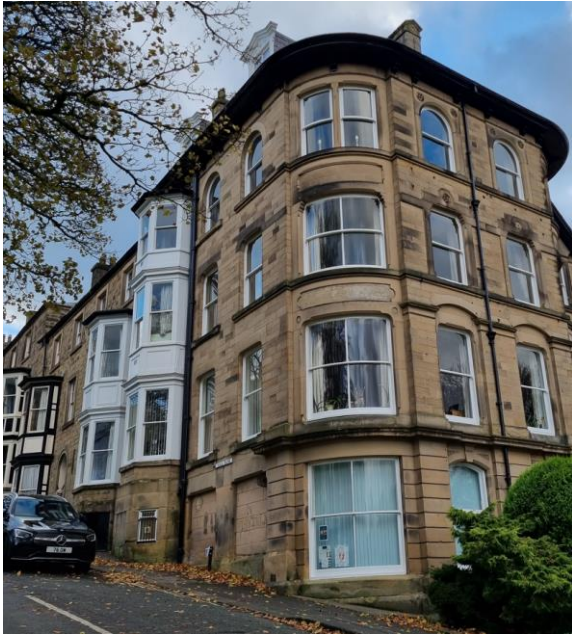
**Figure 7:** View from junction of Hall Bank and Hartington Road looking up Hall Bank. The window to the base of the bay nearest the camera has a steel security grille.

As part of the mitigation assessment the location of the flue was viewed from the junction of Hall Bank and Hartington Road looking towards 2A, 2B and 2-5 Hall Bank to examine any effect the flue may have on the view of these properties – the view is shown in figure 7. As can be seen the flue and guard are visible but make little visual impact given the placement of the flue in the corner of the recessed panel, the dark colour of the current flue guard blending it into the shadow caused by the recess. From the south of Hall Bank looking down towards the site the flue is obscured by the bay windows which extend to the upper floors of the buildings.
