| A_JAH_P_374 | <b>BC</b> |
| PROPOSED ROOF SERVICE PLAN | |
| Jodrell Arms Hotel | |
| 39 Market Street, Whaley Bridge, SK23 7AA | |

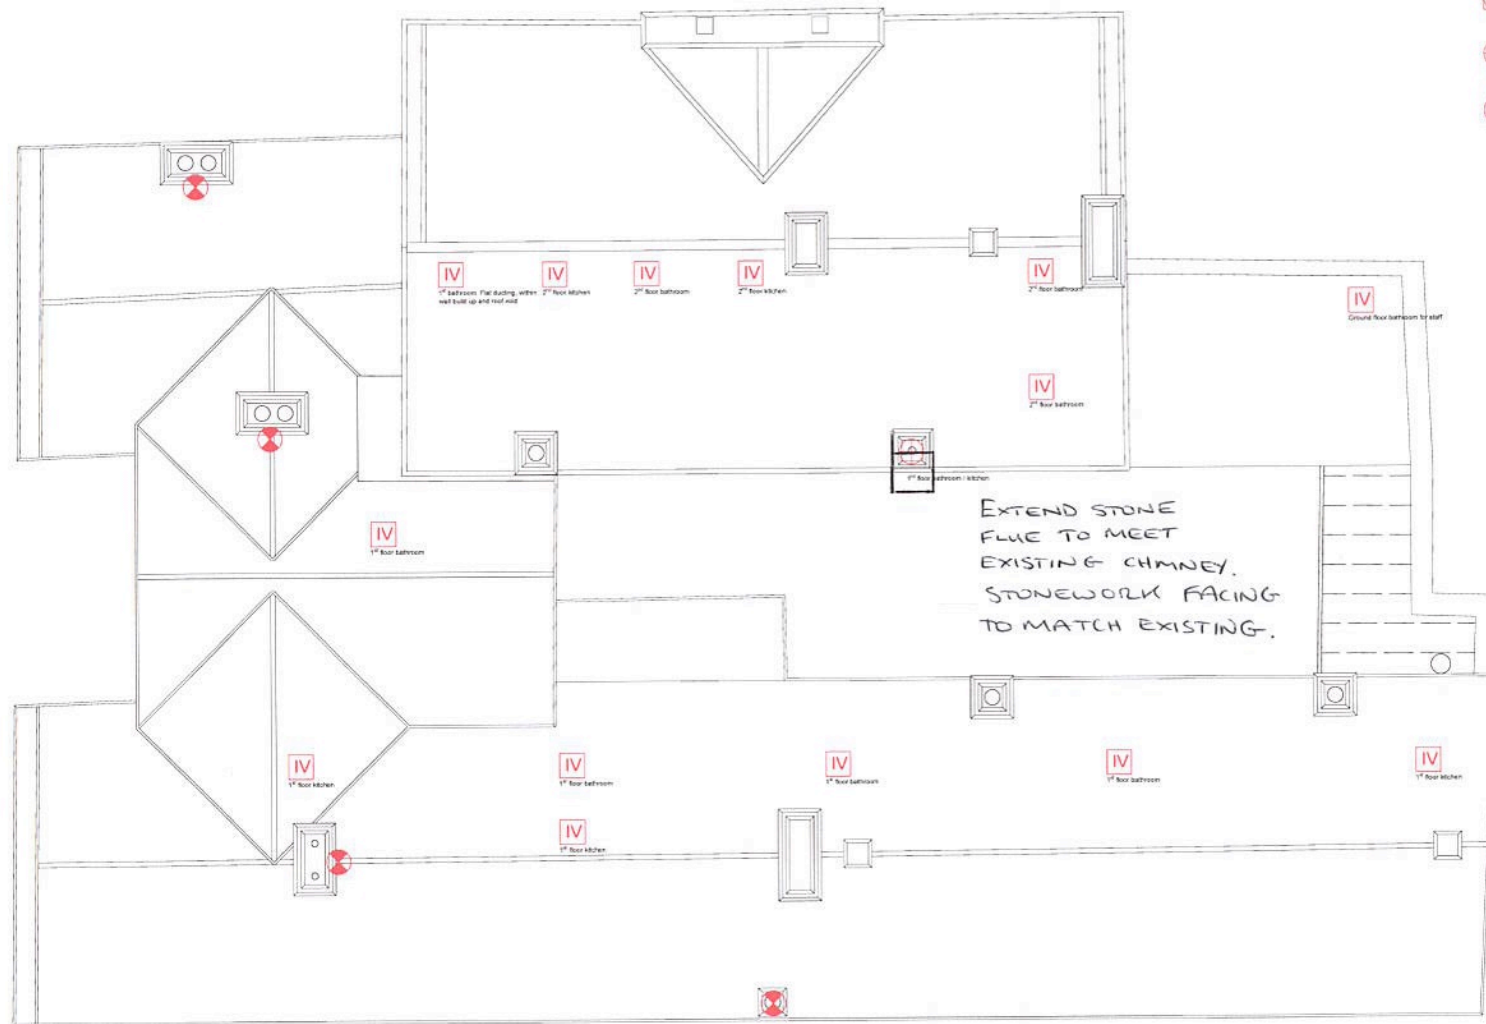
- IV Inline Slate Ventilation (see sample)  
Located on courtyard slope to be out of sight
- + Ventilation through chimney  
Chimney pot and cow
- X Chimney with cow  
Log Burning Fire  
Refer to fireplace information  
Chimney Pots
- Existing Chimney Pots  
Review condition and retain where possible. If necessary similar pots relocated to adjacent to similar existing pots.  
Replacement pots as below  
Existing To be lifted, and resealed and new lime/cement flashing
- Replacement Chimney Pots  
VK Knowles K10355-1 Double Beaded Pot. Height to match adjacent pot.

EXTEND STONE  
FLUE TO MEET  
EXISTING CHIMNEY.  
STONEMASONRY FACING  
TO MATCH EXISTING.

KITCHEN  
EXTRACT
