existing floor plans  
43 High Street  
planning issue

Grace Cole

Drawing no:  
GCP-003b

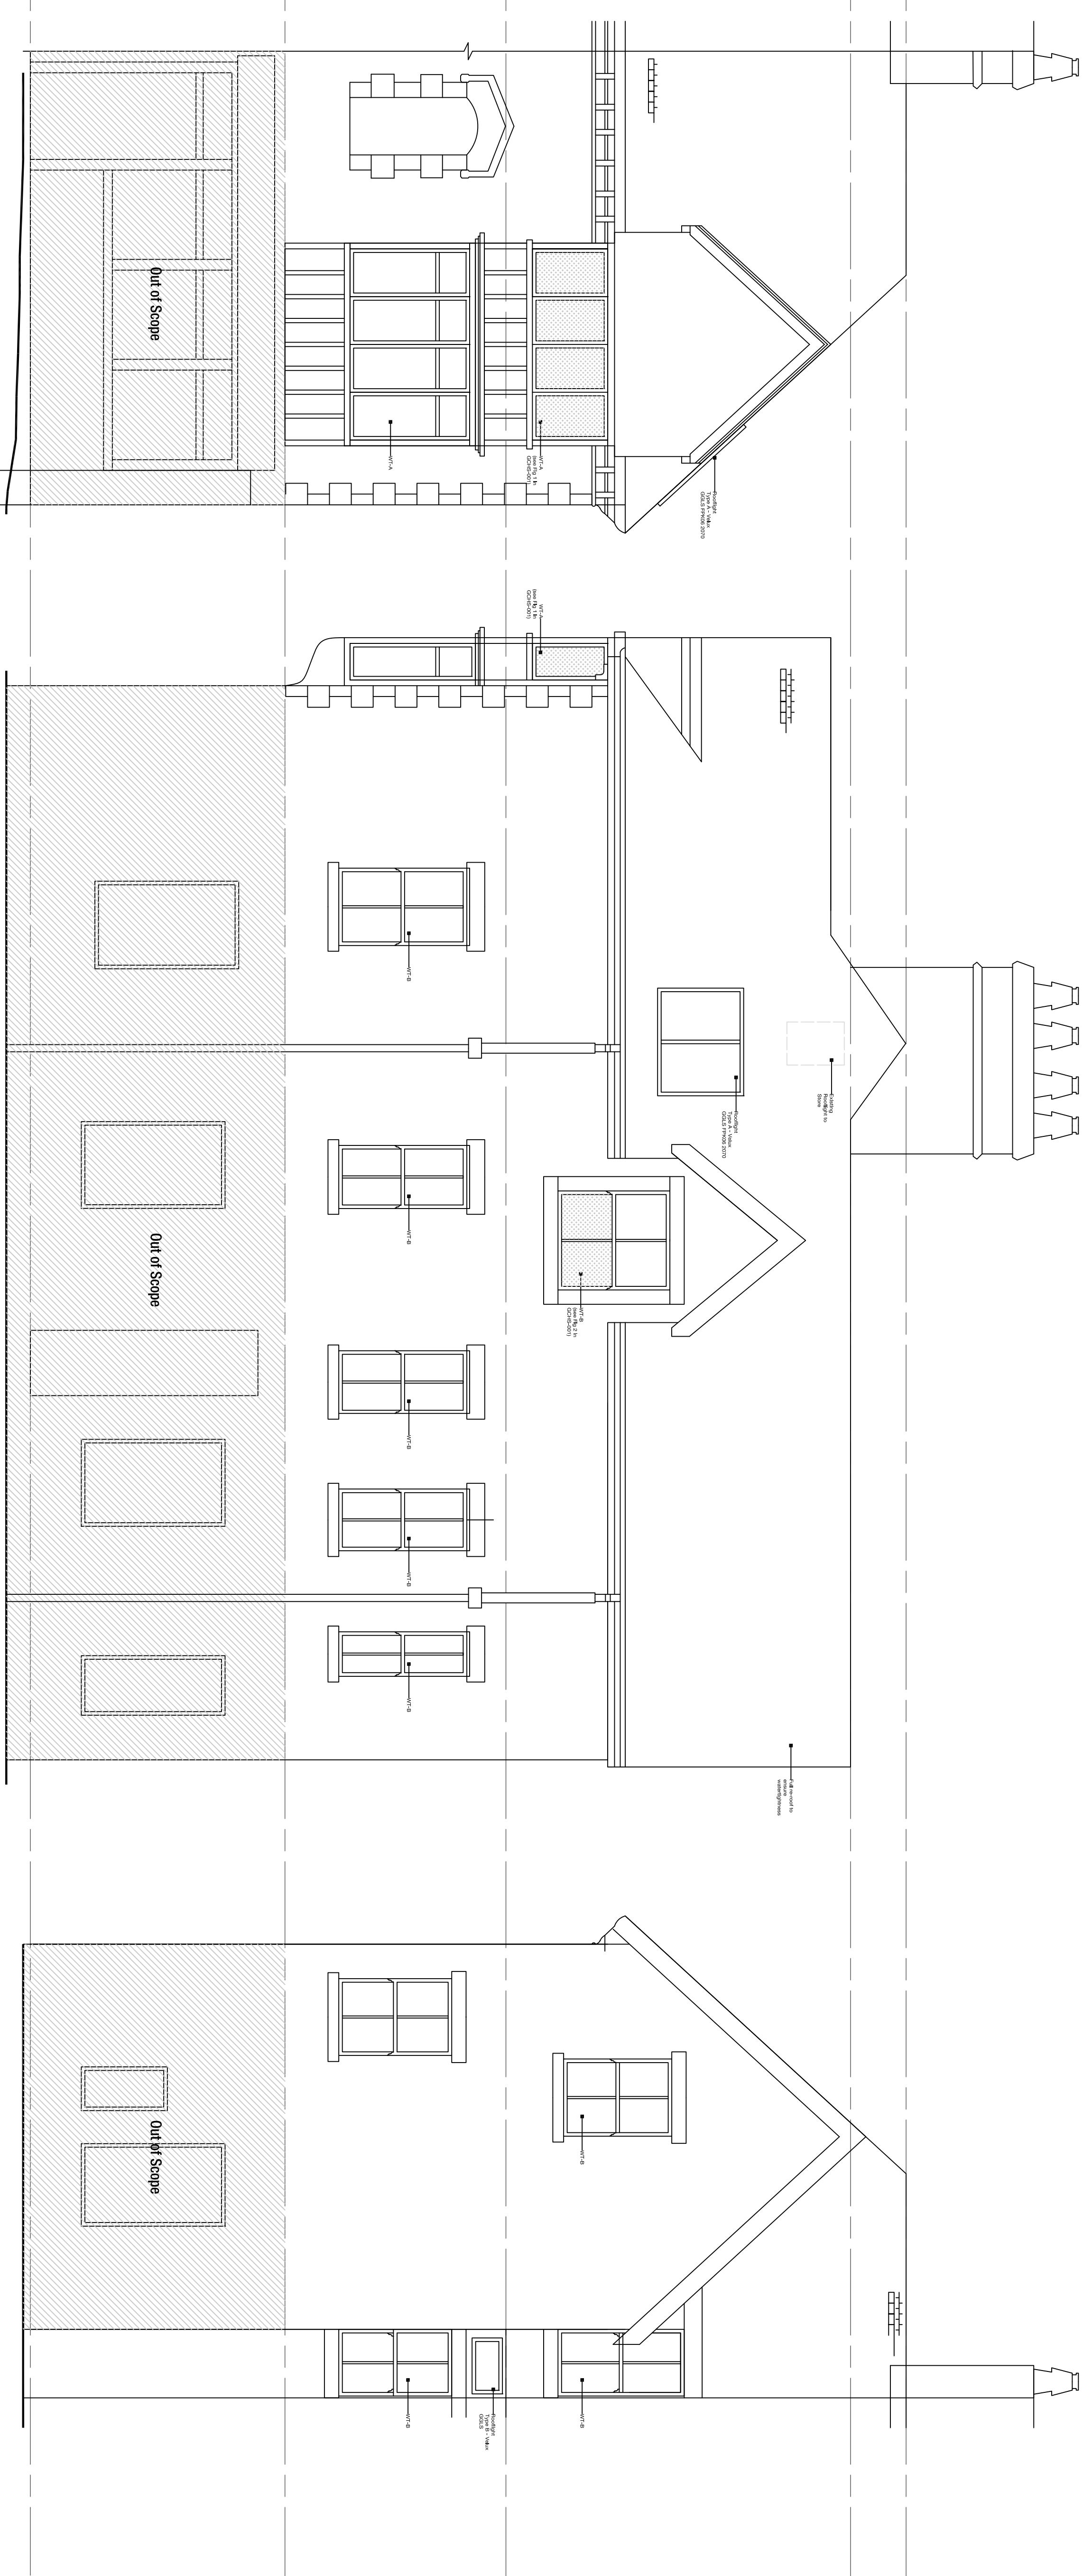
1:50 front elevation - south west @ A1

1:50 side - south east @ A1

1:50 rear - north east @ A1

Window Type A-

All existing leaking dilapidated timber sash to be restored using Accoya to provide a more robust and weather proof seal to the principal elevation.  
Where required the existing stained glass panels are to be repaired, restored and encapsulated within a double glazed pane.  
All new timber to be repaired as existing.  
Frame rebate to be increased on the inside to allow for double glazed units providing a u-value in line with Part L.  
Proposals to ensure no visible difference to the facade and window arrangements.

Window Type B -

All existing windows to the side and rear elevation to be replaced with heritage uPVC sliding sash windows.  
Windows to be from the Legacy range and to 'timber effect' On the second floor the uPVC unit will add the encapsulated restored stained glass pane in to the new system. All windows to be like for like with decorative horns and traditional sliding sash systems finished in white 'wood effect'. See Heritage statement for image of a recently installed unit in a similar scenario showing the thin frames to match.

Rooflight Type A

The main living space in 43b (flat 2) is dark, due to the fact the room was originally the master bedroom. A Velux rooflight is proposed to allow more daylight.  
Velux GGLS FPK06 2070, low profile velux rooflight glazing bar to centre. A Lower profile unit would not be suitable and has been advised against by contractor as the driving rain in Buxton and in particular the exposed location of market place would not be suitable.

Rooflight Type B

Velux GGLS - This will replace the dilapidated original plane of glass that has been temporarily fixed with a Perspex sheet.

The works are to be done to vastly improve the thermal efficiency and water tightness of the residential units as well as adding additional insulation at roof level. It should be clear from the pictures in the annex of the heritage statement that the windows are not suitable for installing secondary glazing due to the advanced rot present. See technical sub for window system details. Exact window specification to match existing, product brochures attached for window and rooflight systems. See Heritage statement for existing pictures of glazing. See condition report for contractor assessment of frames
