HERITAGE STATEMENT

TO ACCOMPANY APPLICATION FOR LISTED BUILDING CONSENT FOR:

Outbuildings I, J, K & L to be refurbished as holiday-let properties.

Torr Vale Mills, Torr Vale Road, New Mills, High Peak, SK22 3HS

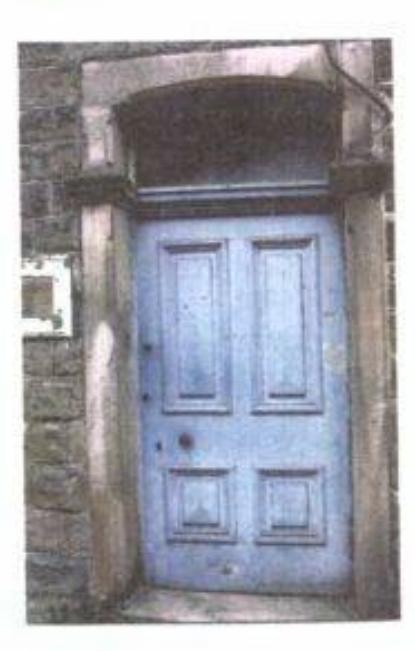
Front Door

The front door should be retained. The plan form, panelling and window partitions of the interior should be retained in any future use. The internal panelled doors should be retained, as should the timber flooring. If possible, the interior furniture such as the desks and drawing tables should be retained for use in situ, although relocation might be acceptable within the scope of a sensitive scheme for reuse.

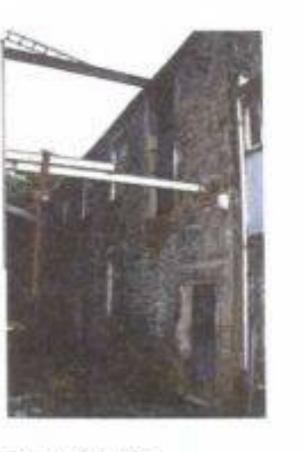
Front elevation

Materials	Local coursed sandstone
Plan	Rectangular
Height	2 Storeys
Roof	Gable covered with slates
Chimneys	One to addition at rear
Additions	Small addition to rear at first floor level, built into the hill
	houses a forge and has a chimney, added 1889 - 1896
Door	Three external doors
Windows	Level 1 Six Type T
	Level 0 One Type T

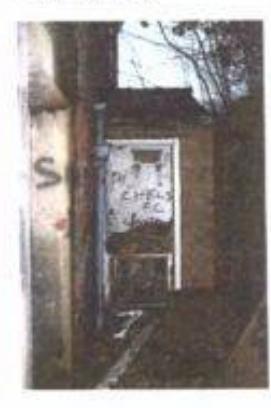
Brick addition

Materials	Coursed local sandstone		
Plan	Central stairway, one room each side of the stair		
Height	3 Storeys		
Roof	Gable covered with slates		
Chimneys	1 Central, square plan, 2 clay chimney pots		
Additions	Small brick toilet block to rear		
Door	Four panel, damaged		
Windows	Level 2 One Type G, Two Type U		
(1999) (1999) (1999) (1999) (1999) (1999)	Level 1 Two Type U, One boarded window		
	Level 0 One boarded window

The first and more significant proposed alteration is the enlargement of a current singlestorey brick built lean-to toilet block on the south-east gable of the Fireman's house building K. The structure is proposed to be extended to floor above with an enlarged ground footprint to finish flush with the south-west gable to form a new entrance doorway replicating existing. The majority of the visual impact to this aspect will be the door and the slate roof rising from the first floor-floor level to the first floor-roof level.

The only aspect which differs from the existing footprint and elevations is our desire to situate the stair access to the second floor in an enlargement of the existing toilet addition at the rear of the property. This aspect is not visible from any of the public aspects of the property and due to it sitting tight next to the quarry level is only marginally visible from the rear at all. We have proposed it be enlarged in the same material as existing for the toilet block namely red brick and slate sloped roof.

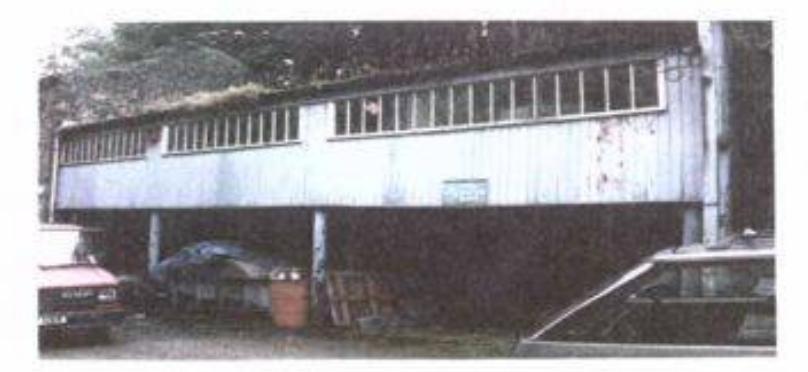
Front elevation

Materials	Brick wall to rear, vertical weatherboarding lined with tar
	paper to front and south side of upper floor
Plan	Rectangular
Height	2 Storeys
Roof	Single pitch towards hill to rear, covered in slates
Additions	Second Floor added 1896 - 1903.
Door	Part glazed and part panelled
Windows	Long row of windows to front

The second amendment is that the rear wall of the wooden structure over the open store [bldg L] be squared off instead of following its original dog leg pattern. All the other buildings in this contiguous range are of a uniform rectangular form hence this proposed alteration would only serve to enhance the uniformity of their pattern. Also an additional window of the same type and size is proposed in this elevation.

The scale and materials will be virtually as existing as the only proposed alteration externally is to reinstate the rear wall flush with the existing portion carrying on the line of the workshop block thus accentuating the visual unity and simple rectangular plan exhibited by the surrounding buildings. Internally the only alteration is the installation of partition walls on the first floor to create a bedroom and bathroom areas. The ground floor will be left open and used for covered disabled parking as suggested in the conservation plan. Hence all other aspects of the conservation plan are being complied with in the proposed scheme.

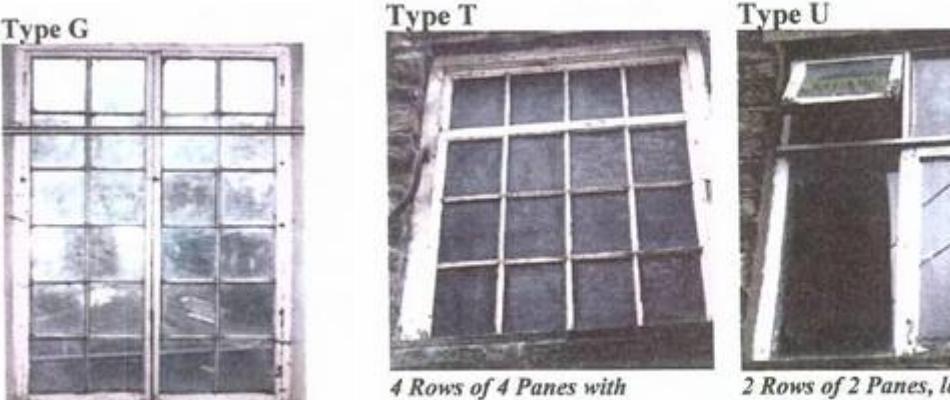
Additionally the two existing Type G windows in the south-west gable will be repaired and the modern casement Type U windows in the remaining windows will be replaced with the original Type T windows as shown below

6 Rows of 4 Panes

Transom

2 Rows of 2 Panes, lower Panes larger
