# LAND OFF DINTING ROAD, GLOSSOP -PRELIMINARY ECOLOGICAL APPRAISAL

April 2015

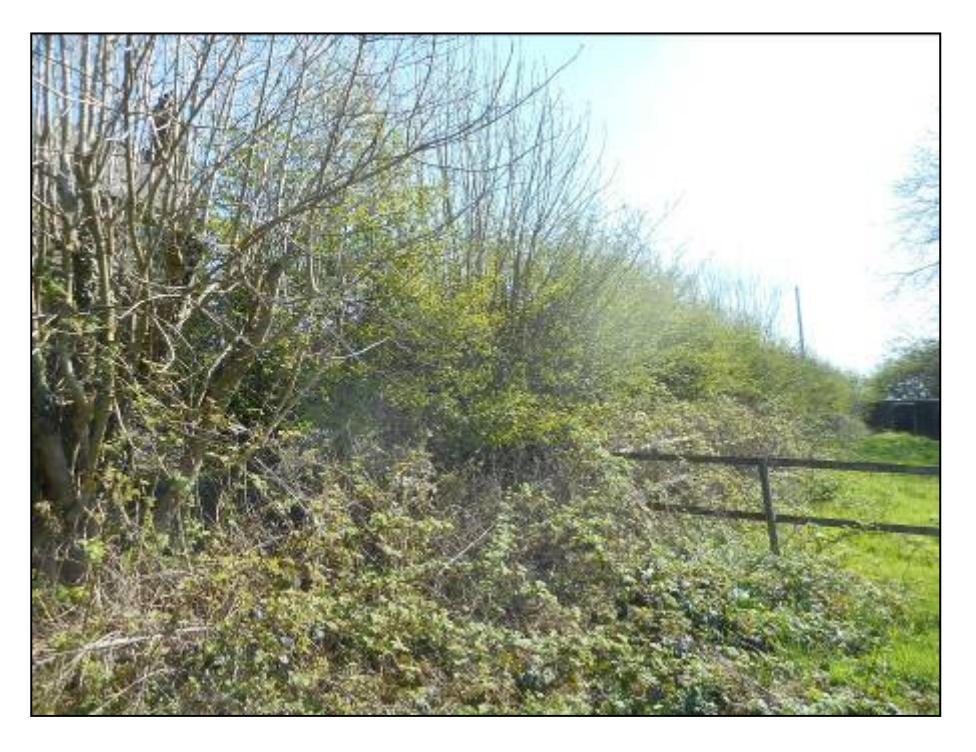
### Photograph 1 - Hedgerow on northern boundary of site

There is a single hedgerow along the northern boundary of the site (see Photograph 1). This predominantly consists of outgrown hawthorn (*Crataegus monogyna*) with some small pollarded ash (*Fraxinus excelsior*) scattered throughout and bramble (*Rubus fruticosus*), dog rose (*Rosa canina*), nettle, ivy (*Hedera helix*) and cow parsley (*Anthriscus sylvestris*) also present.

There was no current or historic evidence of the presence of nesting birds in the trees and hedgerows within the site and its immediate vicinity, although these features offer suitable habitat for nesting birds and could be used during the current nesting season or subsequent seasons.

Due to this, if possible, any work likely to cause disturbance should preferably avoid the nesting season for birds (February to September inclusive).

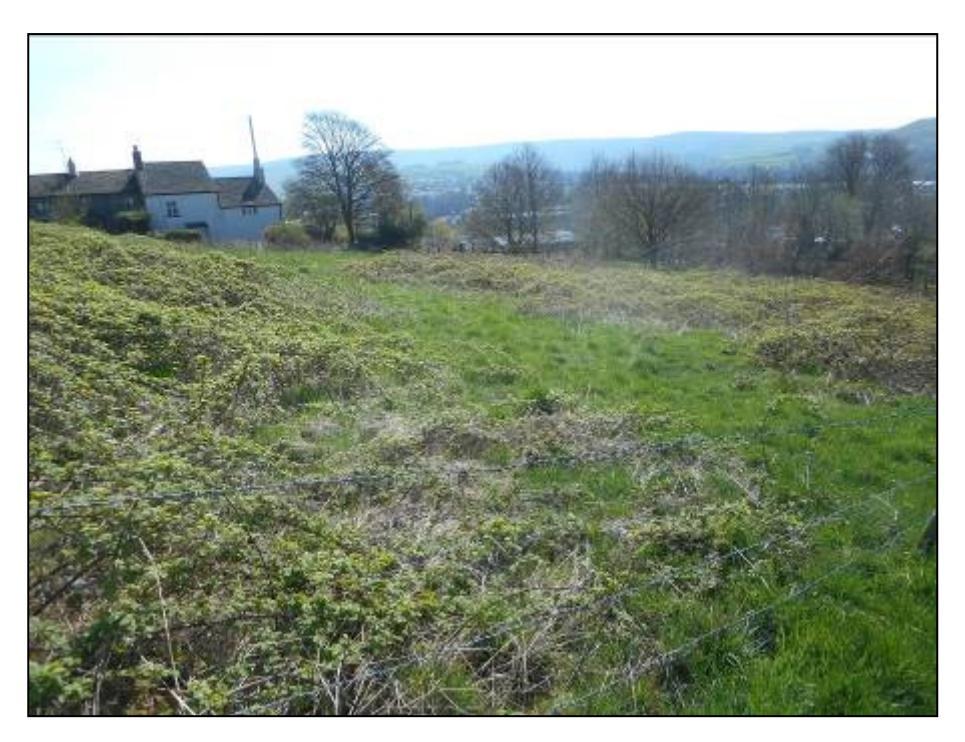
Photograph 2 - Bramble scrub in eastern section of site

There are large areas of scrub within the site, mainly in the eastern section of the site, but also around the majority of the boundary (see Photograph 2). The scrub is mainly low-lying bramble, but also contains nettle and rosebay willow-herb (*Chamerion angustifolium*).

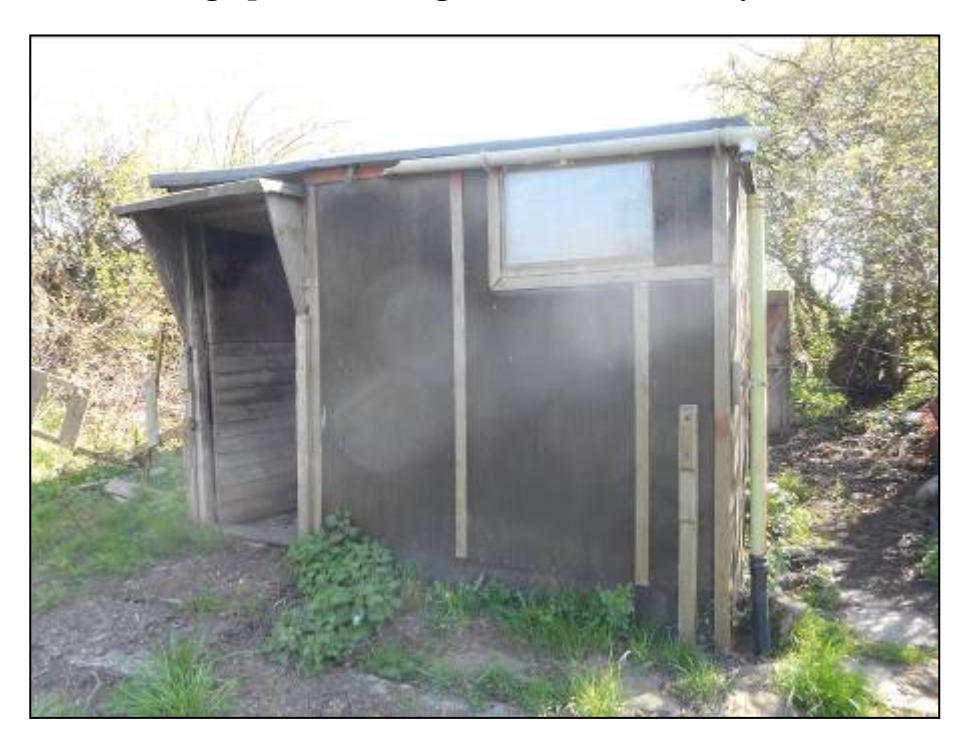
Photograph 3 - Building on northern boundary of site

There is a single building within the site boundary, which is a shed of mixed wood and corrugate tin construction with a flat, felted roof (see Photographs 3 - 5).

There was no evidence of the current or historic presence of bats within the building within the site, and no suitable features for roosting or resting bats on the ash tree within the site or the trees immediately adjacent to the site on the southern and western boundaries.

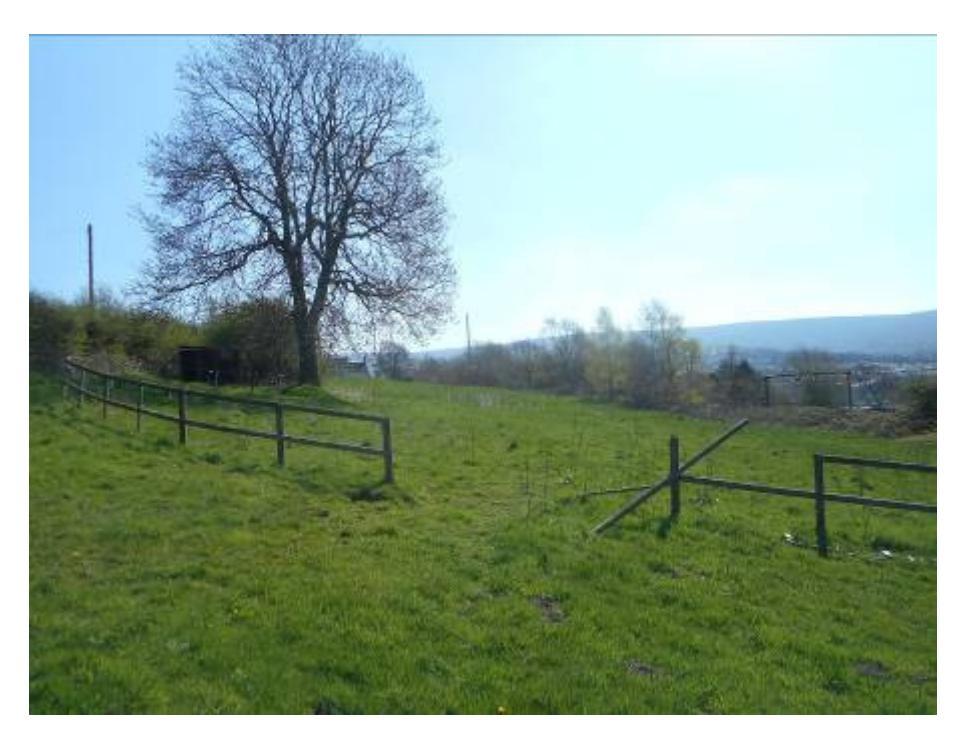
Photograph 6 - View from western boundary of site showing single ash tree

There is a single large ash tree within the site (see Photograph 6), and there are a number of trees and self-seeded saplings adjacent to the southern boundary of the site including hawthorn, elder (*Sambuchus niger*), oak (*Quercus robur*), holly (*Ilex aquifolium*), sycamore (*Acer pseudoplatanus*) and silver birch (*Betula pendula*). There are also three trees adjacent to the western boundary of the site comprising of a single sycamore and two hazel (*Corylus avellana*) trees, and a small group of outgrown hawthorn and elder shrubs approximately mid-way along the northern boundary to the south of the building.

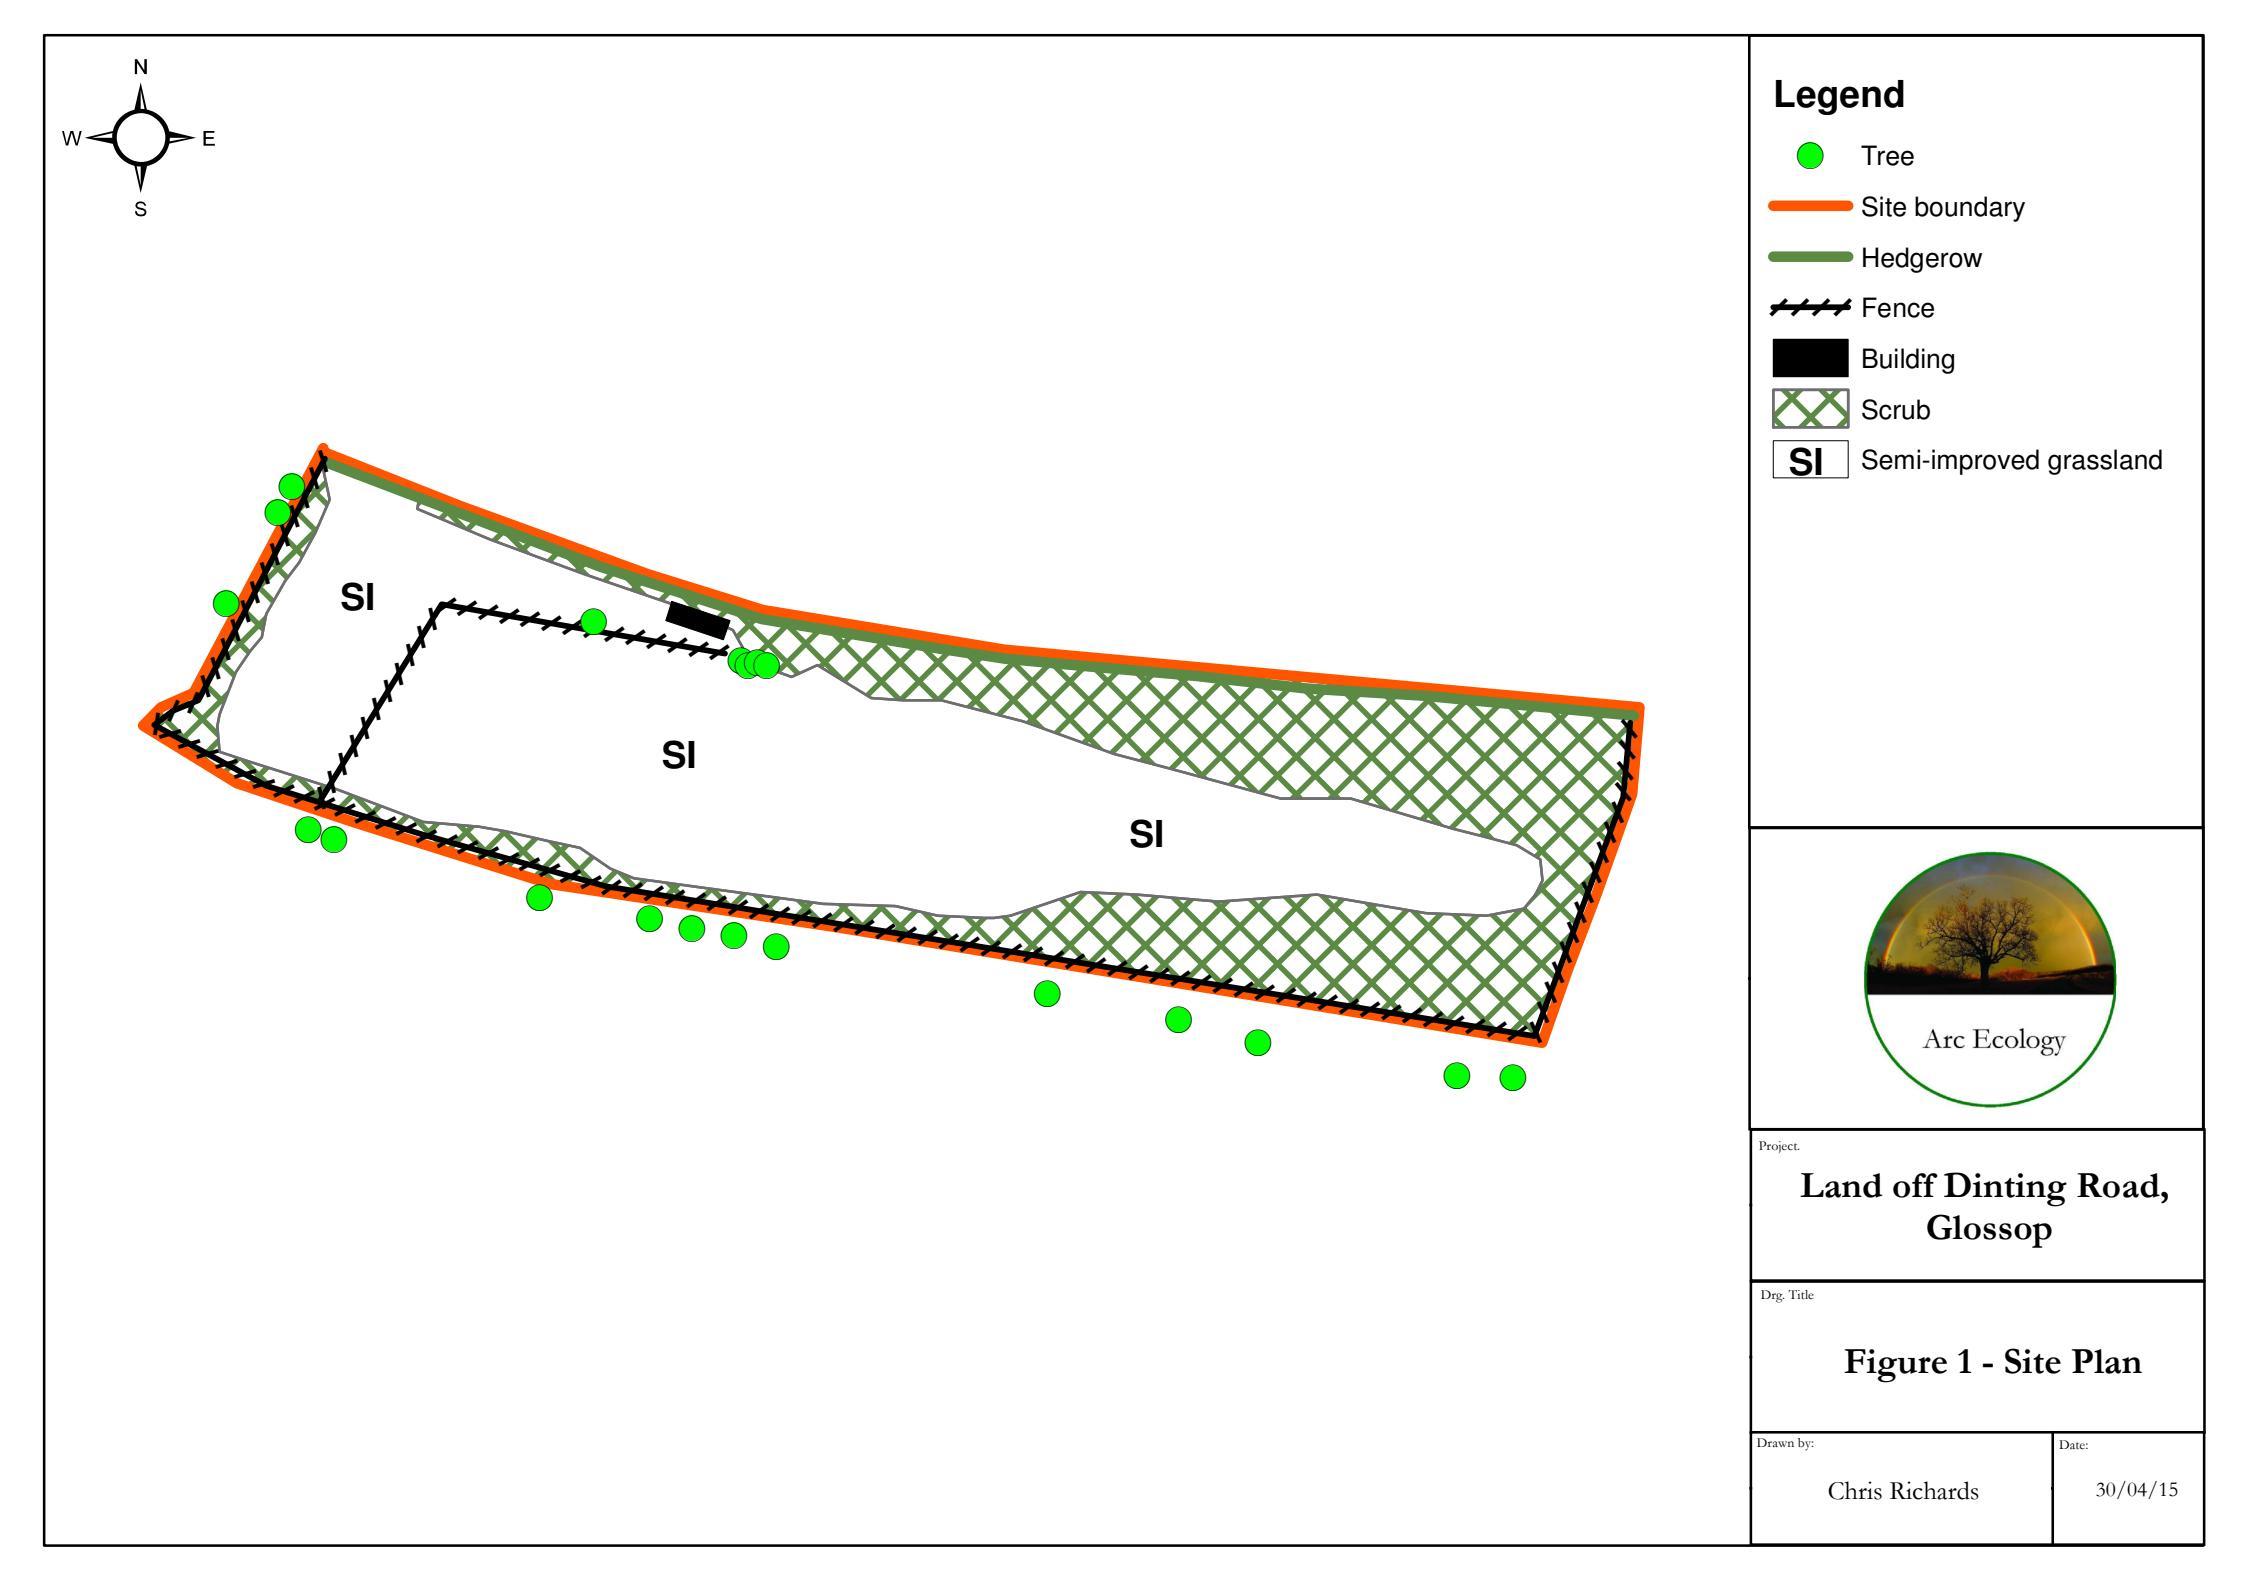
## FIGURE 1 - SITE PLAN SHOWING HABITATS AND FEATURES

The site lies approximately 1km to the north-west of the centre of the village of Glossop, High Peak at OSGR SK 024 925 (approximate site centre) and consists of an area of semi-improved grassland with its associated hedgerows, scrub and trees.
