cheshire woodlands

arboricultural consultancy

7411-AS3

PROJECT: LAND AT LONGCLOUGH DRIVE, GLOSSOP

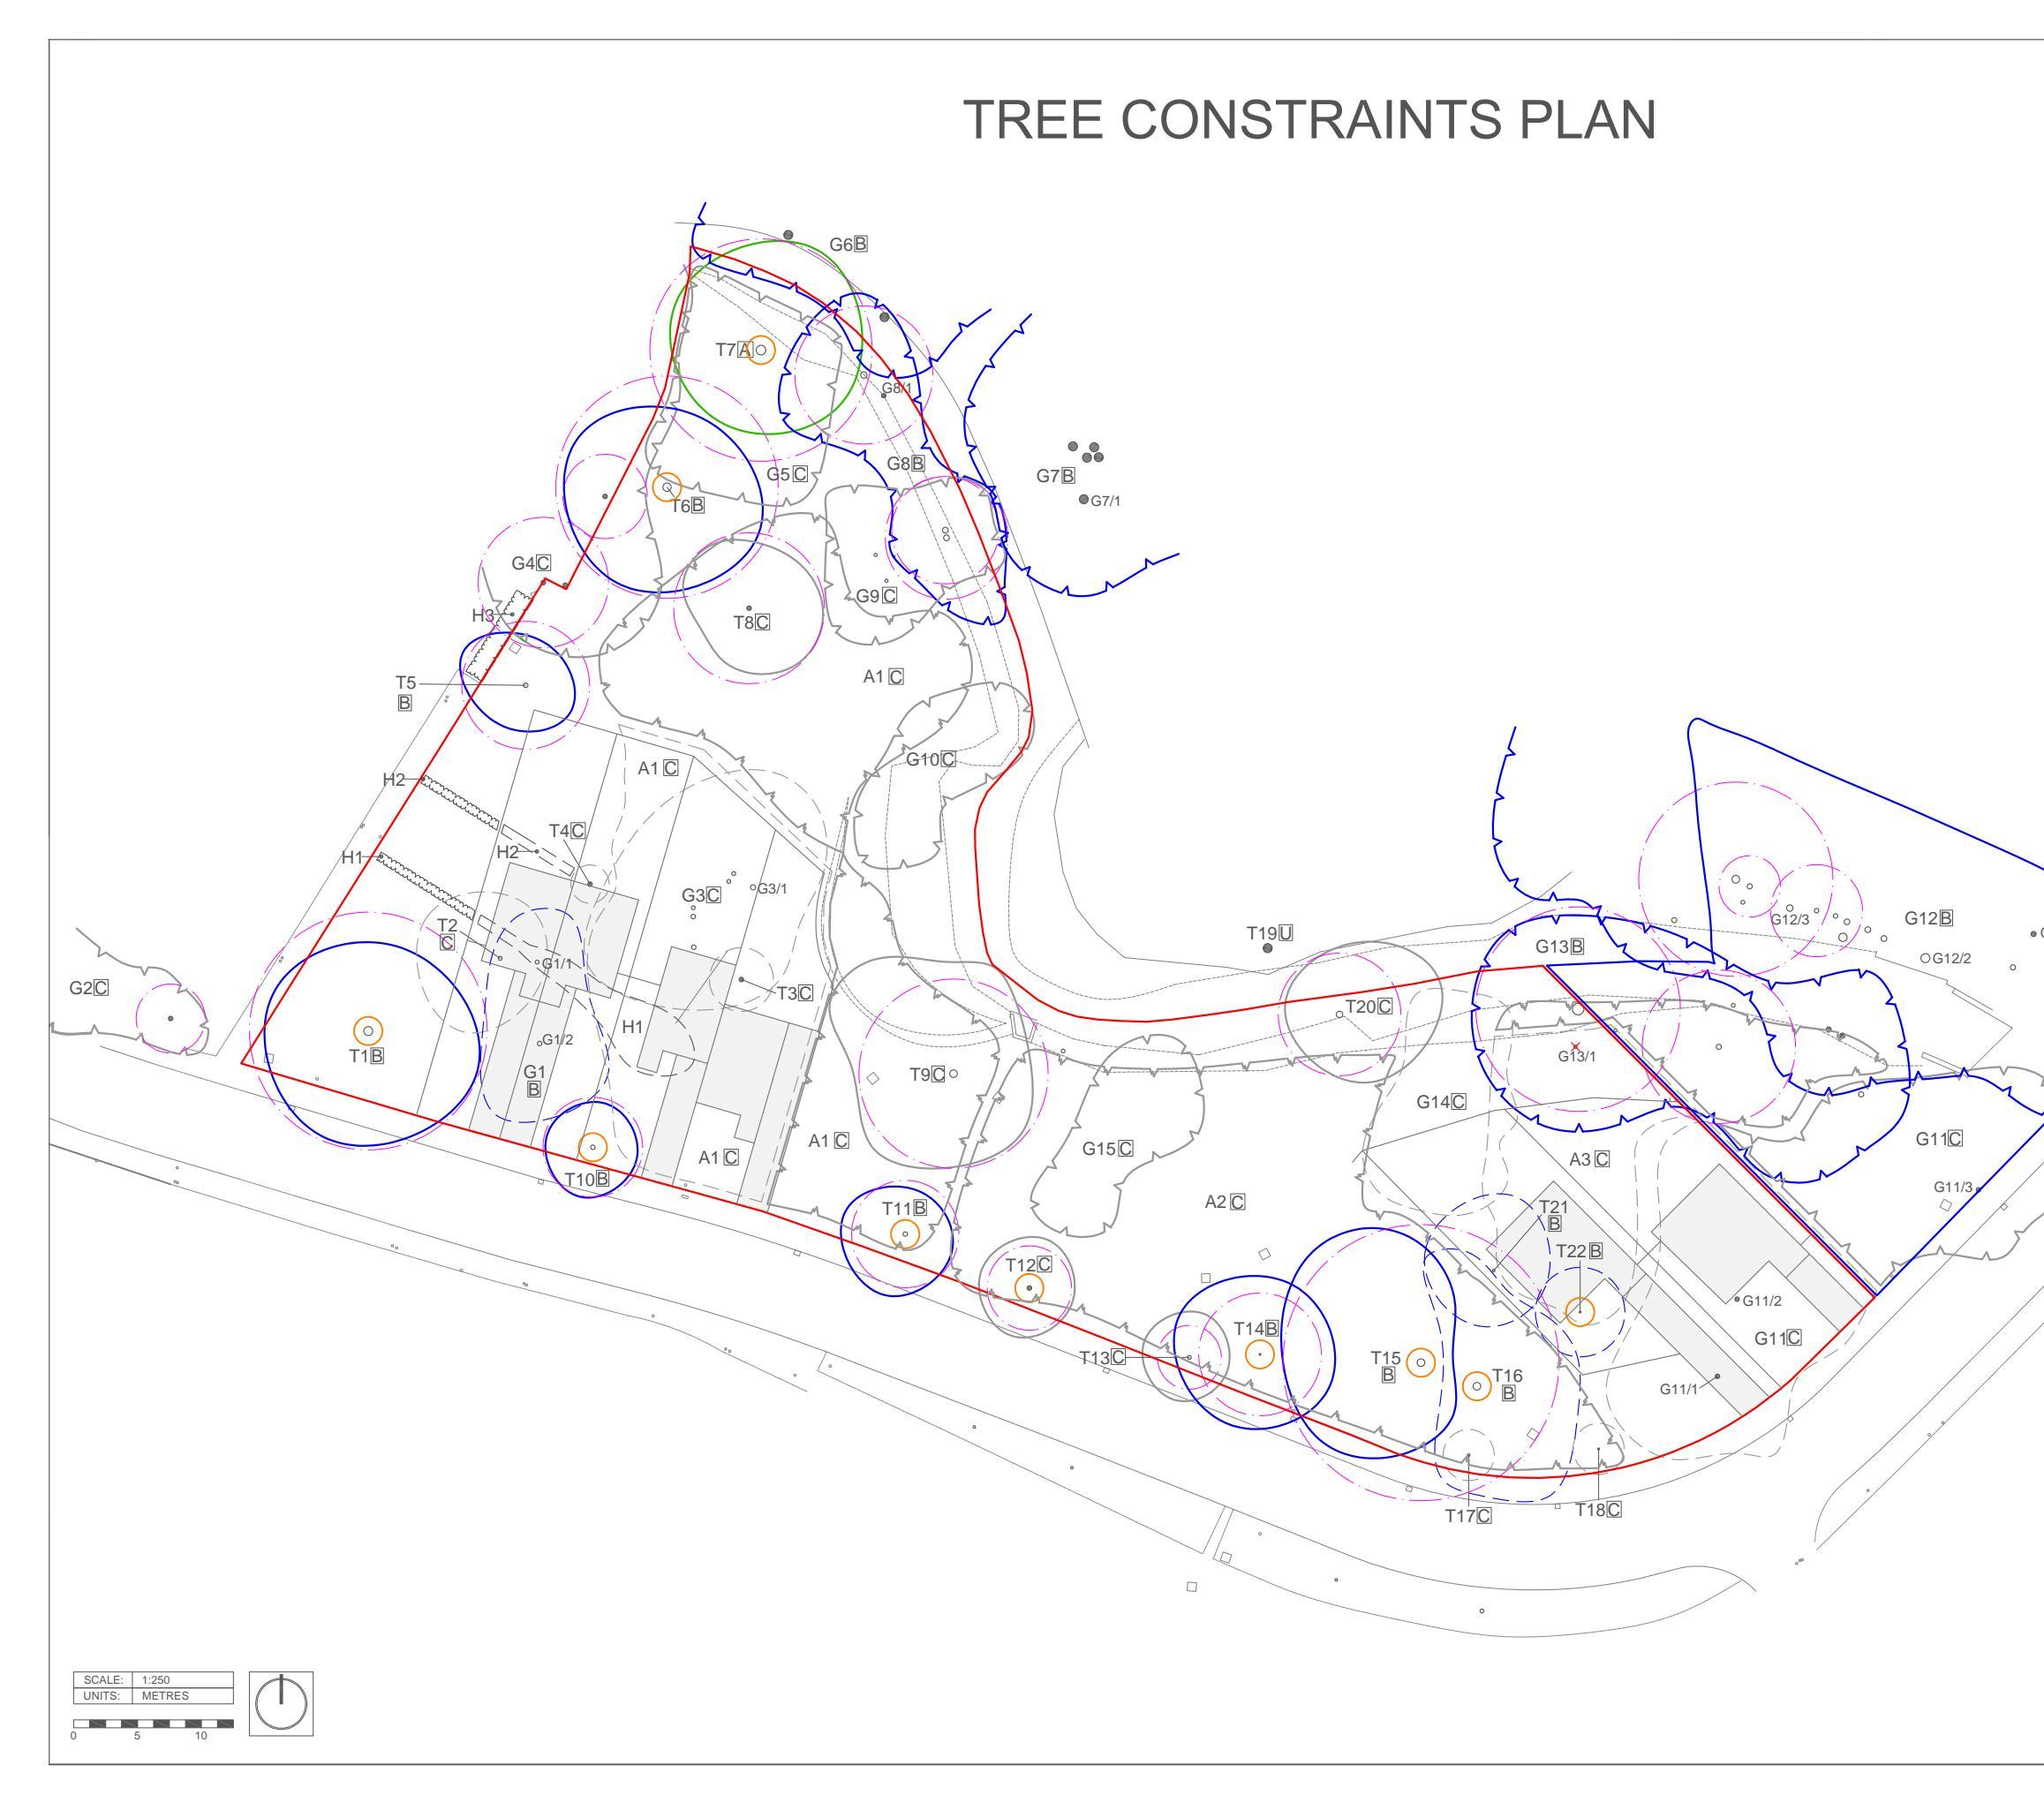
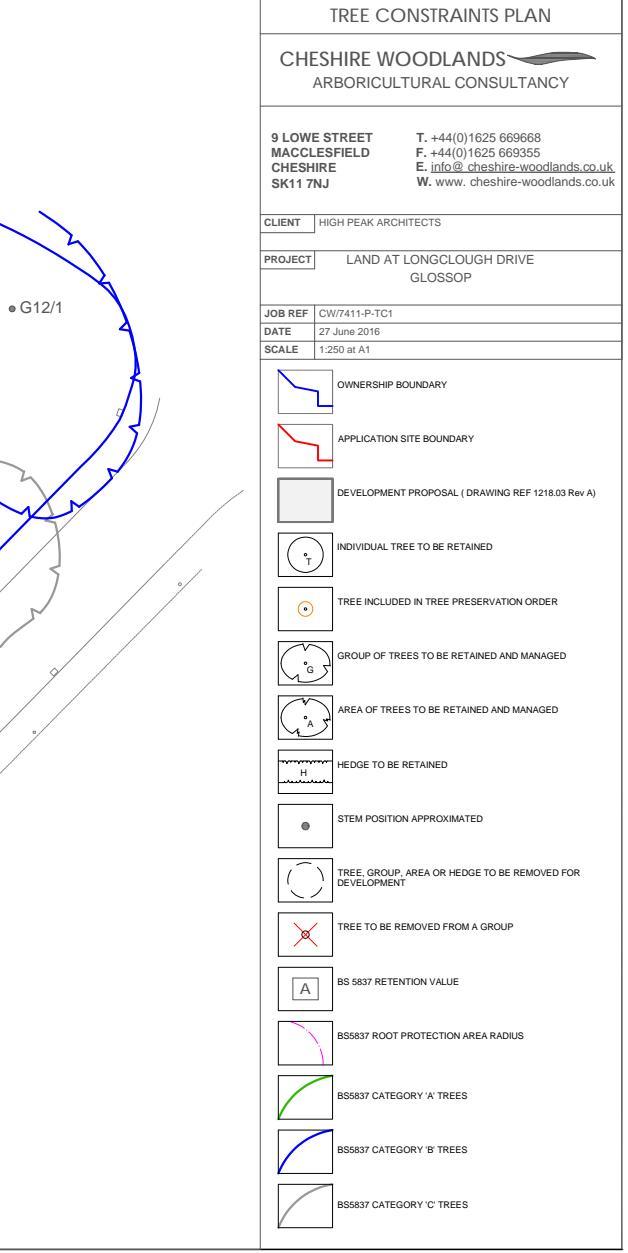
APPENDIX 2

- 3.4 The development proposal comprises the erection of six, split-level, 2/3 storey, detached and semi-detached dwellings as shown on the tree constraints plan at appendix 2.

- 6.1 The existing site plan overlaid with the sketch site layout is the base for the tree constraints plan at appendix 2.
- 6.2 The trees were identified, measured and recorded in the survey schedule at appendix 1. Stem diameters and canopy spreads were mostly measured using a tape, tree heights using a tape and clinometer.

- 6.3 The structural condition of the trees was assessed on the basis of the 'visual tree assessment method' (Mattheck and Breloer 1994).
- 6.4 Below-ground constraints are represented on the drawing as 'root protection areas' (RPA), calculated in accordance with section 4.6 and table D.1 of BS5837.

7.9 All of the retained trees and hedges can be protected during construction in accordance with current best practice as set out in BS5837, with details to be resolved by planning condition.

- 9.4 All trees and hedges proposed for retention should be protected during site construction works in accordance with a tree protection plan and arboricultural method statement to be agreed with the LPA.
