MACCLESFIELD ROAD BUXTON

ECOLOGICAL ASSESSMENT (Doc Ref: TEP 2011.001)

December 2009

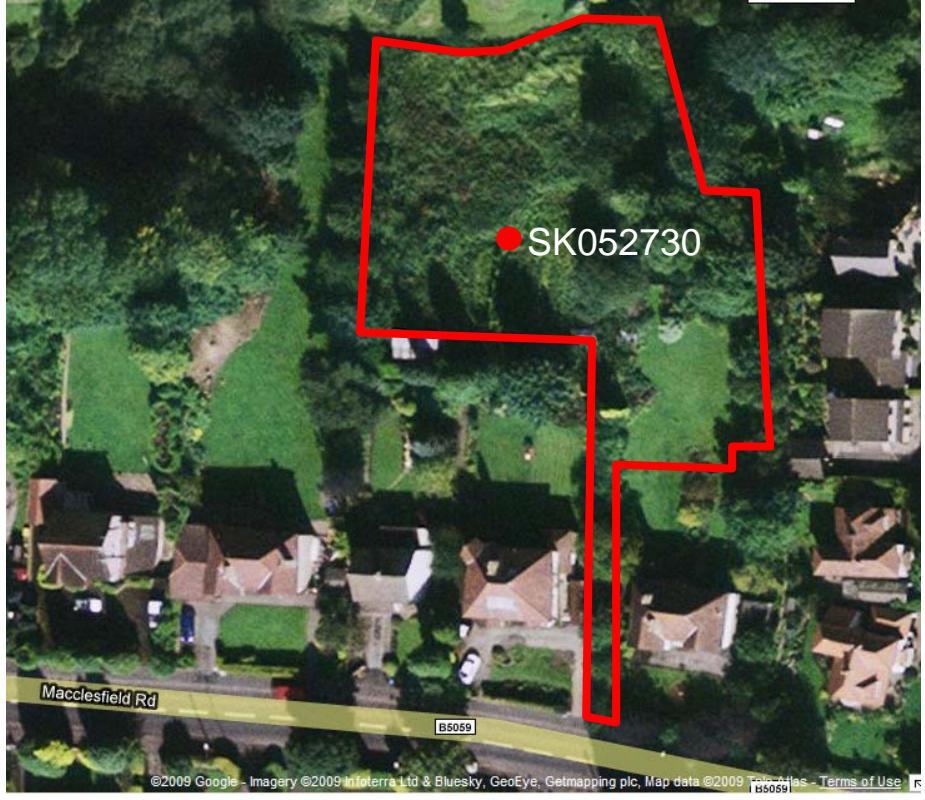
Figure 1: Aerial photograph of the site

- 3.1 The site comprises land to the rear of 20, 22 and 22a Macclesfield Road, Buxton. The majority of the site is overgrown with scrub vegetation; e.g. nettle (*Urtica dioica*) and bramble (*Rubus fruticosus*). Land nearer to the properties is managed as a domestic garden. There are a number of mature trees along the boundaries of the site.
- 3.2 The River Wye runs along the northern boundary of the site, linking the site with other private gardens, woodlands and parkland in Buxton. Within the site there is a band of marginal aquatic vegetation, approximately 6m wide,

bordering the river (see Drawing D2011.001). This is dominated by branched burr-reed (*Sparganium erectum*), with occasional greater reedmace (*Typha latifolia*) and one patch of the introduced Indian rhubarb or umbrella plant (*Darmera peltata*).

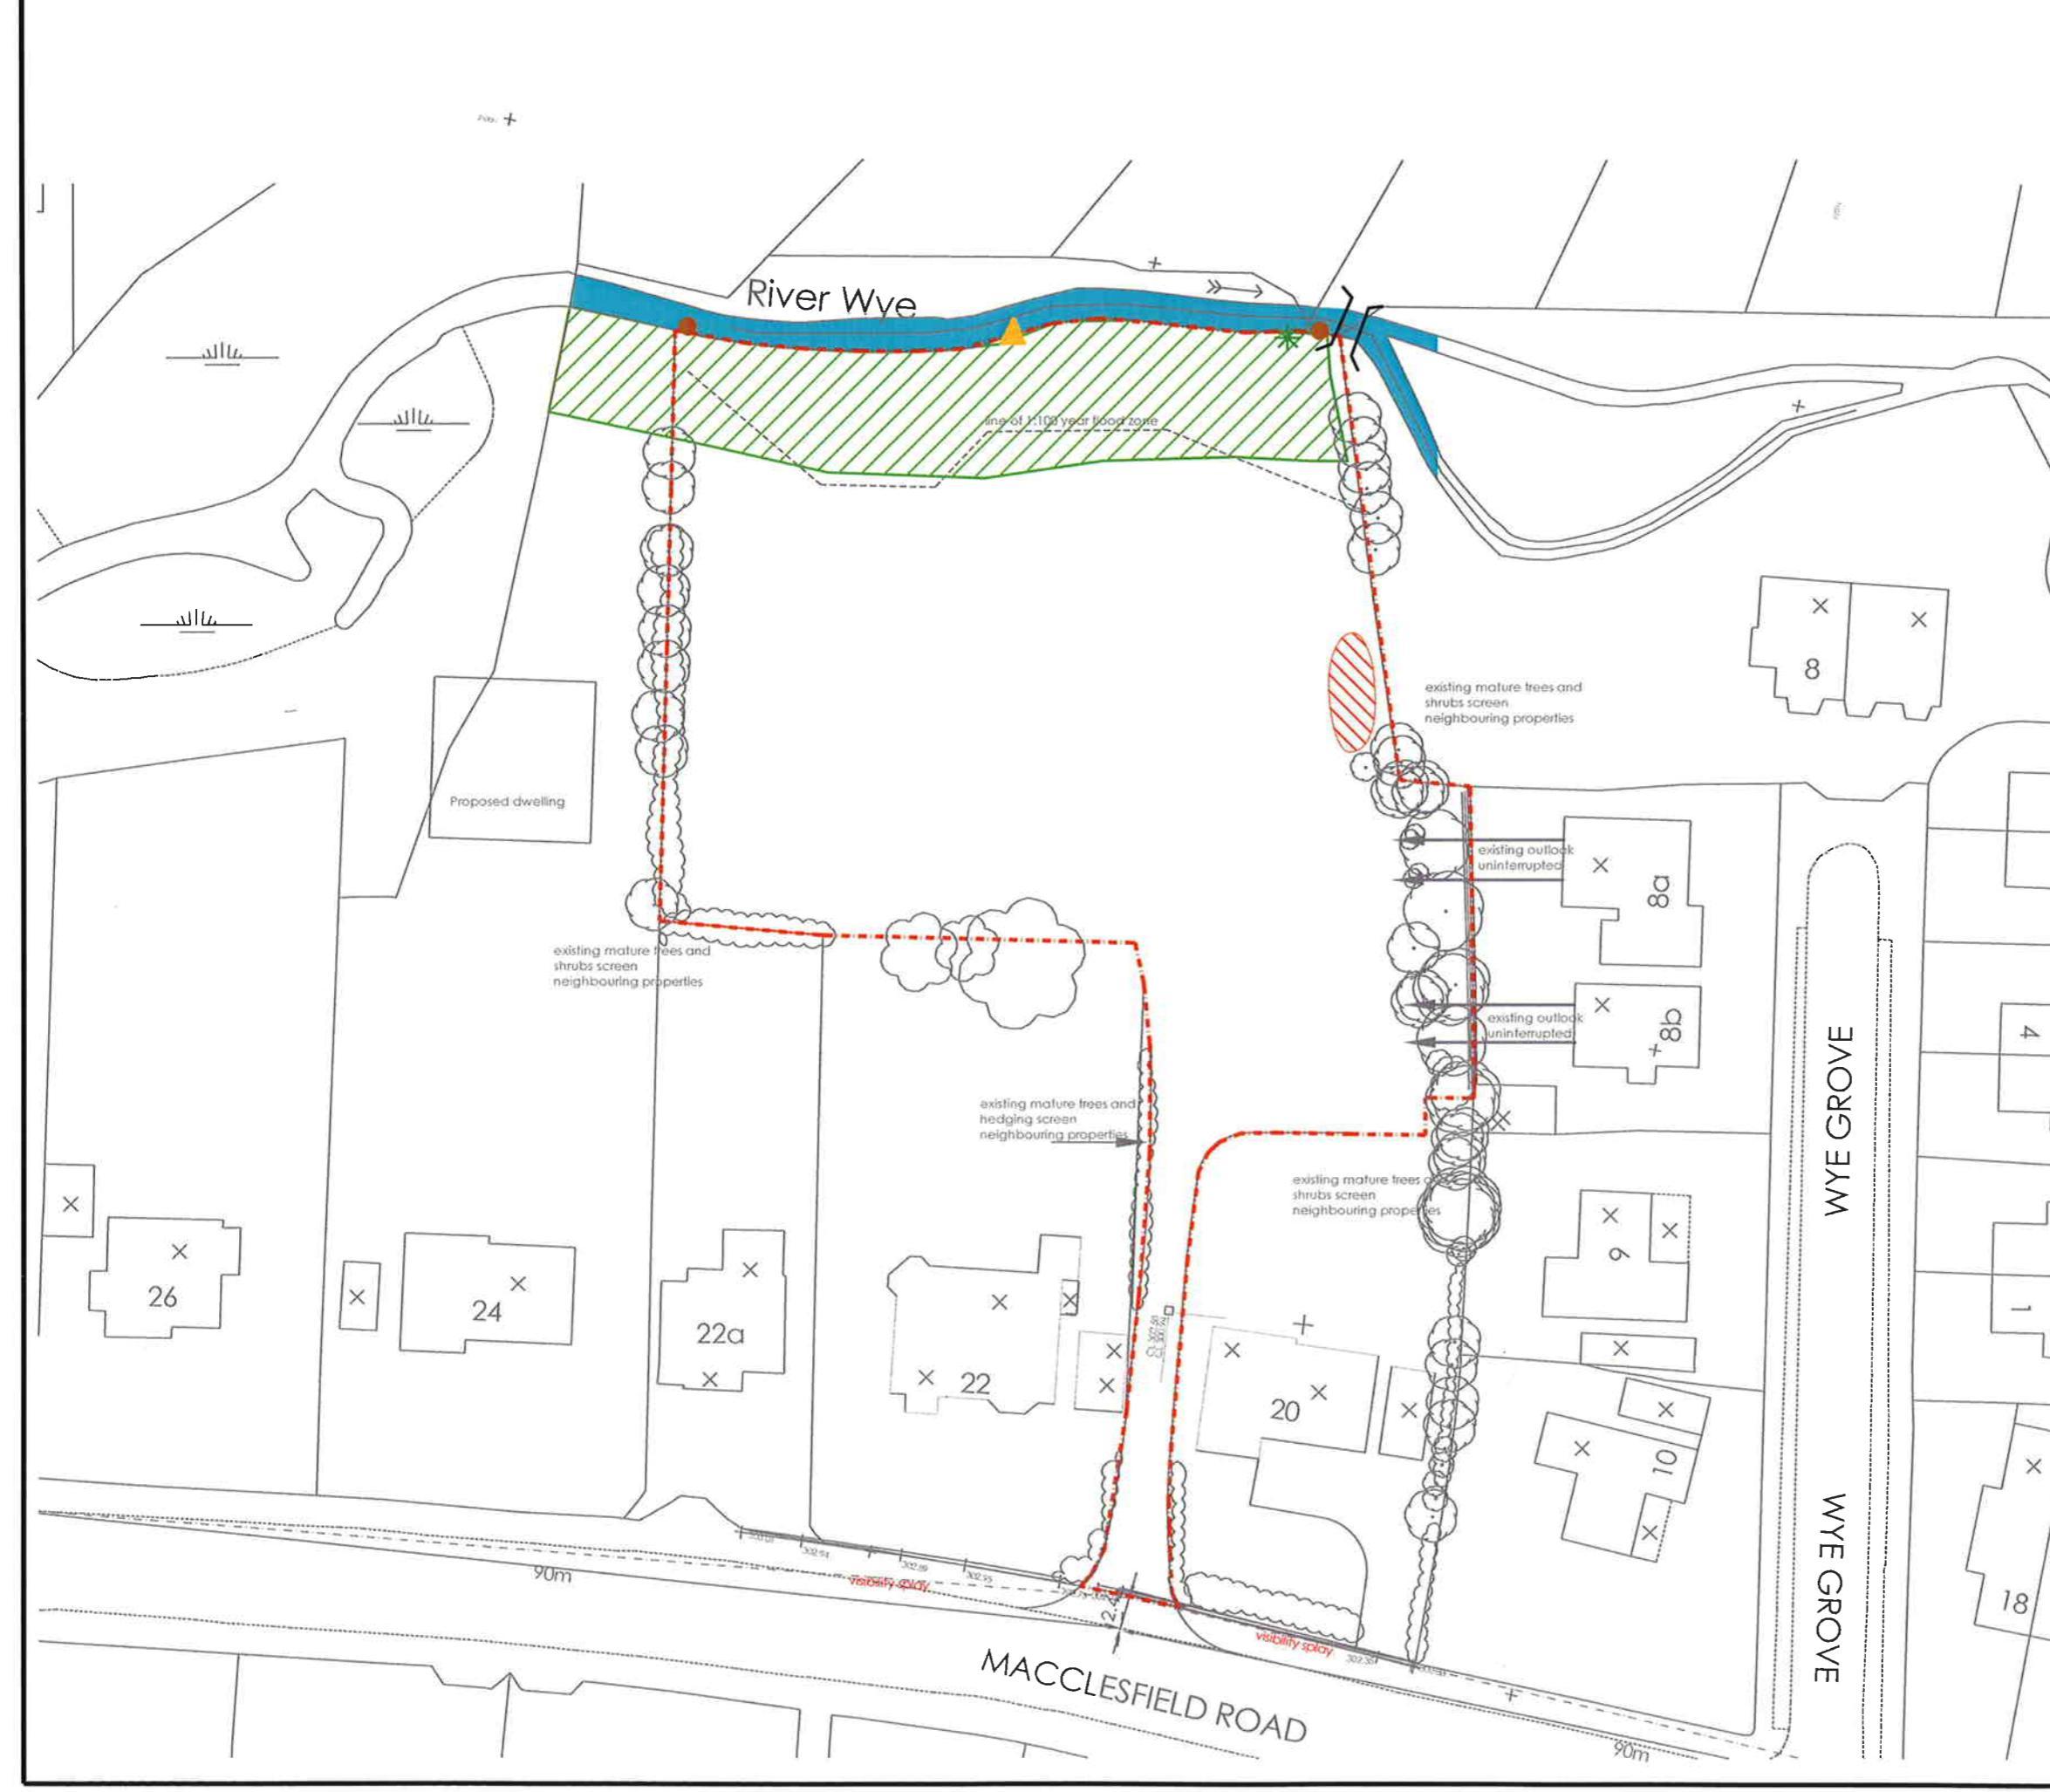
3.3 There is a patch of the alien invasive weed, Japanese knotweed (*Fallopia japonica*) on the eastern boundary of the site in the north (see Drawing D2011.001).

5.1 A patch of Japanese knotweed of approximately 40m² was identified on the eastern boundary of the site in the north (see Drawing D2011.001).

5.2 Two water vole burrows were identified on the southern bank of the river, on the northern boundary of the site (see Drawing D2011.001). One pile of water vole feeding remains was identified near to one of the burrows.

5.3 The marginal aquatic vegetation on the northern boundary of the site provides good food and cover opportunities for water vole.

- 1.6 A Japanese knotweed method statement will be required to prevent the spread of this species during development. Alternatively, a report will be required confirming that all material contaminated with Japanese knotweed has been removed from site prior to commencement of works.

- 1.7 No development should take place within 5m of the southern bank of the river in order to protect water vole habitat.
