REBUILD EXISTING GARAGE IN Random  
NATURAL STONE ON SAME FOOTPRINT  
WITH FLAT SLOPPING ROOF TO REPLACE  
CORRUGATED ASBESTOS/ BRICK & STEEL  
STRUCTURE.

TO THE REAR OF BIRCH COTTAGE, CHURCH LANE  
NEW MILLS SK22 4NP

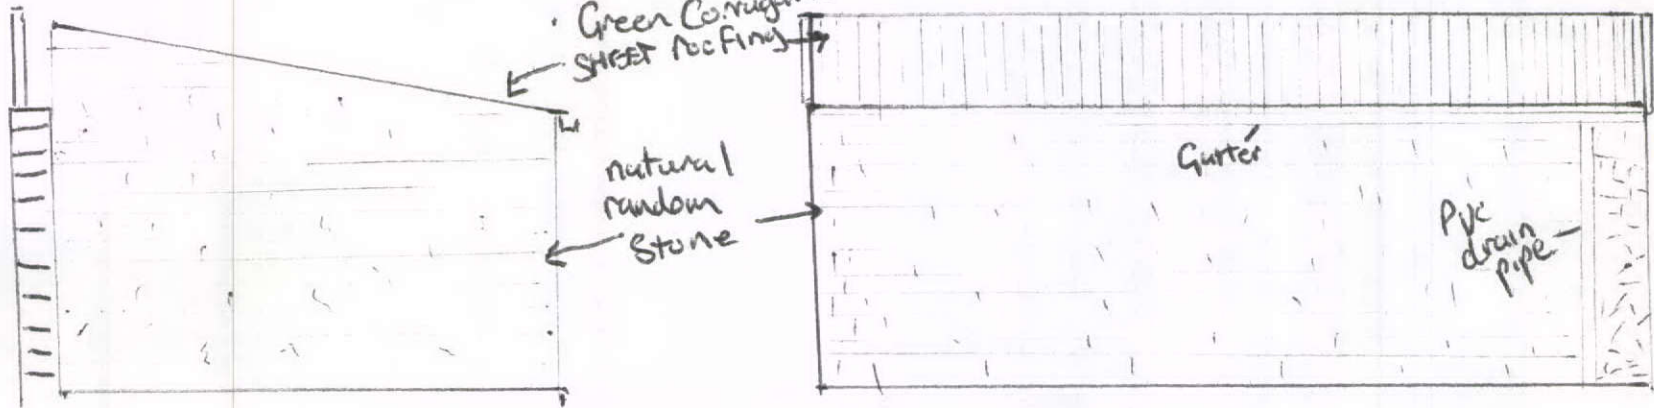
Scale  
1:200

Flat slopping roof to replace Apex corrugate Asbestos

material green corrugated  
sheet metal felt backed

Black rain gutter

Pair Timber  
Door's Painted  
Brown.

Green Corrugated  
Sheet Roofing

natural  
random  
stone

Gutter

Pvc  
drain  
pipe

natural  
random  
stone  
ext walls

Black  
Pvc  
Drain  
To Side  
away
