DRAWING DESCRIPTION
**PROPOSED FIRST FLOOR
 CONSTRUCTION PLAN**

JOB TITLE
**THE RAILWAY
 BRIDGE STREET
 BUXTON, SK17 6BS**

DRAWN BY	M. Taylor	SCALE	1:50@A1
DATE	MAR 2017	DRAWING NO.	1836/12
CHECKED		REVISION

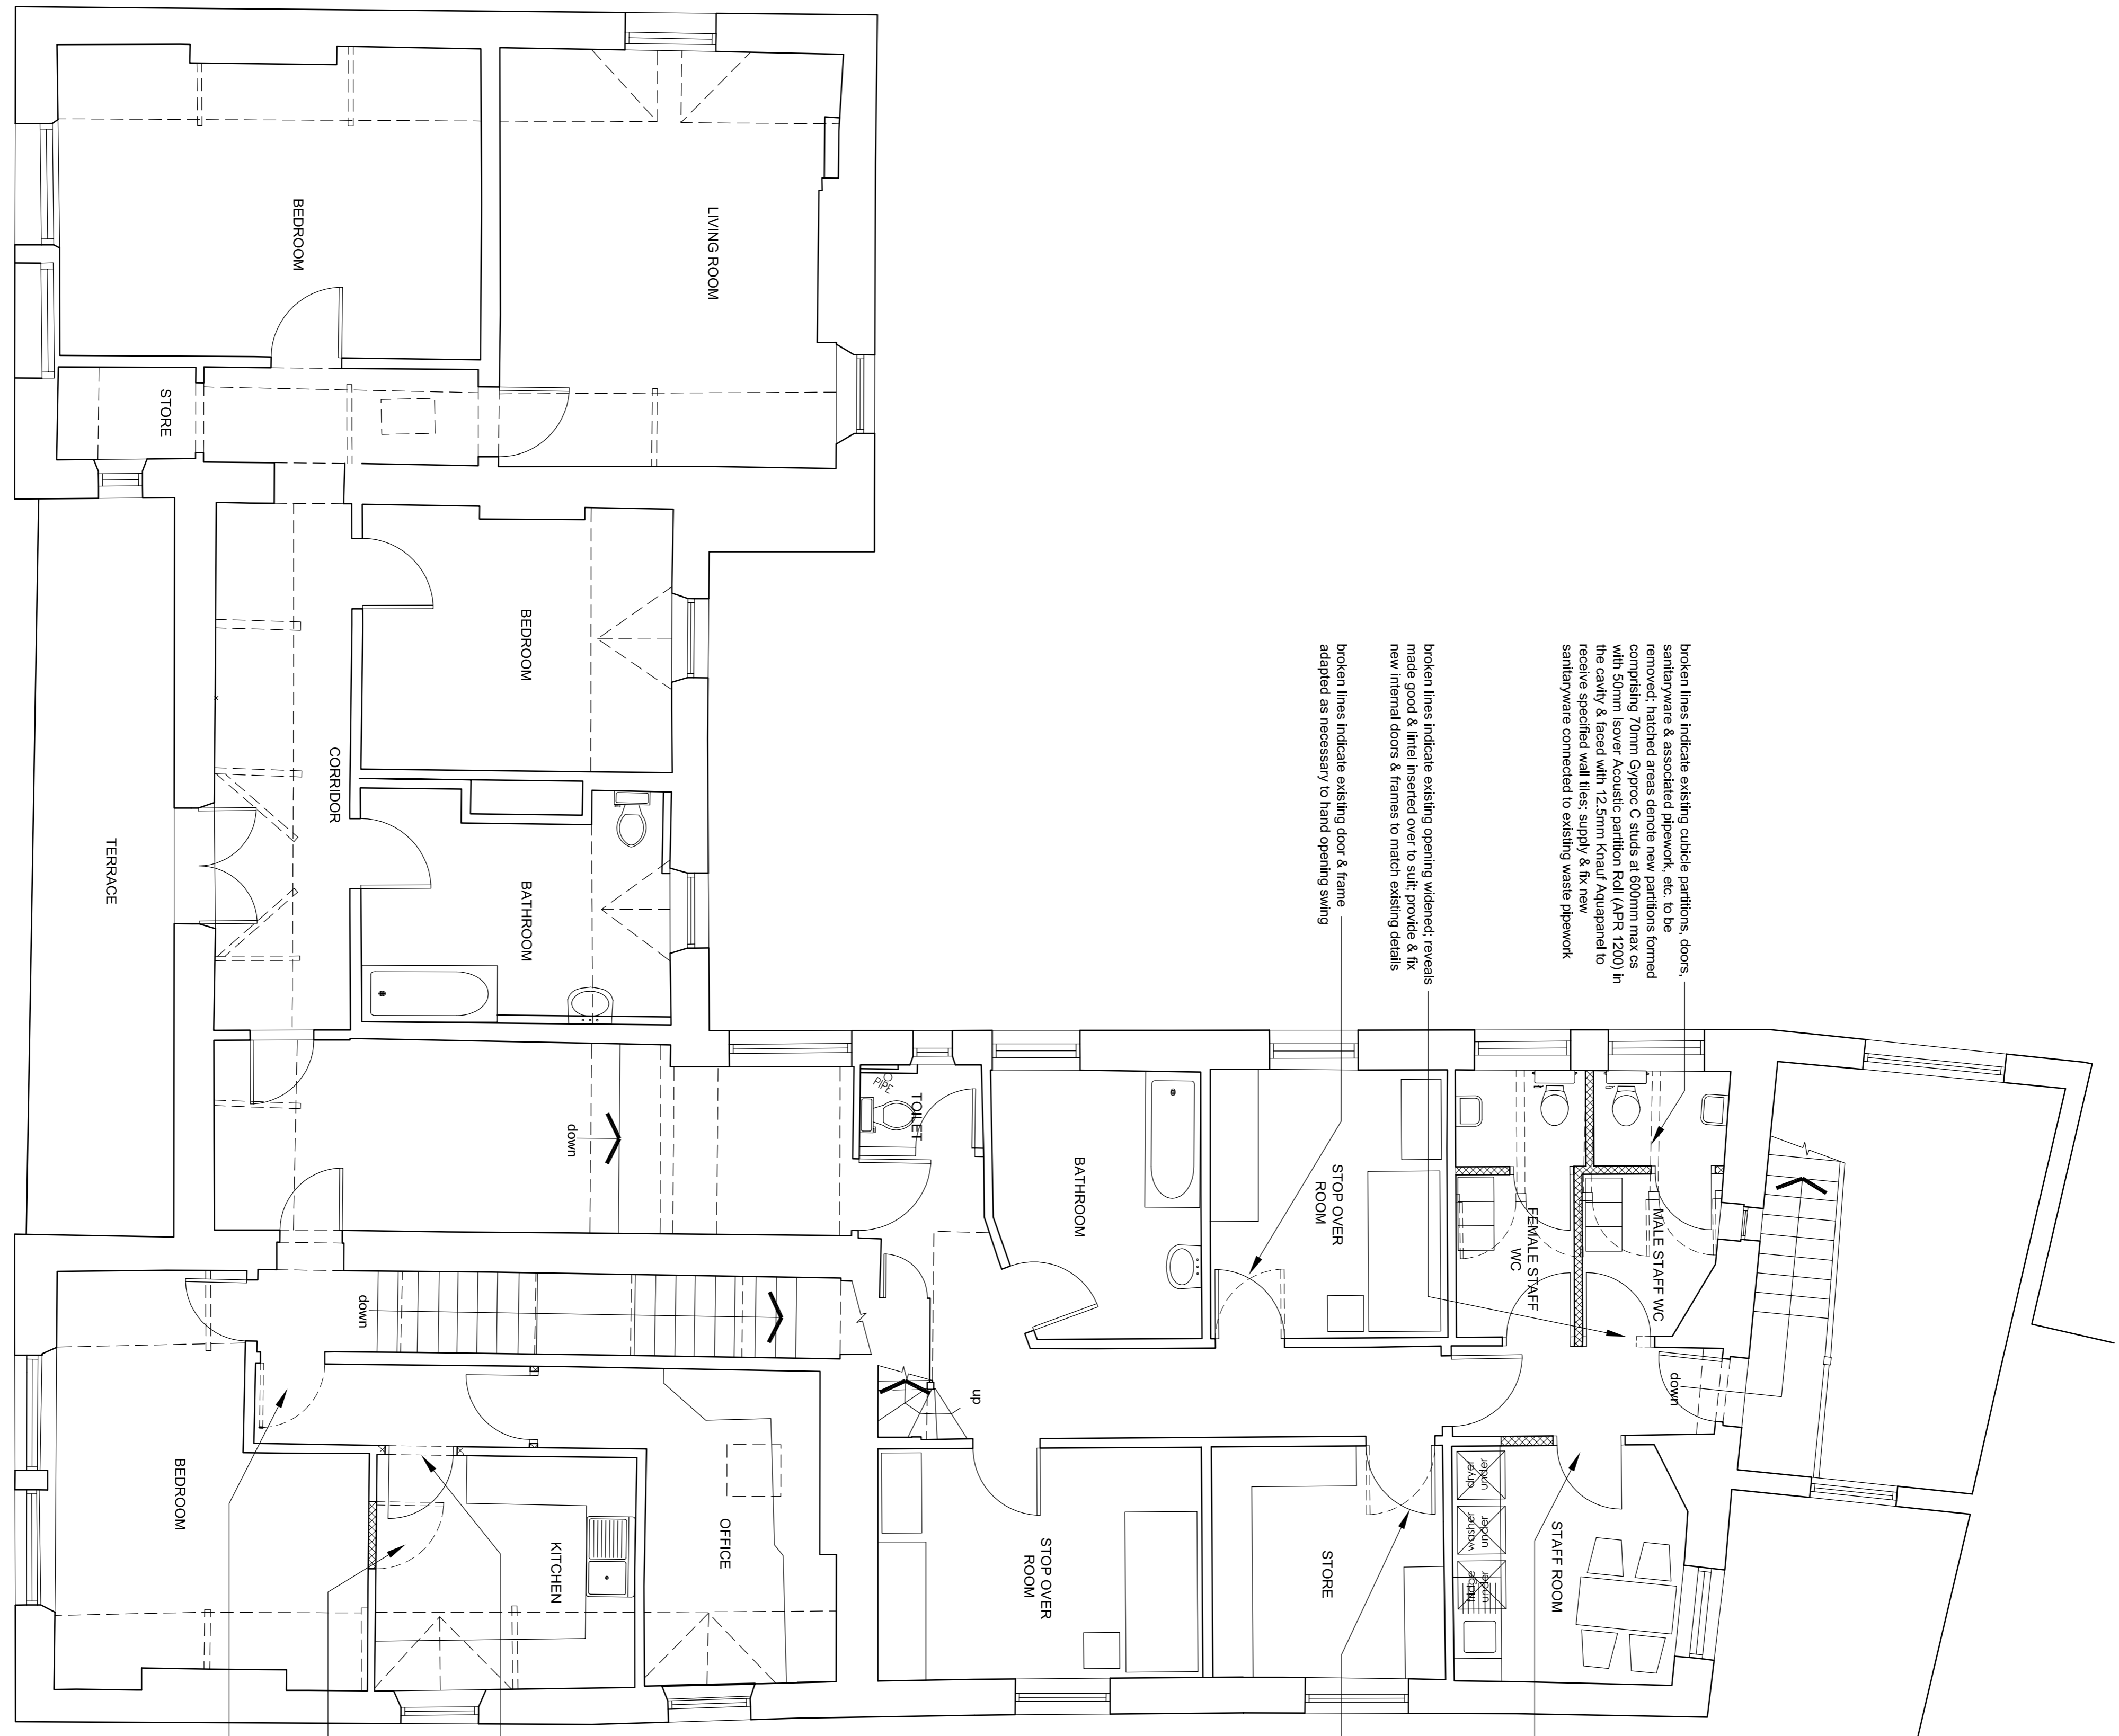
broken lines indicate existing outside partitions, doors, sanitary ware, etc. to be removed; hatched areas denote new partitions formed comprising 70mm Gyproc C studs at 600mm max cs with 50mm Isover Acoustic partition Roll (APR 1200) in the cavity & faced with 12.5mm Krauf Aquapanel to receive specified wall tiles; supply & fit new sanitaryware connected to existing waste pipework

broken lines indicate existing opening widened; reveals made good & lintel inserted over to suit; provide & fit new internal doors & frames to match existing details

broken lines indicate existing door & frame adapted as necessary to hand opening swing

hatched area denotes existing opening partially built up with stud partition to suit existing wall thickness comprising 70mm Gyproc C studs at 600mm max cs with 50mm Isover Acoustic partition Roll (APR 1200) in the cavity & faced with 12.5mm plasterboard, scrim & painted skim finish both sides; supply & fit new internal door & frame to match existing details

broken lines indicate opening formed in existing wall; reveals made good & lintel inserted over to suit wall construction; provide & fit new internal door & frame to match existing

broken lines indicate existing door & frame removed; hatched area denotes opening built up level with adjacent existing surfaces

broken lines indicate existing door & frame removed & reveals made good prior to redecoration
