Application for Listed Building Consent

Property – 8 Eagle Parade, Buxton

Applicant – Hyde Brewery

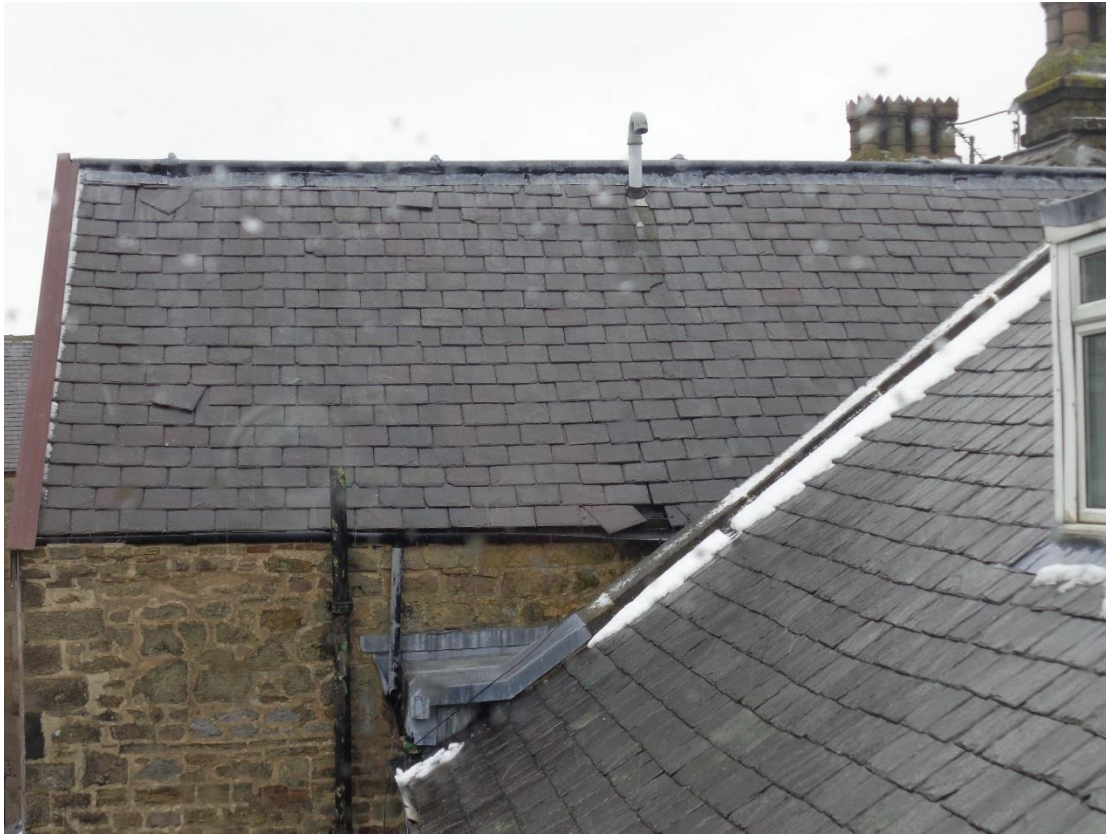
Photo 1 – View of roof to the rear of the property.

Firstly, there is severe moisture ingress causing a number of apartments to be inhabitable. This is due to the roof, guttering and render to the rear of the property. The works will try to salvage as much of the existing roof slate tile as possible, however we anticipate a 50% replacement with like for like tiles. The rear annex is currently roofed in fibre cement tiles, we propose to remove these and replace with slate, which will be more in keeping with the remaining property. The roof will be lined with a breathable membrane to assist the internal condensation issues.

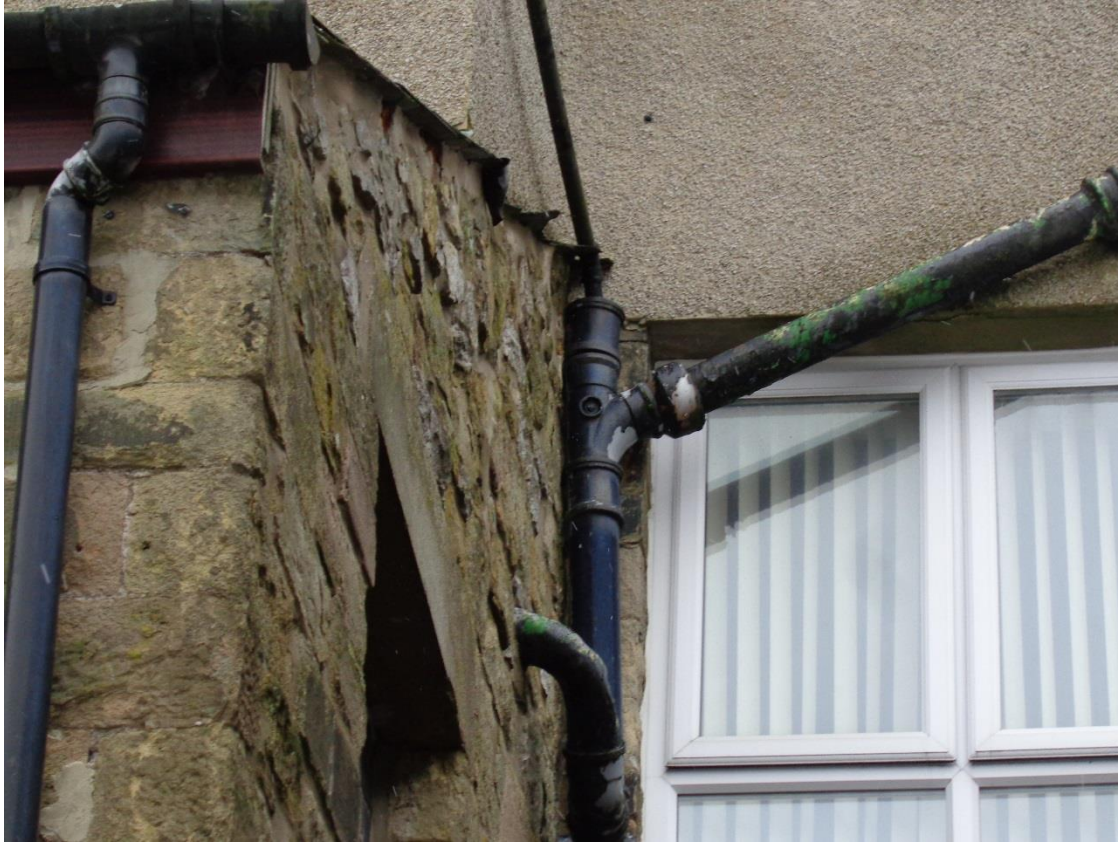
Photo 2 –Guttering to be replaced, impeding on window.

Another cause for concern in relation to the leak, is the guttering, this appears to be too small for purpose. We proposed the installation of a deep flow water system to correctly route the water away from the rear of the building and contribute to diminishing the leak.

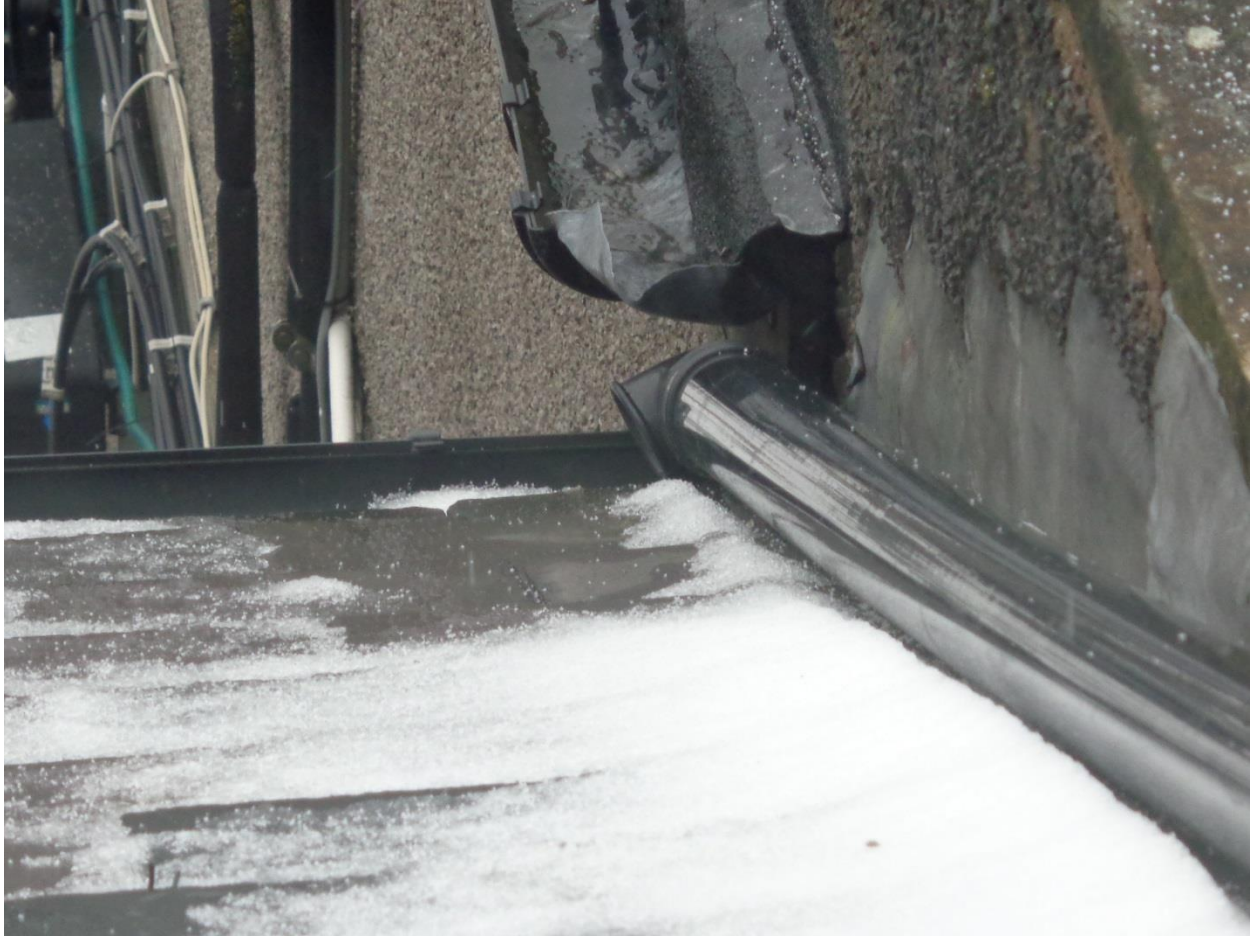
Photo 3- Existing Gutter system

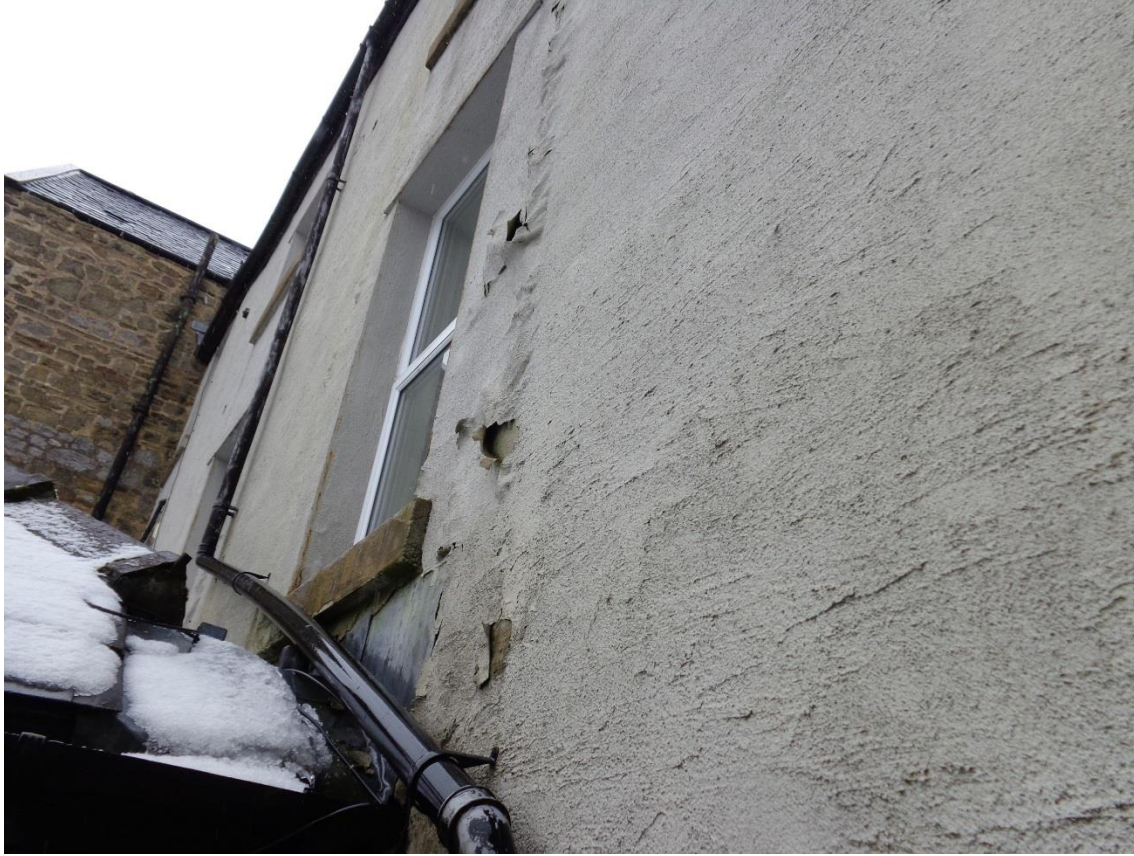
Photo 4 – Rear render to be replaced with breathable render.

Due to the above factors, the render is in need of serious attention. The type of render as existing appears to be trapping in water. We propose a removal of this and a new K Lime render applied which will be breathable, with a stone base. In this area we will also require cleaning of the building using a Jos system.

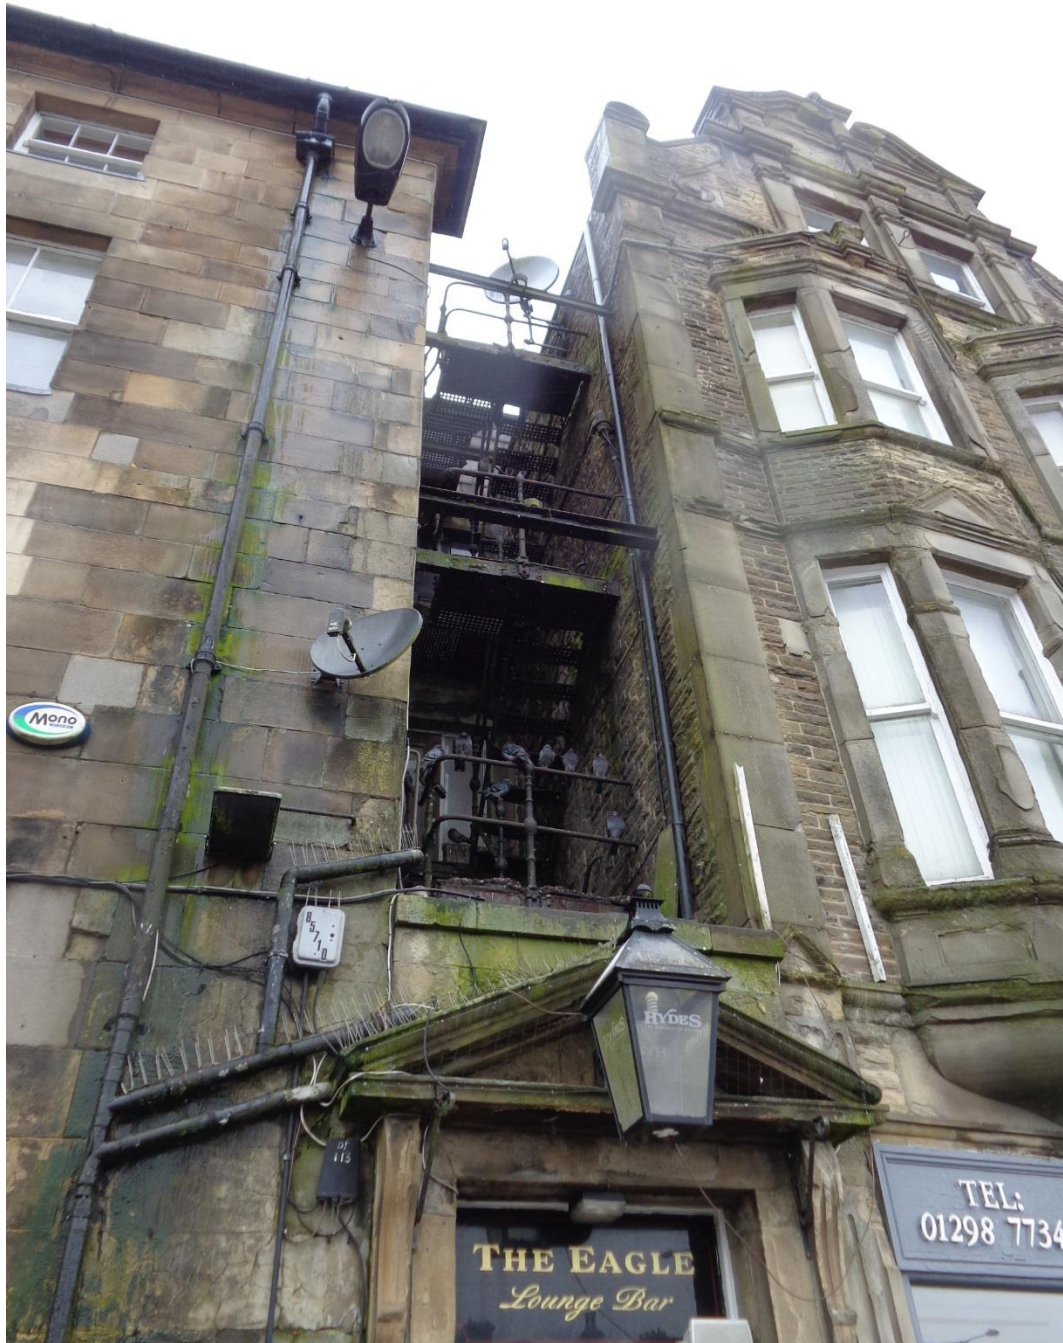
Photo 5 – Existing dilapidated fire escape to front elevation.

The existing redundant fire escape to the front elevation is facilitating moisture ingress and promoting dry rot to the interior of the building. This is also harvesting a pigeon infestation and health risks associated with the pigeon guano. There is also associated splash back from the landing/steps causing saturation to the stonework. The dilapidated fire escape is not required as we have a number of suitable and compliant means of escape, we propose this to be removed in its' entirety to eliminate health issues and moisture issues to the building.
