Proposed replacement dormer windows

project Refurbishment of George Mansions  
St John's Road, Buxton

drawing Replacement dormer window details original size A1

job no. SHD059 drawing no. AA(2)02 revision A

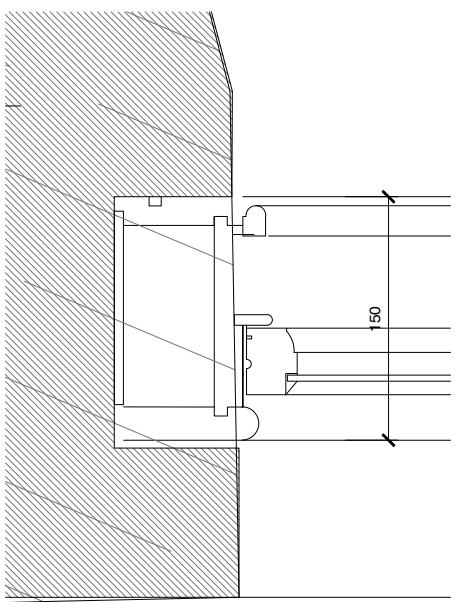
Detail D - Case detail

Case construction indicative only in all instances
