PROPOSED CHANGE of USE of EXISTING GARAGE to LIVING ACCOMMODATION at KYRTON VILLA CHINLEY DERBYSHIRE

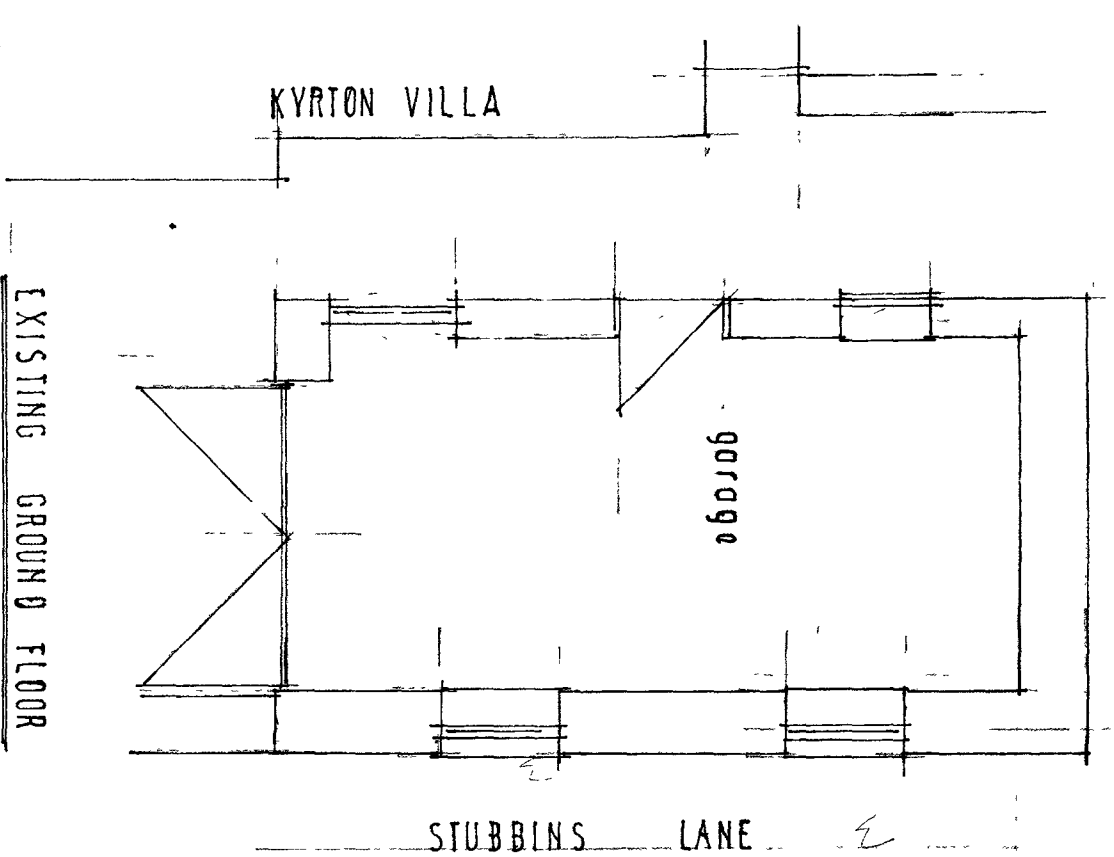
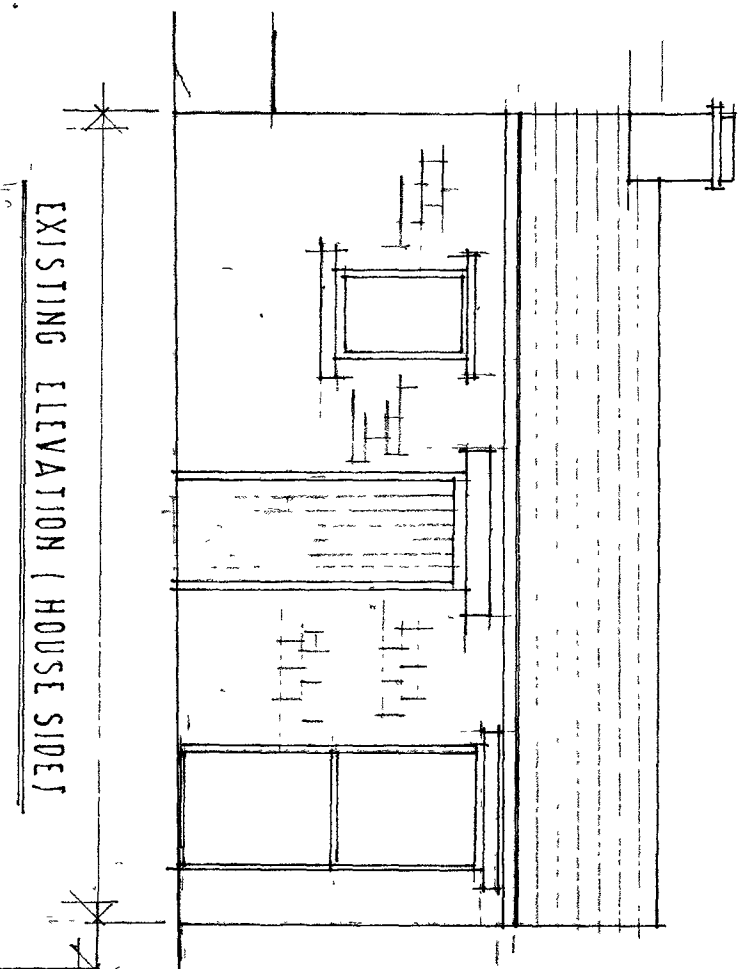
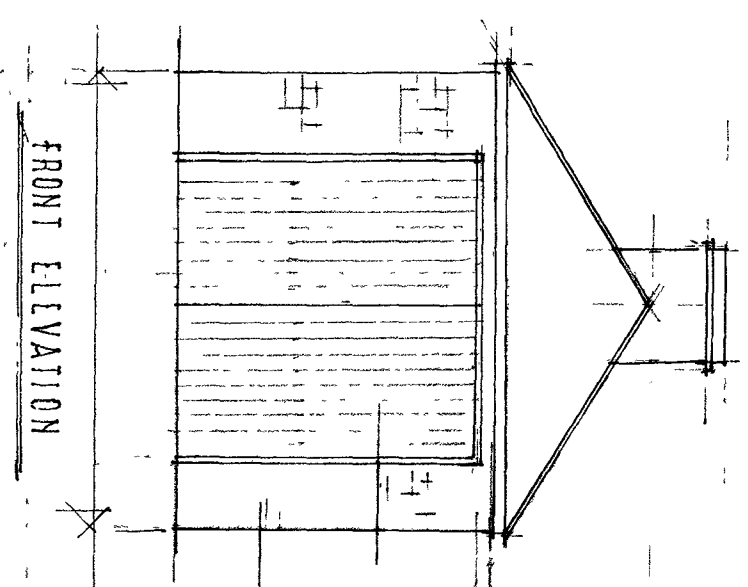
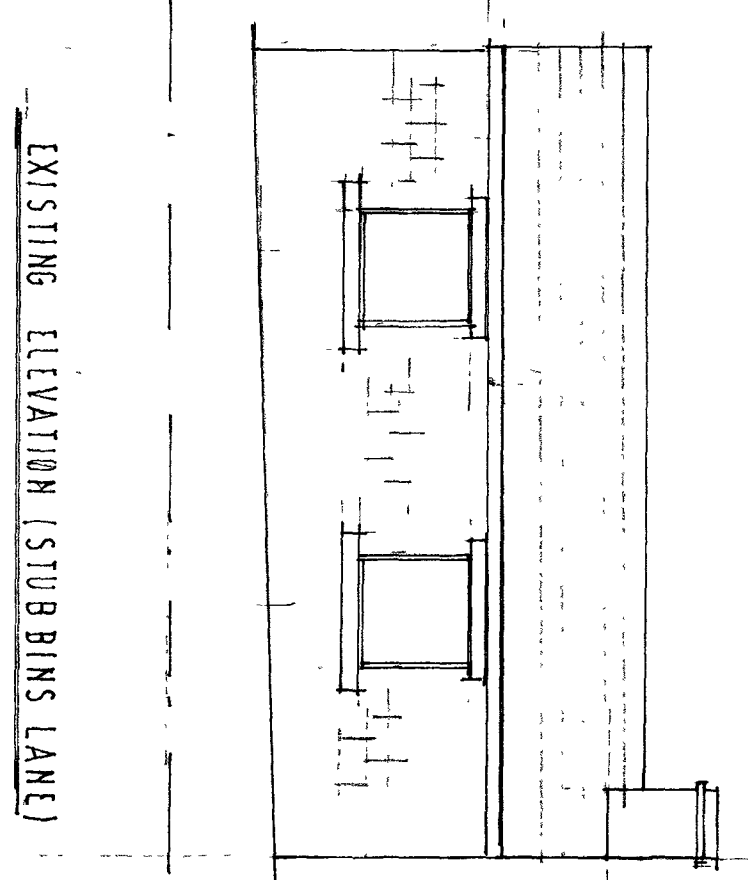
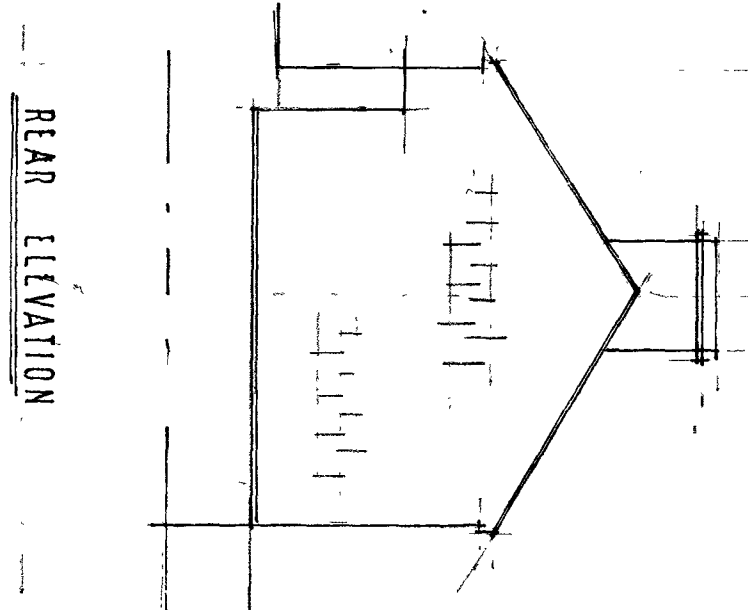
Structurally unstable walls with a mix of natural stone and brickwork including deteriorated steel lintels.

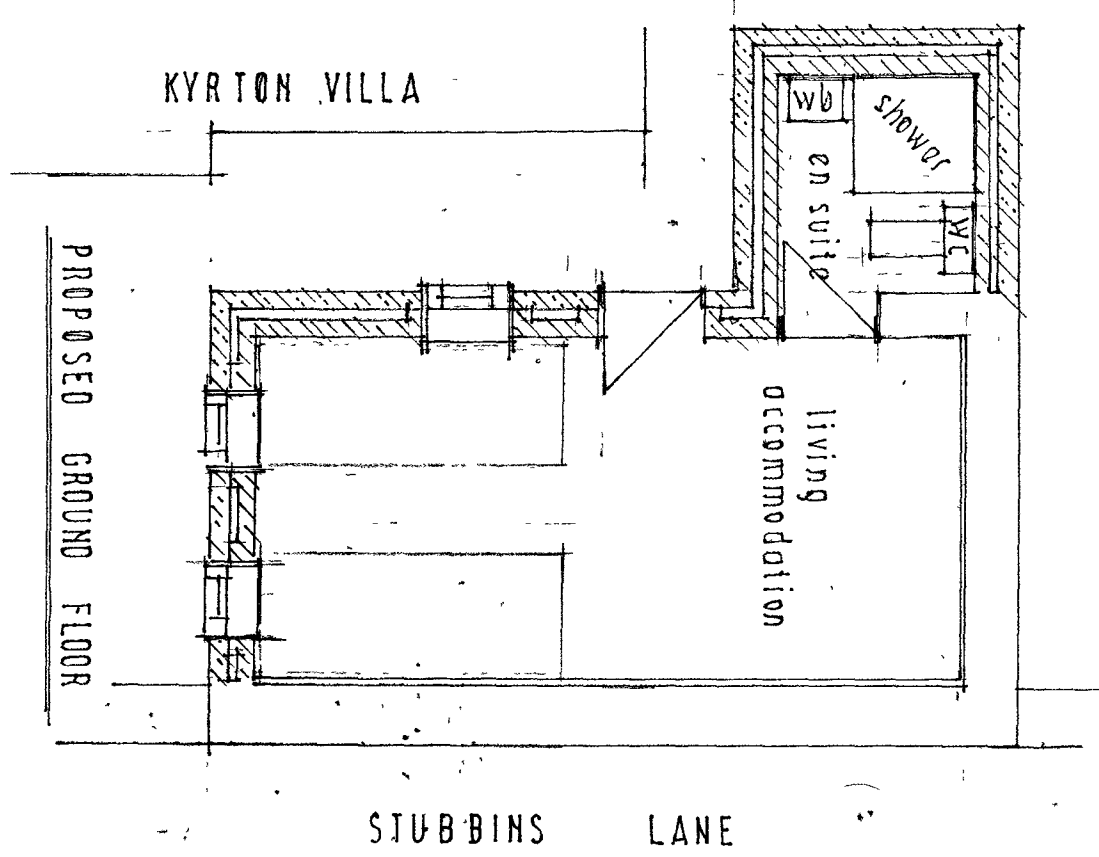
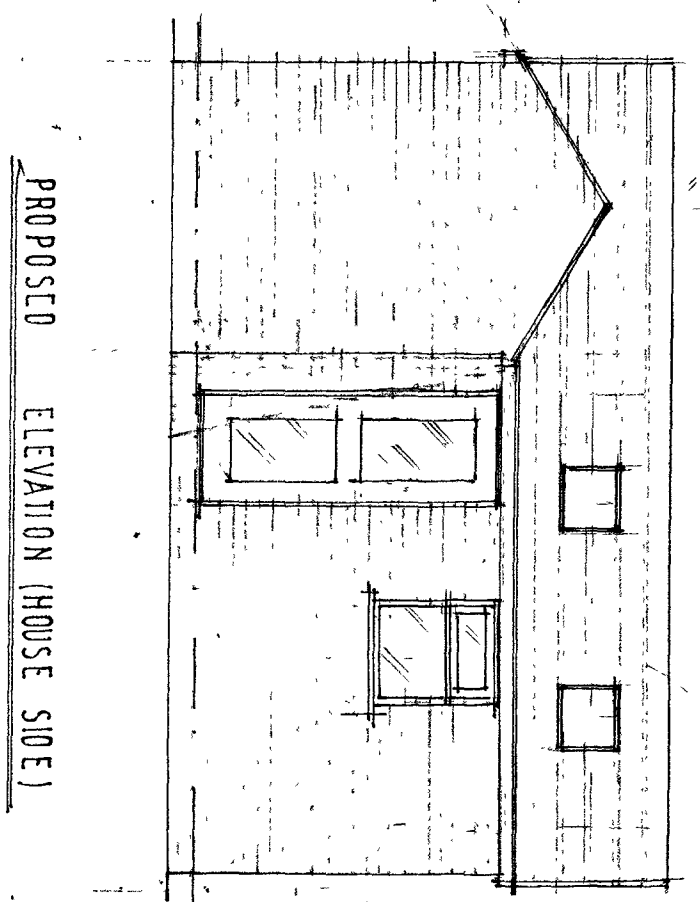
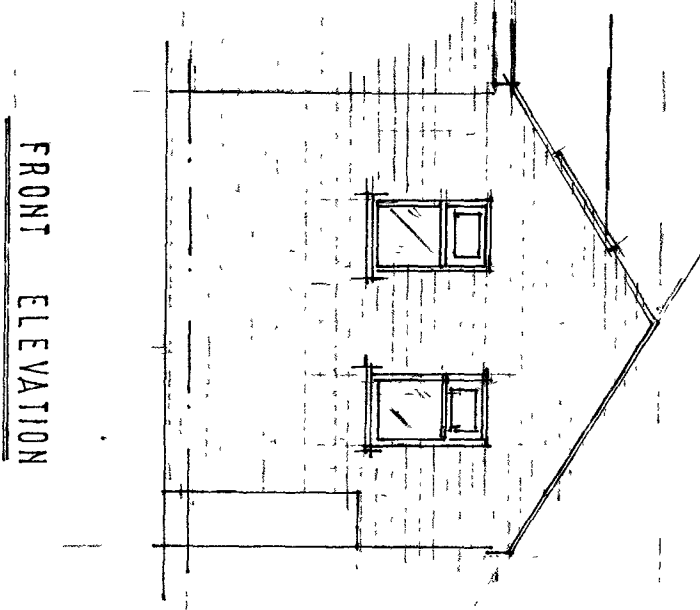
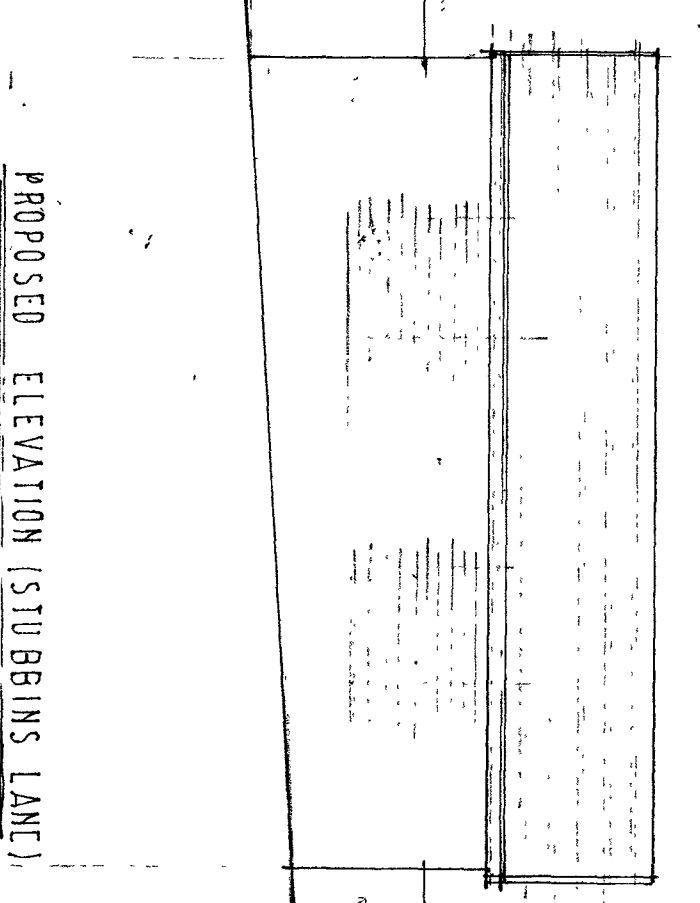
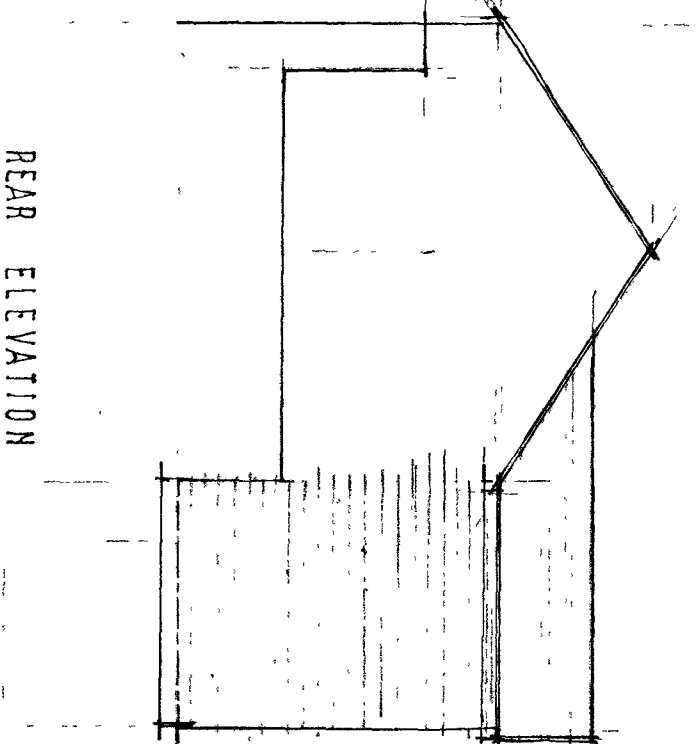
New walls to be natural stone (as existing) with blue slate roof finish (as existing)
